Project Number: 51308-008  
September 2023

## India: Uttarakhand Climate Resilient Power System Development Project

### Appendices Part 7

**Table 4.7 Representative photos showing impacts on substation flora**

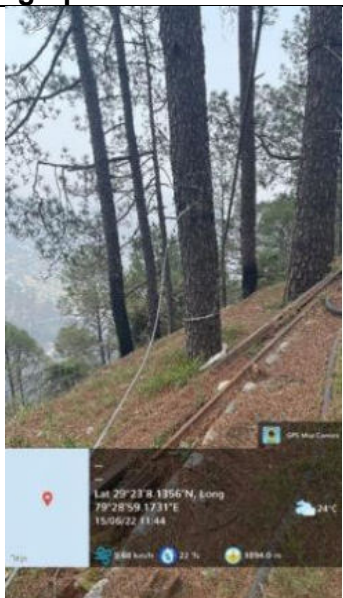
Concern	Sample photograph
<b>Pines substation:</b> Cables around Chir Pine tree ( <i>Pinus roxburghii</i> ) and poles stored in root zone.

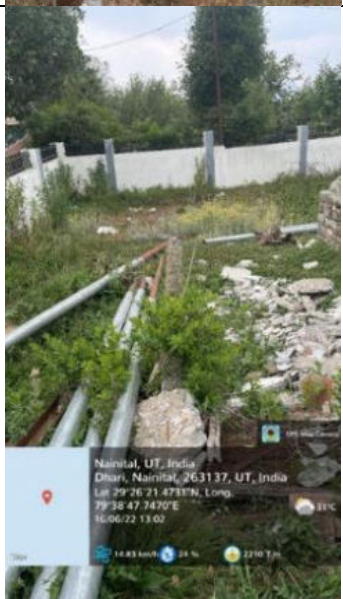
A photograph showing a Chir Pine tree with several cables and poles stored in its root zone. The image includes a GPS overlay with coordinates: Lat 29°23'N, Long 79°28'59" E, and a date of 15/06/22 at 11:44. The temperature is 24°C.
<b>Sarghaket substation:</b> ongoing renovation, and storage of materials.

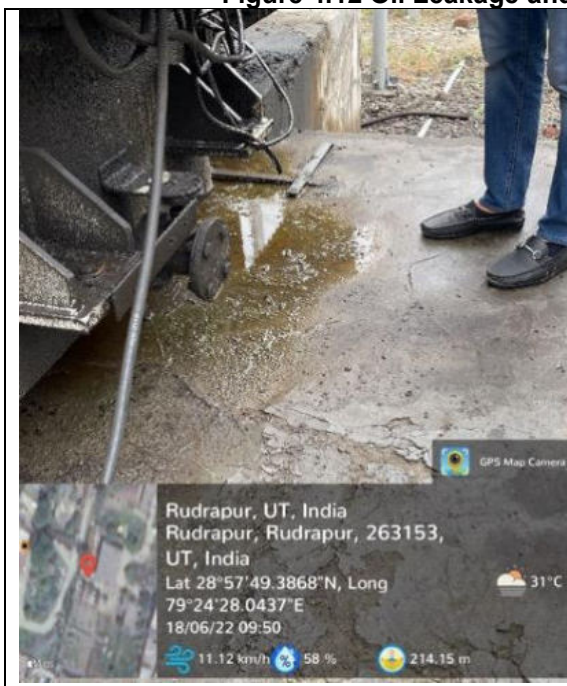
Badhaipura SS

Figure 4.12 Oil Leakage and contamination in substation

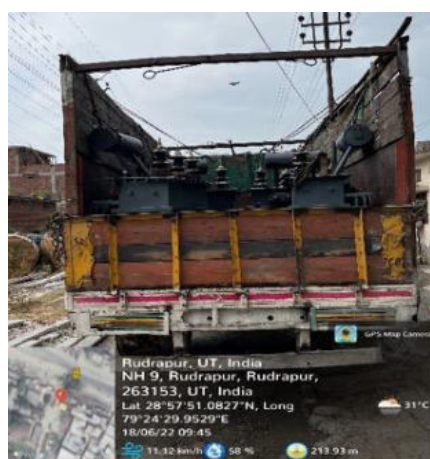
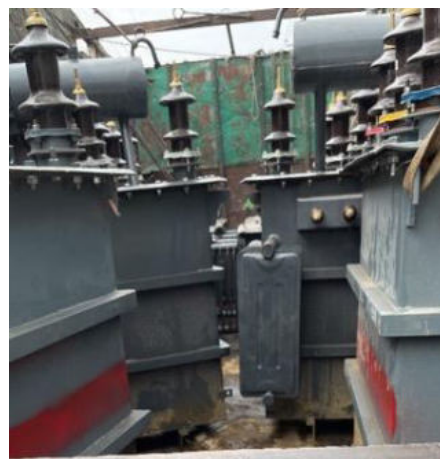
Badhaipura SS: Transformers being transported in trucks for repair/disposal with no lining - potential for oil leakage along road during transport

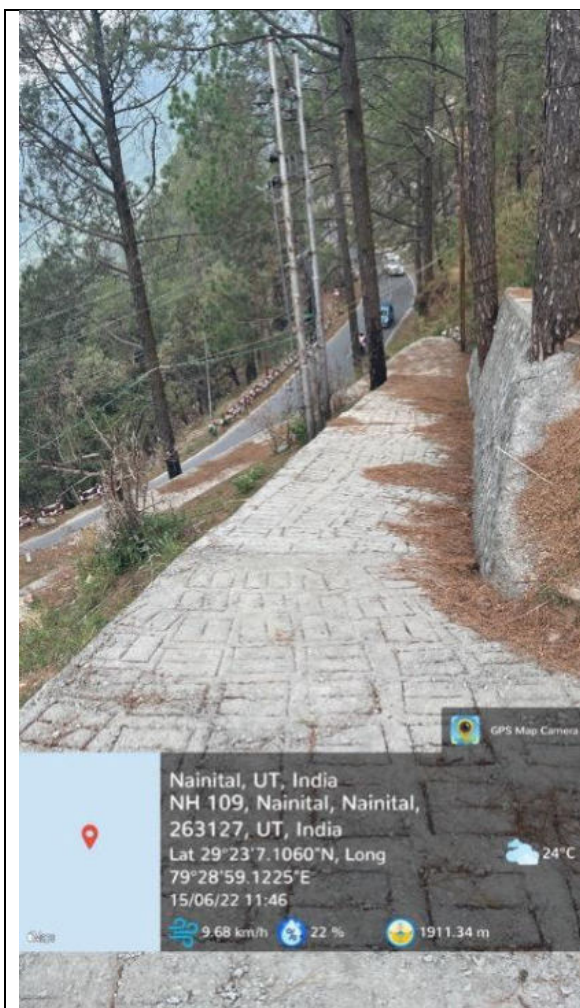
Pines SS: Substation access road – very steep, no vehicle access into SS

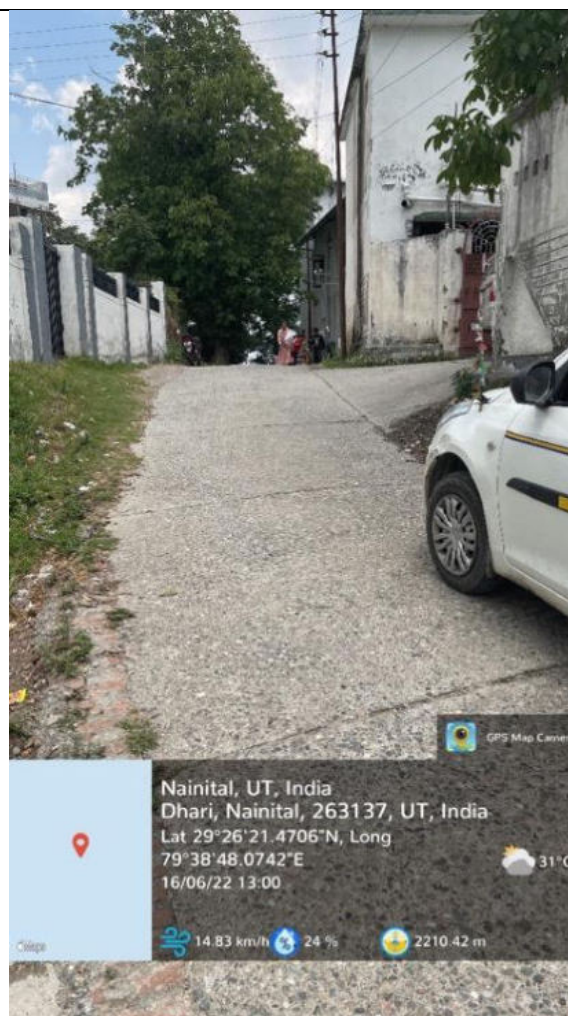
Sarghakheth SS: Access road – Narrow and uphill

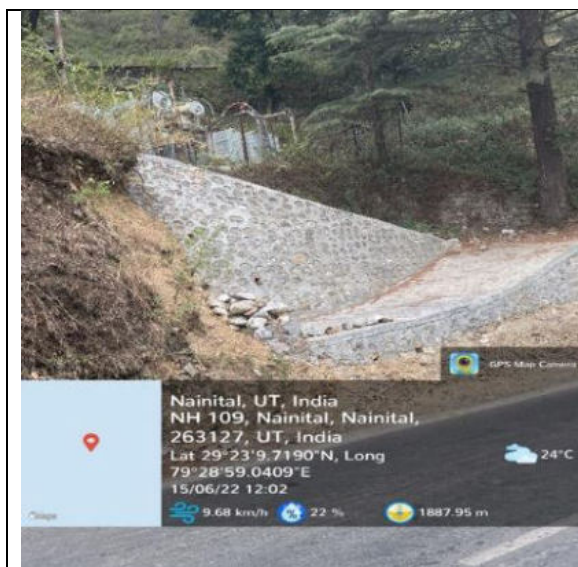
Pines SS: Transformer zone near to main road level – traffic disruption during crane operations to replace transformers.

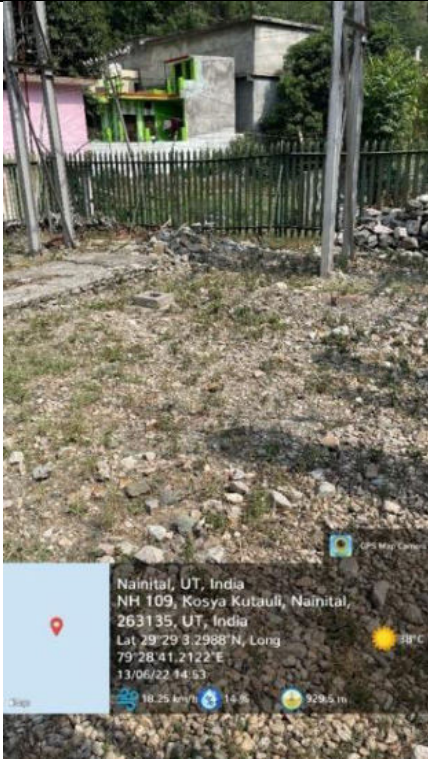
**Garampani SS: Unpaved and uneven yard**

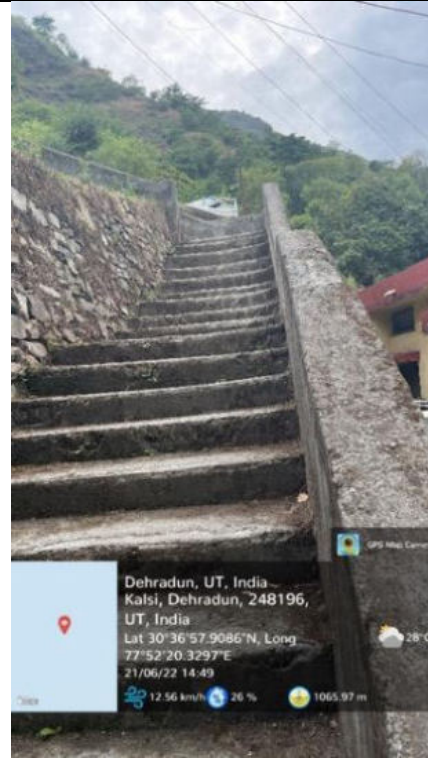
**Sahiya SS: entrance to substation below road level**

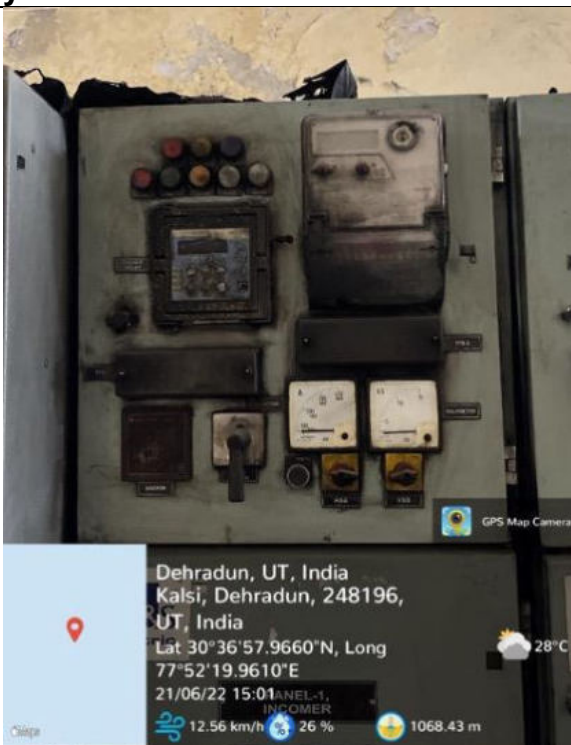
**Sahiya SS: Brunt control room equipment after major fire in 2021**

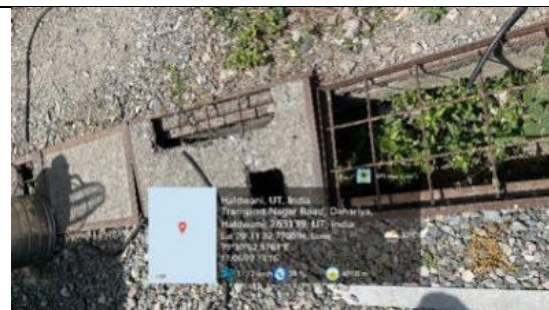
**Transport Nagar SS: gaps and cracks in yard**

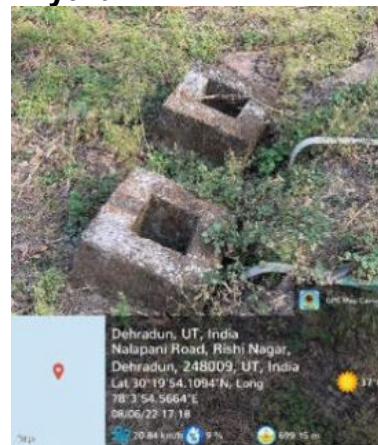
**Sahastradhar SS: Open pits in yard**

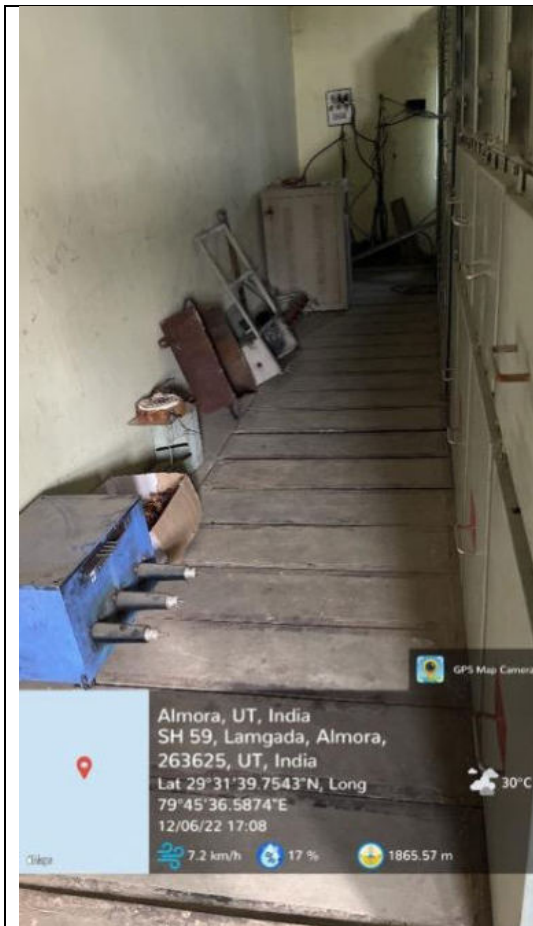
**Lamgarah SS: Limited ventilation and natural light**

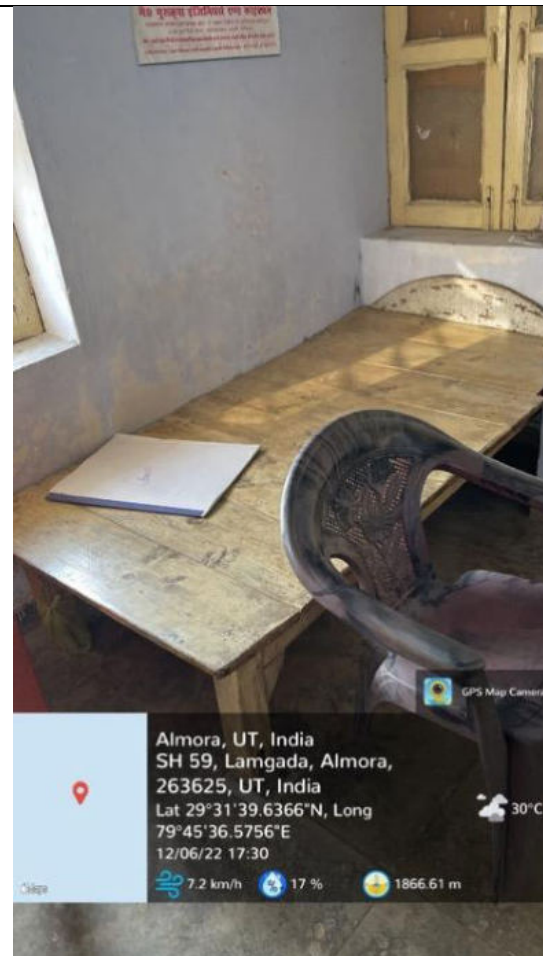
**Lamgarah SS: Resting area inside control room**

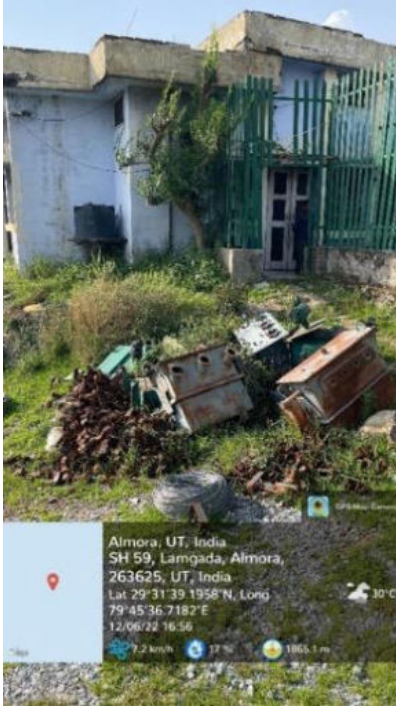
**Lamgarah SS: Damaged infrastructure - control room**

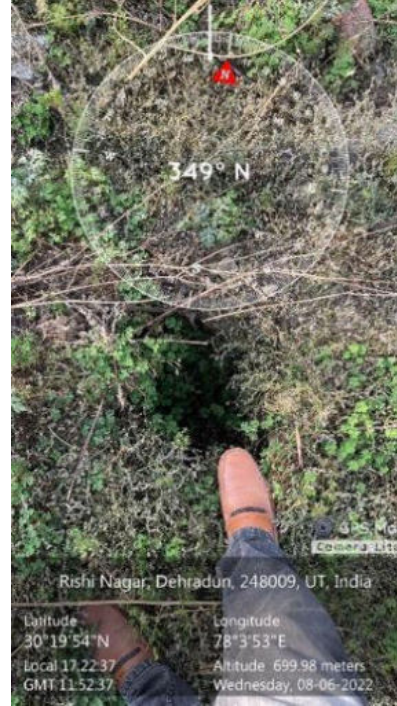
**Sahstradhara SS: Hidden pits in yard**

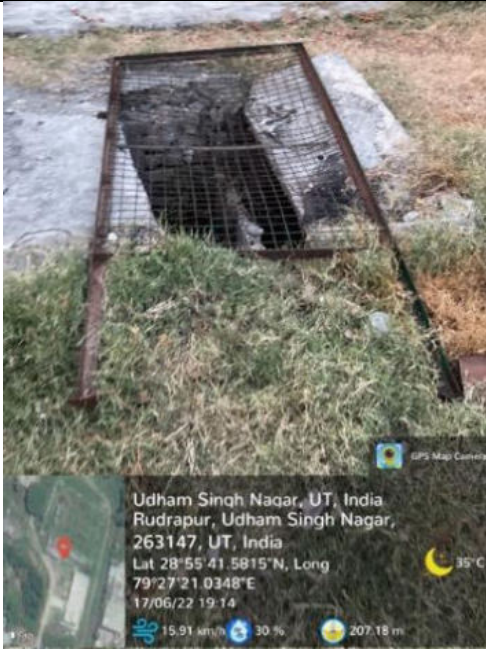
**Lalpur SS: Pit covered with net**

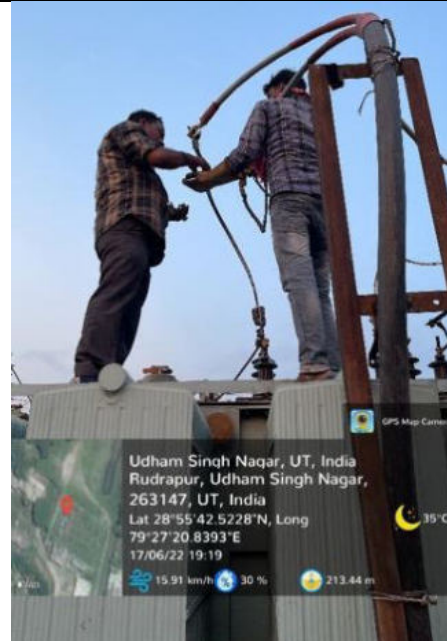
**Lalpur SS: Workers on transformer without PPE**

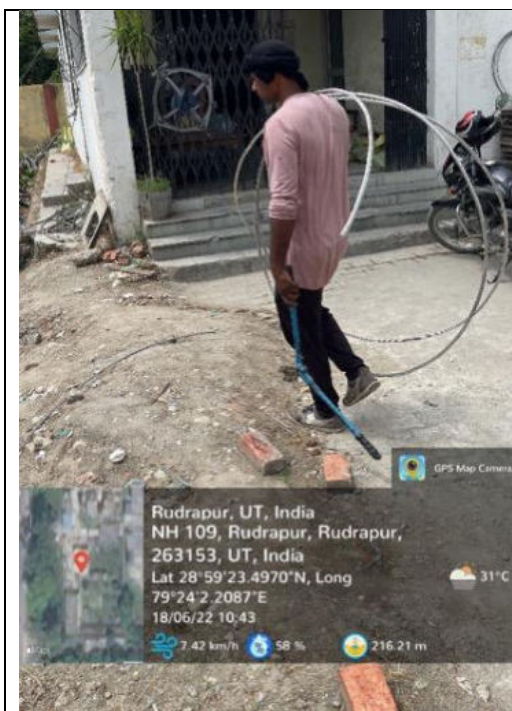
Matkota SS: Workers without PPE

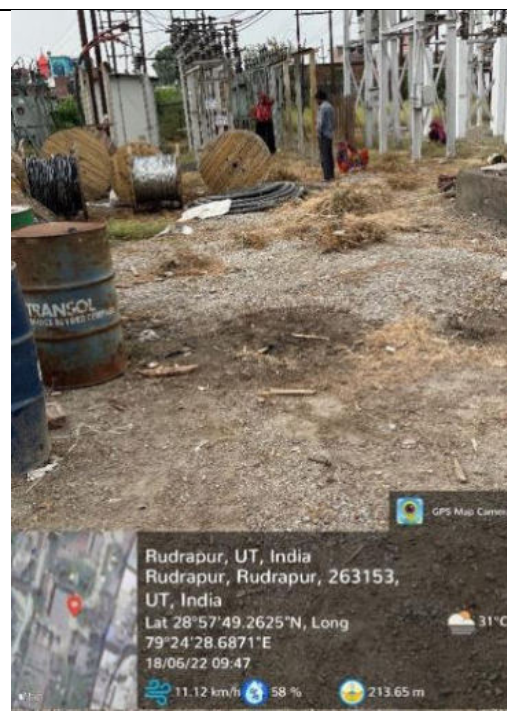
Badhaipura SS: Locals used for yard cleaning without PPE

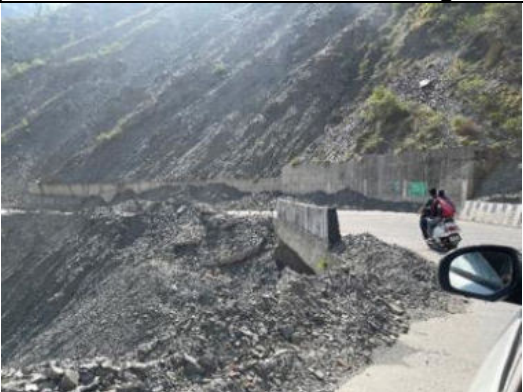
<p><b>Sahiya and Sawra SS: Steep terrain and landslide along access road</b></p>

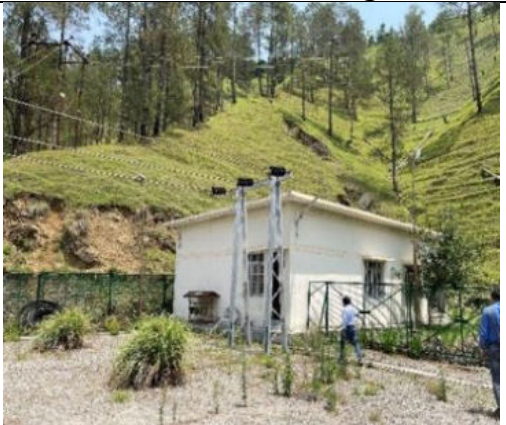
<p><b>Sairaghat SS: Landslide and trees uprooted by cyclone in the background</b></p>

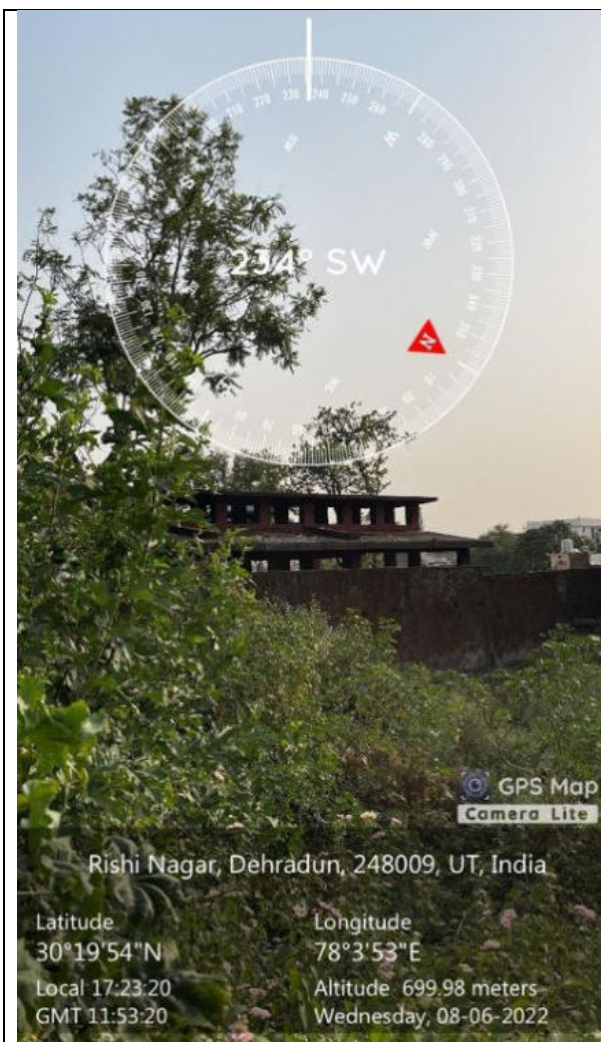
Sahastradhara SS: Crematorium adjacent to substation

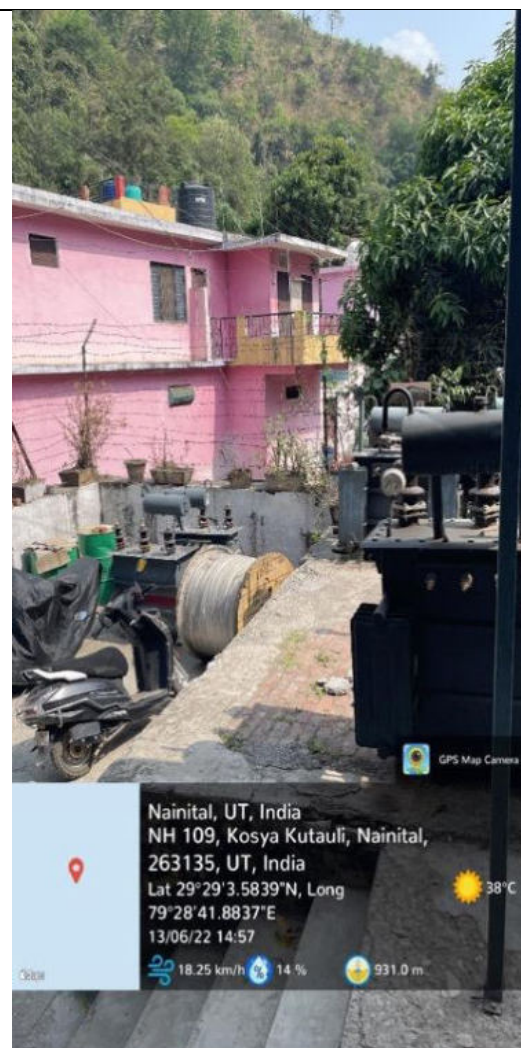
Garampani SS: private residence adjacent to substation

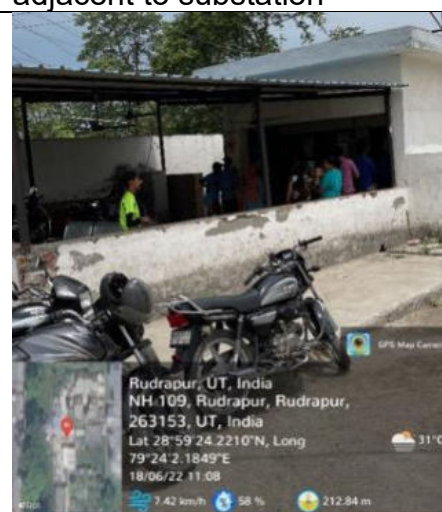
Matkota SS: Electricity office for bill payment inside substation compound

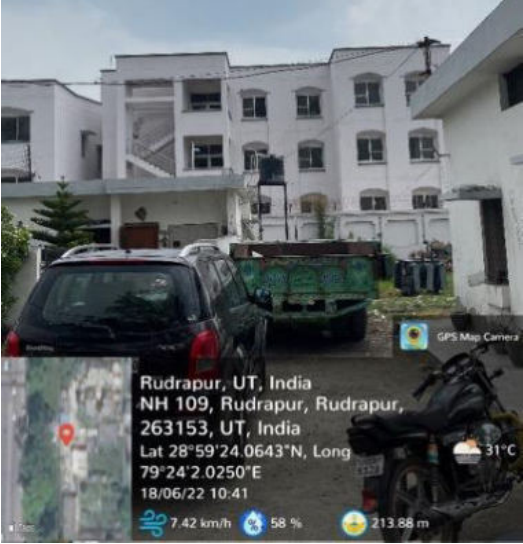
<p>Matkota SS: New hospital and medical college adjacent to substation</p>

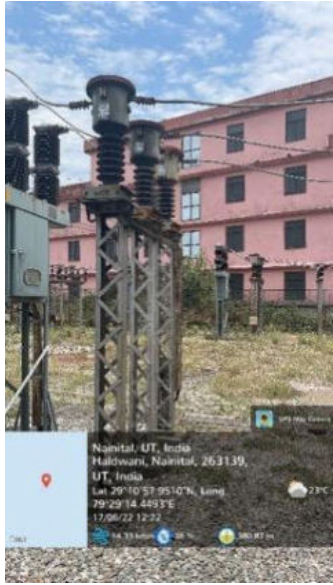
<p>Phoolchaur SS: School adjacent to substation</p>

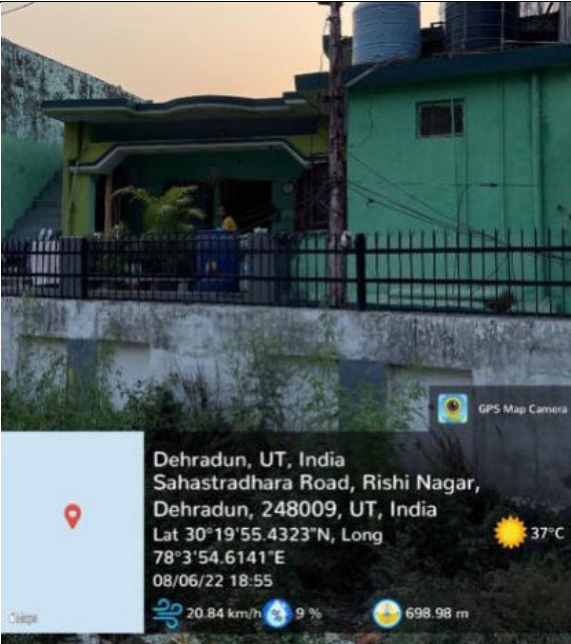
<p>Sahastardhara SS: Low walls are easily scaled by locals</p>

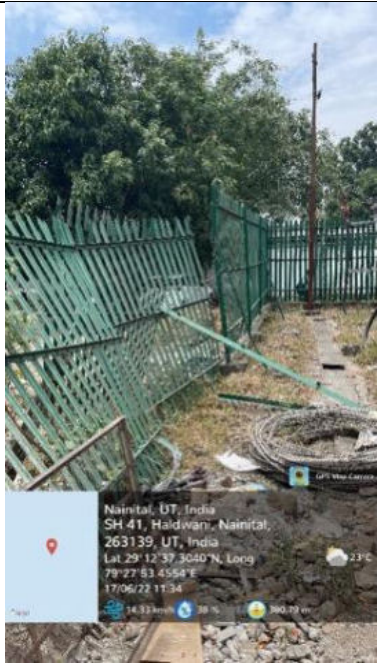
<p>Kamalwaganja SS: Damaged fencing</p>
