# Compliance status report (2026) of 05 Nos Critical recommendations of High Power Committee Final Report (July 2020) for Char Dham Pariyojna

Two roads of Chardham Road Deveopment Pariyojna namely 1- Rudraprayag-Gaurikund M/R NH-107 and 2-Dharasu-Jankichati M/R NH 134 are under purview of High Power Committee (Non stretegic Road). The compliance status report of above two roads is as under.

### Details of Identified Vulnerable Landslide Points on Rudraprayag-Gaurikund NH-107

## Details of Identified Vulnerable Landslide Points on Dharasu – Jankichatti NH-134

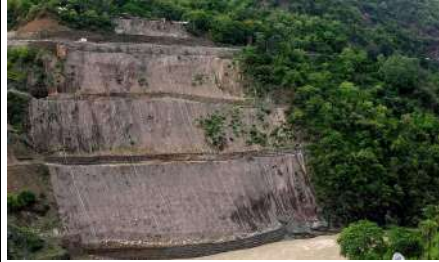
2	2.130 to 2.260	30°17'15.14" N, 78°58'25.19"E, Sinking	Jute Mat, Soil nailing and River protection works	Work Completed	-

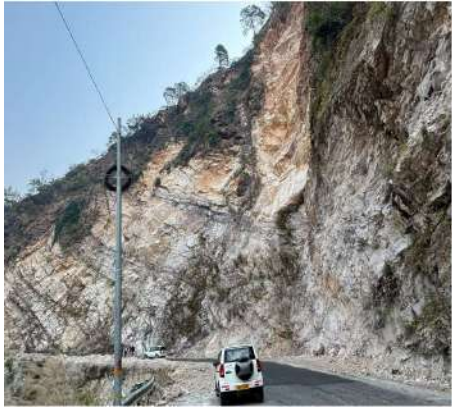
3	4.800 to 4.950	30°18'12" N, 78°58'55"E,  Landslide	Loose scaling, netting with SDRA, shotcrete with sandwiched chainlink fabric with rock anchor, sub surface drainage, CC gravity wall, CC cladding wall, box culvert, valley side RCC cantilever wall over anchored cc cladding wall, river toe protection by articulated grouted concrete mattress	DPR has been sent for sanction

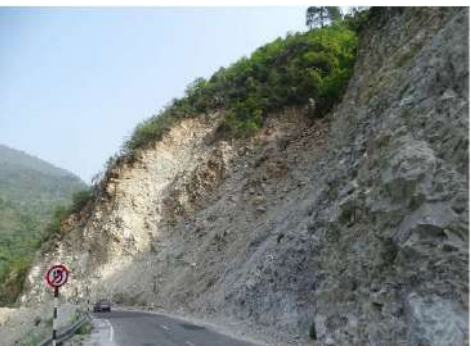
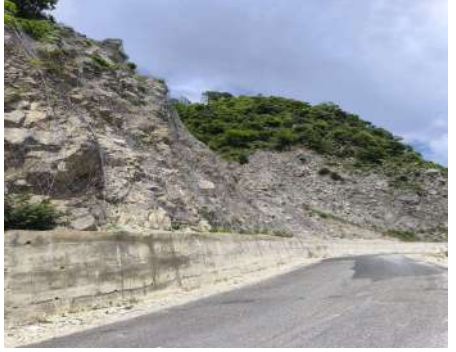
Location No.	Chainage	Latitude / Longitude/ Type of Vulnerability	Proposed / Adopted Treatment Measures	Current Status	Photograph	
					Before	After
1	2	3	4	5	6	
4	7.590 to 7.690	30°19'06.48" N, 78°58'09.30"E Landslide	Loose scaling, soil nailing with HT mesh to prevent rock fall. Gravity wall for slope toe protection	Work completed

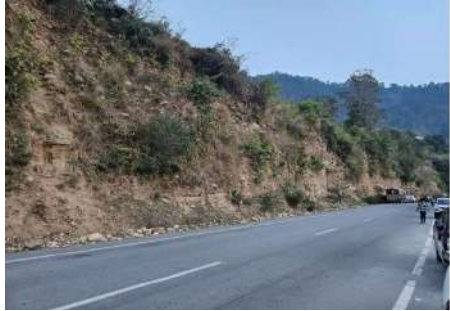
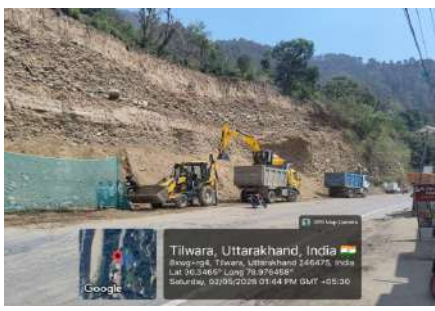
5	11.447 to 11.690	30°20'44" N, 78°58'35"E Landslide	Scaling, net with DT mesh, SDRA, geo-jute mat, CC gravity wall on a raft foundation with bundled SDRA anchors and semi-perforated drainage pipes wrapped in non-woven geotextile.	Work in progress

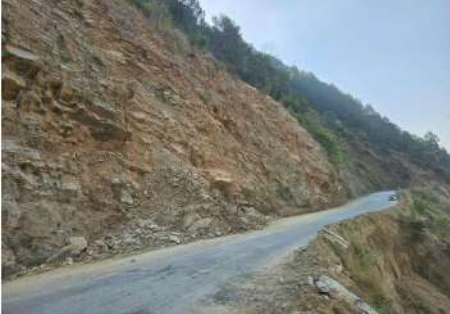
6	13.000 to 13.450	30°21'46.12" N, 78°58'45.84"E Landslide	Scaling, netting with SDRA, 3D net with hydroseeding, anchored CC gravity wall, valley side -anchored RCC cantilever wall Over anchored CC cladding wall, rockfall barrier, sub surface drainage semi perforated pipe wrapped with non woven geotextile	Tender Stage

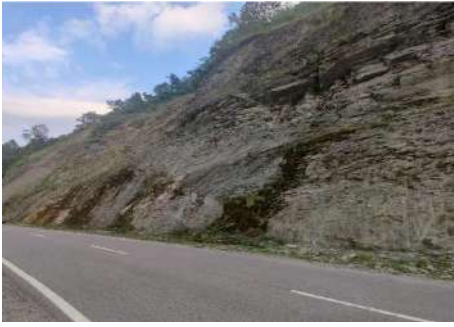
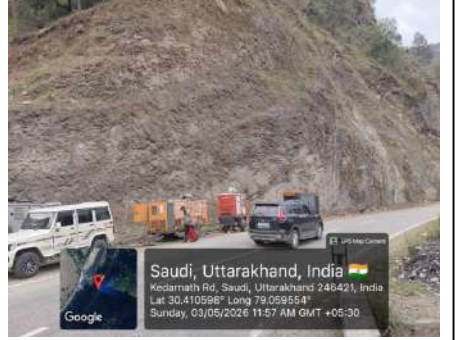
Location No.	Chainage	Latitude / Longitude/ Type of Vulnerability	Proposed / Adopted Treatment Measures	Current Status	Photograph	
					Before	After
1	2	3	4	5	6	
7	23.950 to 24.270	30°21'46.12" N, 78°58'45.84"E Landslide	Scaling, shotcrete (two layers) with chain link fabric, anchors, netting with SDRA, CC cladding wall, road-side drain, Gabion wall with spurs and concrete Jacketing and CC wall over anchored raft foundation.	Work in progress

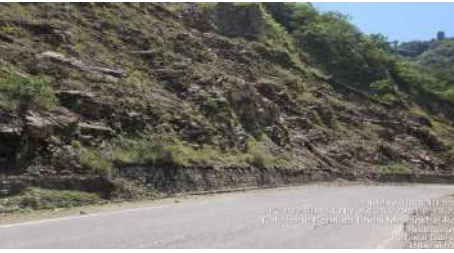
9	30.100 to 30.500	30°16'22.08" N, 79°02'36.96"E Landslide	Scaling, valley side anchored CC cladding wall, slope protection by netting with SDRA, anchored CC gravity wall and anchored CC cladding wall, sub surface drainage by PVC semi perforated pipe	Breast wall has been constructed for Immediate measures.  Full treatment work is sanctioned now at Tender Stage

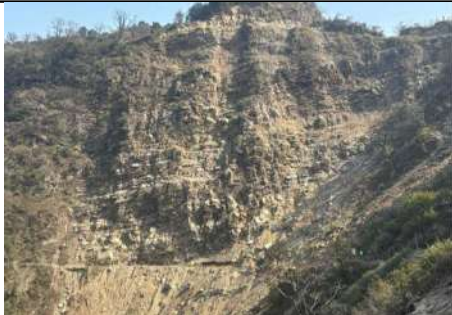
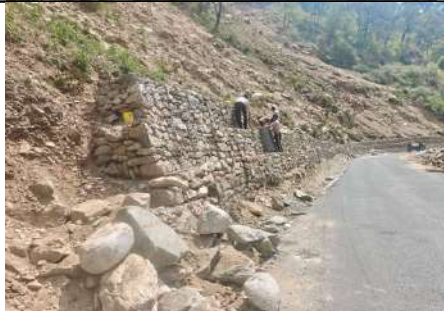
Location No.	Chainage	Latitude / Longitude/ Type of Vulnerability	Proposed / Adopted Treatment Measures	Current Status	Photograph	
					Before	After
1	2	3	4	5	6	
10	34.000 to 34.200	30°17'29.04" N, 79°03'2.52"E Landslide	Loose scaling, netting with SDRA, anchored CC cladding over raft, rockfall barrier, CC gravity wall supported on micropile, gabion wall, CC channel with box culvert and catchpit, attracting gabion spurs connecting with RCC cantilever wall, 3D net with hydro seeding	Breast wall has been constructed for Immediate measures.  DPR has been sent for sanction

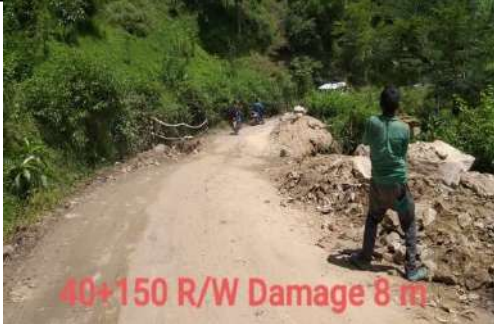
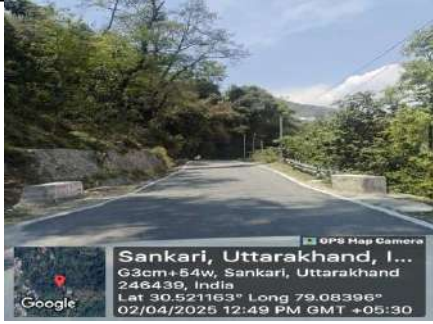
16	40.700 to 41.000	30° 31' 31" N 79° 04' 55" E Sinking	Toe- Articulated concrete block mattress & launching apron, gravity wall, RCC wall  Slope- Soil nailing Sinking stretches on road- RCC slab on SDRA bars Drain channel for channelization, sub surface drainage pipe for sub surface water.	Work completed

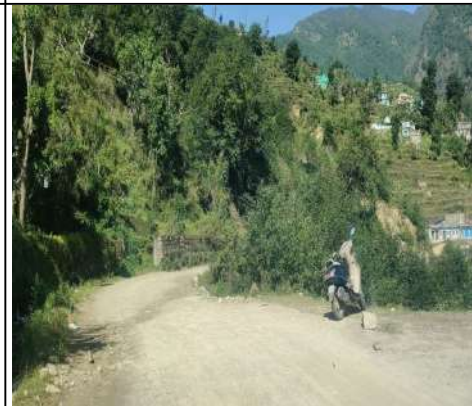
17	42.490 to 42.550	30°30'29.91" N, 79°03'23.62"E Sinking	Toe protection will be done to check sinking	Sinking observed  In DPR stage

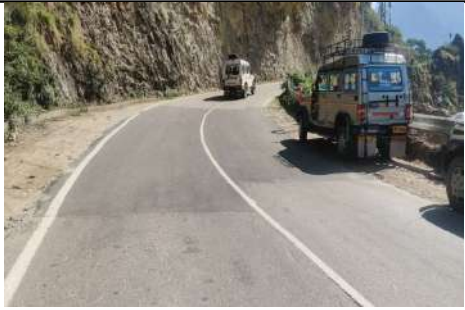
Location No.	Chainage	Latitude / Longitude/ Type of Vulnerability	Proposed / Adopted Treatment Measures	Current Status	Photograph	
					Before	After
1	2	3	4	5	6	
18	48.940 to 49.020	30°19'9.48" N, 79°03'0.12" E Sinking	Toe protection will be done to check sinking	Sinking observed  DPR stage

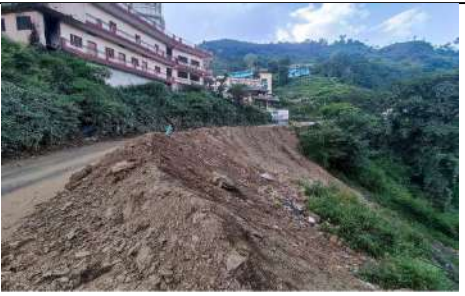
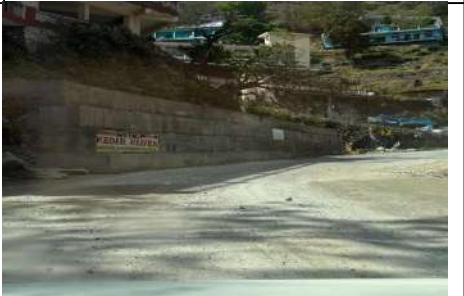
19	48.640 to 48.760	30° 31' 47.18" N 79° 05'02.41" E Sinking	Hill Side Toe Protection, RS Wall, Anchored CC walls and Toe Protection with gabion wall	Work in progress

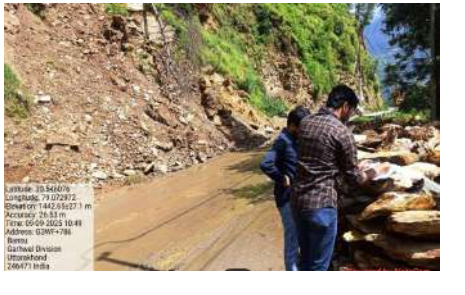
20	50.950 to 50.970	30° 32' 27" N 79° 04'30" E Sinking	Toe protection will be done to check sinking	Sinking /Sliding observed  DPR stage

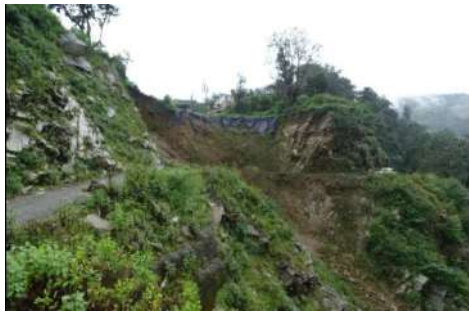
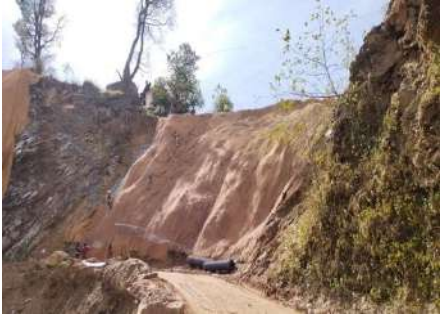
Location No.	Chainage	Latitude / Longitude/ Type of Vulnerability	Proposed / Adopted Treatment Measures	Current Status	Photograph	
					Before	After
1	2	3	4	5	6	
22	54.750 to 54.950	30° 19' 57.36" N 79° 02'17.16" E Landslide	Gabion wall, RCC wall for river toe protection, CC cladding on hill side, SDRA with sandwiched chainlink and double layer shortcrete, Erosion Control: Geo-Jute Matting combined with high-strength wire mesh and deep SDRA.	Work completed.

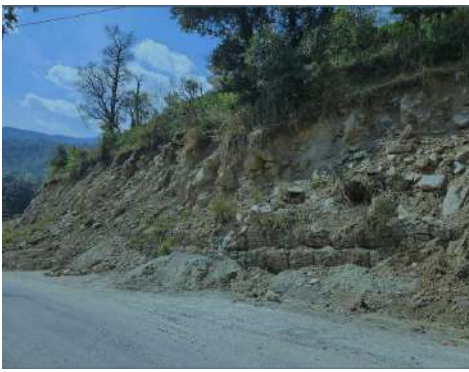
23	54.350 to 54.580	30° 34' 39.47"N 79° 2' 52.57" E Landslide	Loose scaling, netting with SDRA, 3D net with hydro seeding, contour drain, anchored CC gravity wall, anchored CC cladding wall	Tender Stage

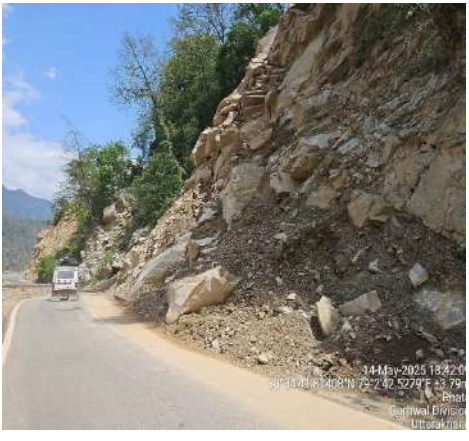
-
24	54.900 to 55.275	30° 34' 42.35" N 79° 2' 36.91" E Landslide	Loose Scaling, hill cutting, netting with SDRA, anchored CC cladding wall, anchored CC gravity wall, for road work anchored RCC cantilever wall over anchored CC cladding wall. Contour drain, box culvert	DPR prepared

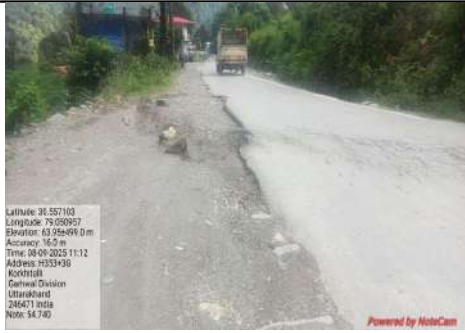
Location No.	Chainage	Latitude / Longitude/ Type of Vulnerability	Proposed / Adopted Treatment Measures	Current Status	Photograph	
					Before	After
1	2	3	4	5	6	
25	54.630 to 55.300	30° 19' 57.72" N 79° 01'59.28" E Sinking	Toe protection will be done to check sinking	Sinking observed  DPR stage

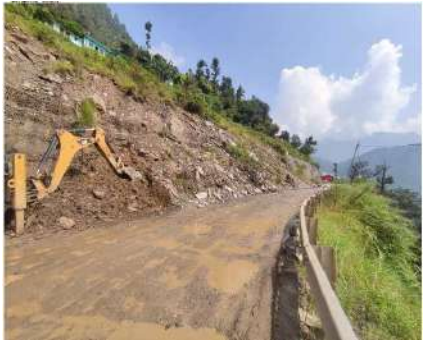
Location No.	Chainage	Latitude / Longitude/ Type of Vulnerability	Proposed / Adopted Treatment Measures	Current Status	Photograph	
					Before	After
1	2	3	4	5	6	
28	56.328 to 56.432	30° 33' 32.32" N, 79° 03' 18.27" E Landslide	Gabion wall for road protection, netting with SDRA, RCC road over micropile, CC wall over micropile.	Tender Stage

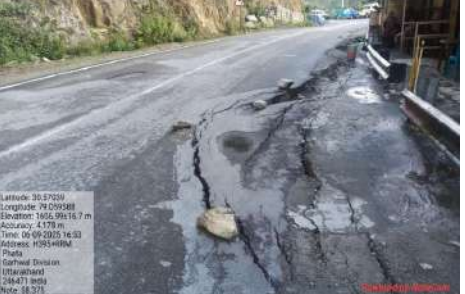
-
29	58.940 to 59.020	30°34'28.34"N, 79°03'23.19"E Landslide	Toe protection will be done to check sinking	Sinking observed DPR stage

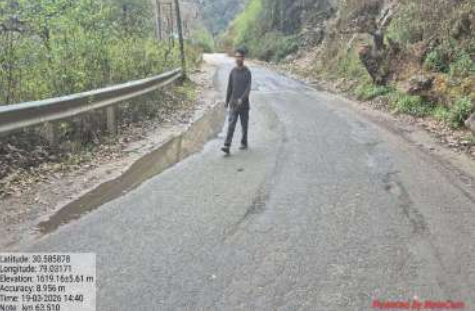
-
30	63.010 to 63.040	30°21' 3.24" N 79°0'55.08" E Landslide		Landslide observed

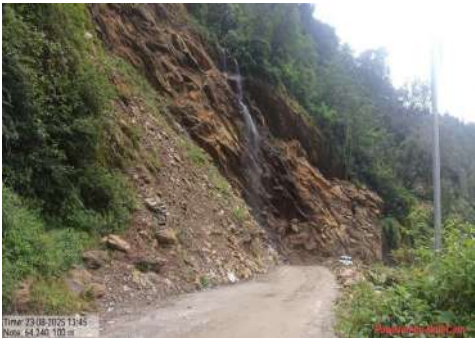
Location No.	Chainage	Latitude / Longitude/ Type of Vulnerability	Proposed / Adopted Treatment Measures	Current Status	Photograph	
					Before	After
1	2	3	4	5	6	
31	64.240 to 64.340	30° 35' 01" N 79° 01' 23" E Sinking	Toe protection will be done to check sinking	Sinking observed  DPR stage

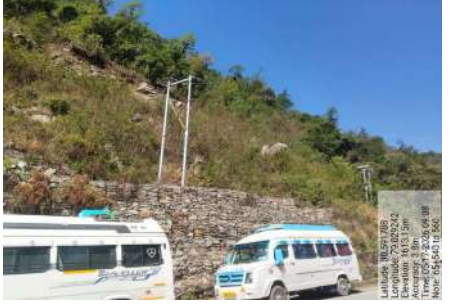
33	65.520 to 65.560	30°35'30.23" N 79°1'46.02" E Landslide	Breast wall with gabbion constructed	Now Stable	-

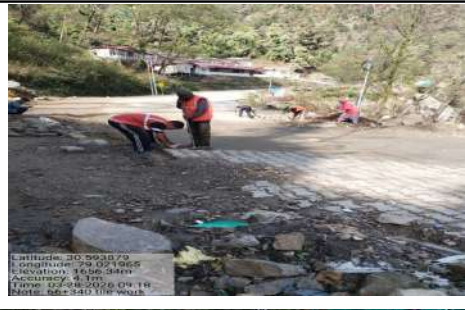
Location No.	Chainage	Latitude / Longitude/ Type of Vulnerability	Proposed / Adopted Treatment Measures	Current Status	Photograph	
					Before	After
1	2	3	4	5	6	
34	66.300 to 66.540	30° 35' 37" N 79° 01'18" E Sinking	Toe protection will be done to check sinking	Sinking observed  DPR stage

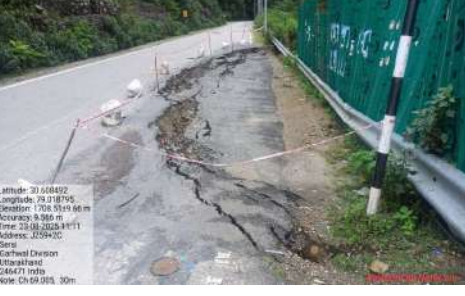
35	68.930 to 69.000	30° 36' 19" N 79° 01'09" E Sinking	Toe protection will be done to check sinking	Sinking observed  DPR stage

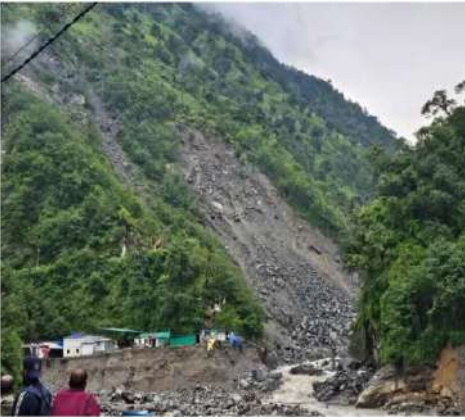
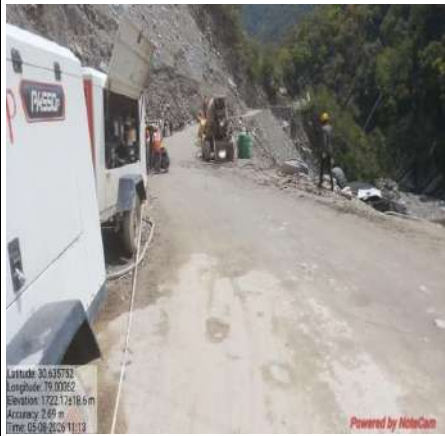
Location No.	Chainage	Latitude / Longitude/ Type of Vulnerability	Proposed / Adopted Treatment Measures	Current Status	Photograph	
					Before	After
1	2	3	4	5	6	
39	71.220 to 72.380	30°38'8.52"N 79°0'3.33"E Landslide	Benching, Netting with hydroseeding, SDRA, CC gravity wall on RCC Raft on anchor clusters, Rockfall barrie, contour drain Valley Side & Toe Protection Gravity walls on RCC rafts, reinforced with deep anchor clusters. Articulating Grouted Concrete Mattress over dental concrete.	work in progress

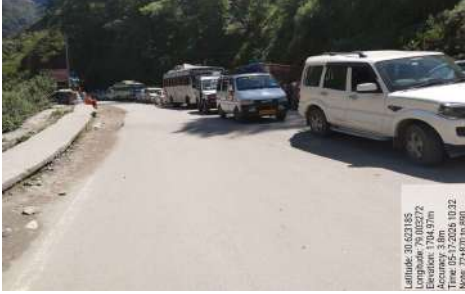
-
41	72.870 to 72.890	30° 37' 23" N 79° 00' 11" E Sinking	Toe protection will be done to check sinking	Sinking observed DPR stage

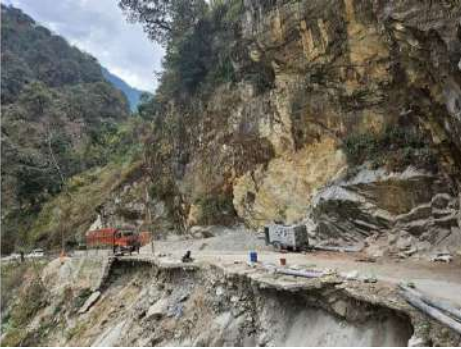
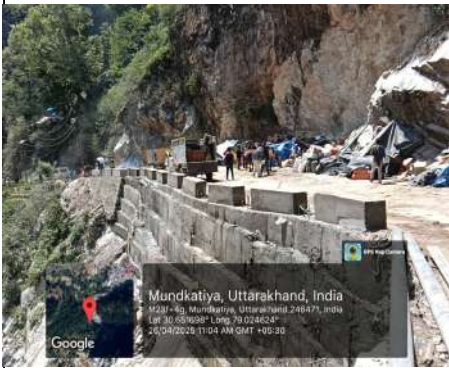
-
46	Exist ch 74.590 to 74.650	30° 39' 5.54" N 79° 1' 28.94" E Landslide	shotcrete sandwiched, semi perforated sub-surface drain, CC cladding wall over raft, RCC cantilever wall, articulating grouted concrete mattress and Anchored CC cladding wall over raft	Work in progress

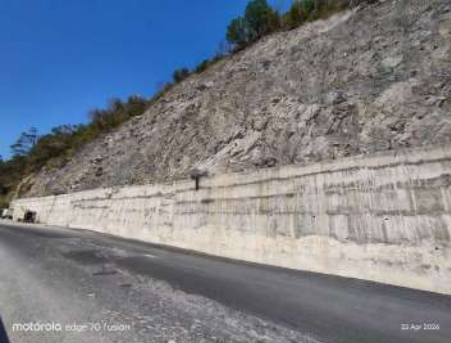
Location No.	Chainage	Latitude / Longitude/ Type of Vulnerability	Proposed / Adopted Treatment Measures	Current Status	Photograph
1	2	3	4	5	6
1	0.150 to 0.310	30.62830000 78.32009167  Landslide	1. Scaling / removal of loose debris, 2. Anchoring with SDRA, 3. HT wire mesh, 4. Anchored RCC Toe Wall.	Work Completed

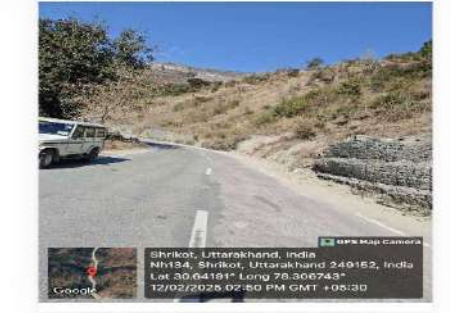
2	5.260 – 5.480	30.64194444 78.30666667  Landslide	1. Scaling / removal of loose debris, 2. HT Wire mesh 3. Anchoring with SDRA 4. CC Channel	Bid Invited

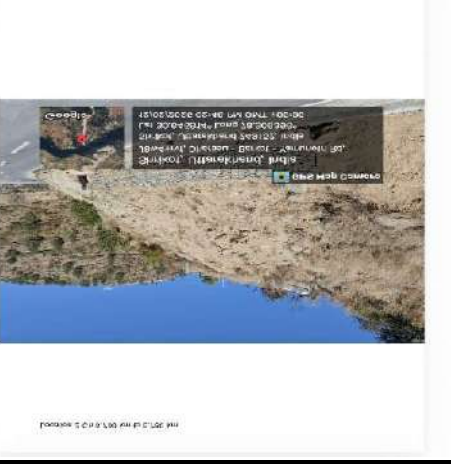
3	5.700 – 5.780	30.64555556 78.30666667  Landslide	1. Terracing and Benching 2. HT Wire mesh. 3. RR Drain at Toe 4. RCC Toe Wall	Bid Invited

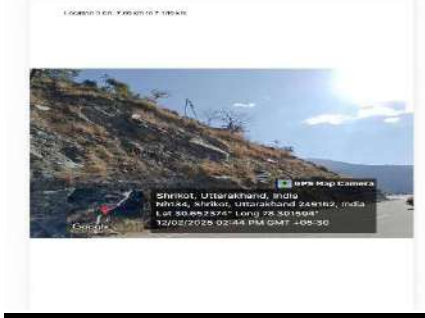
Location No.	Chainage	Latitude / Longitude/ Type of Vulnerability	Proposed / Adopted Treatment Measures	Current Status	Photograph
1	2	3	4	5	6
4	7.000 – 7.180	30.65278556 7830215528  Landslide	1. Scaling / removal of loose debris, 2. Anchoring with SDRA, 3. HT wire mesh, 4. Anchored RCC Toe Wall over micropile. 5. Terracing and Benching	Bid Invited

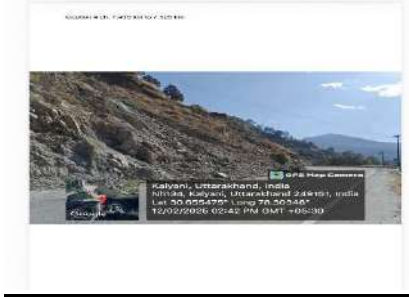
5	7.435 – 7.525	30.655 78.30333333  Landslide	1. Scaling / removal of loose debris, 2. HT wire mesh, 3. Anchored RCC Toe Wall over bundled anchors 4. Shotcrete	Bid Invited

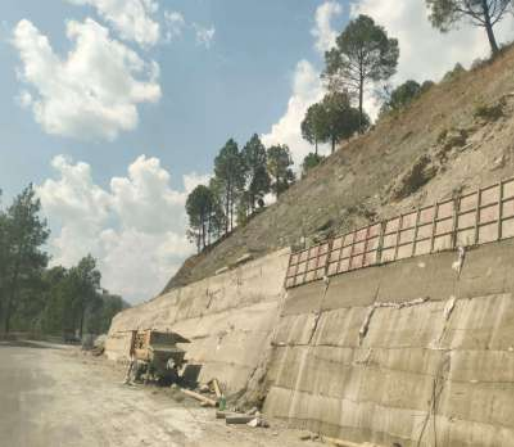
Location No.	Chainage	Latitude / Longitude/ Type of Vulnerability	Proposed / Adopted Treatment Measures	Current Status	Photograph
1	2	3	4	5	6
10	8.900 - 9.030	30.66715442 78.29920917  Landslide	1. Scaling / removal of loose debris, 2. Anchoring with SDRA, 3. HT wire mesh, 4. Anchored RCC Toe Wall.	Work In Progress

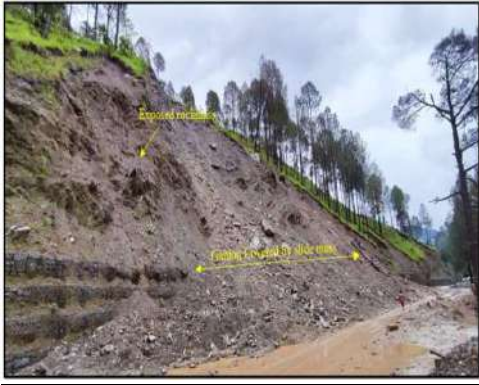
11	9.700 – 9.770	30.67000000 78.29972222  Landslide	1. Removal and offloading of overburden 2. HT Wire mesh. 3. CC Gravity wall wall with CC drain 4. Anchored Gabion blocks and channel	Bid Invited

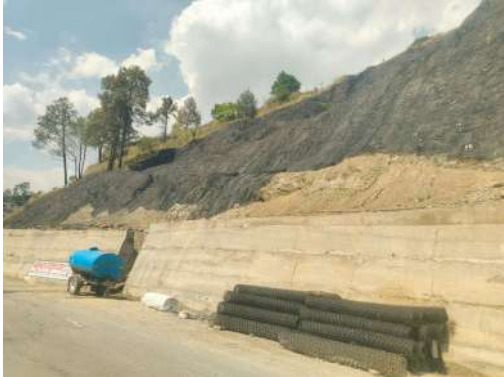
12	10.850 - 11.035	30.867805333 78.29950889  Landslide	1. Scaling / removal of loose debris, 2. Anchoring with SDRA, 3. HT wire mesh, 4. Anchored RCC Toe Wall	Work In Progress

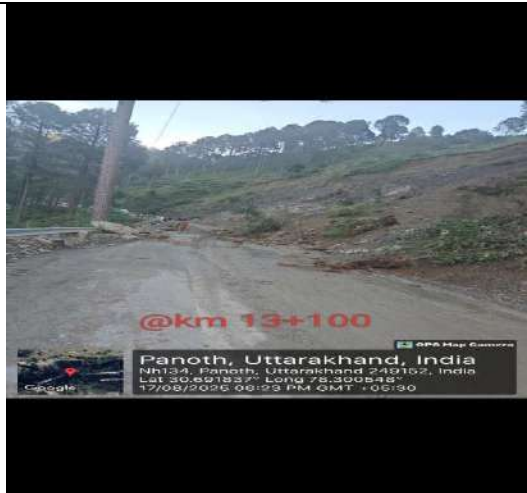
14	13.100-13.280	30.691837 78.300548  Landslide		Survey stage

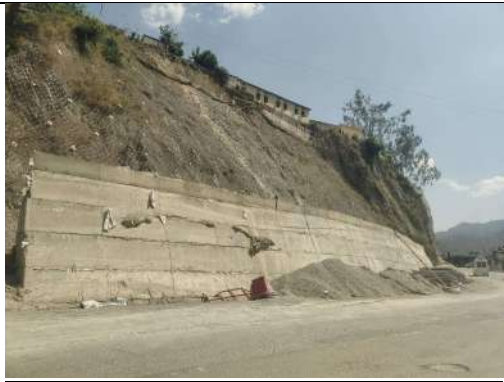
15	14.890 - 14.970	30.69848194 78.23004533  Landslide	1. Scaling / removal of loose debris, 2. Anchoring with SDRA, 3. HT wire mesh, 4. Anchored Cladding RCC Toe Wall 5. Shotcrete	Work In Progress

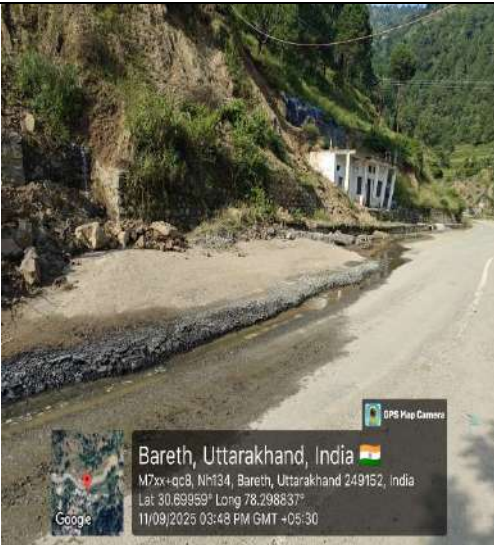
17	15.450-15.530	30.69959 78.298837  Landslide		Survey stage

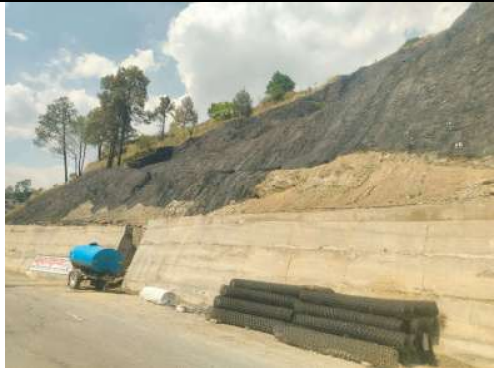
18	16.900 - 17.050	30.70873389 78.32924822  Landslide	1. Scaling / removal of loose debris, 2. Anchoring with SDRA, 3. Wire mesh, 4. Anchored RCC Toe Wall 5. Terracing and Benching 6. Geojute and Seeds	Work In Progress

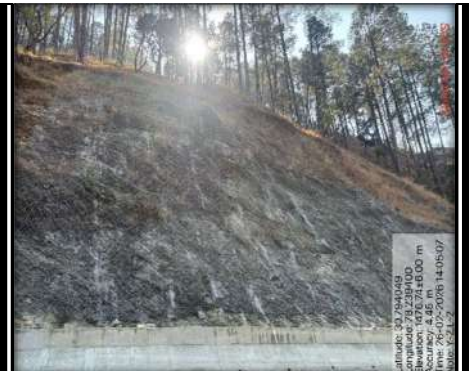
Location No.	Chainage	Latitude / Longitude/ Type of Vulnerability	Proposed / Adopted Treatment Measures	Current Status	Photograph
1	2	3	4	5	6
19	49.395 to 49.455	30.79440414 78.23925944  Landslide	1. Scaling / removal of loose debris, 2. Anchoring with SDRA, 3. HT wire mesh, 4. RCC Toe Wall, 5.Hydroseeding.	Work Completed

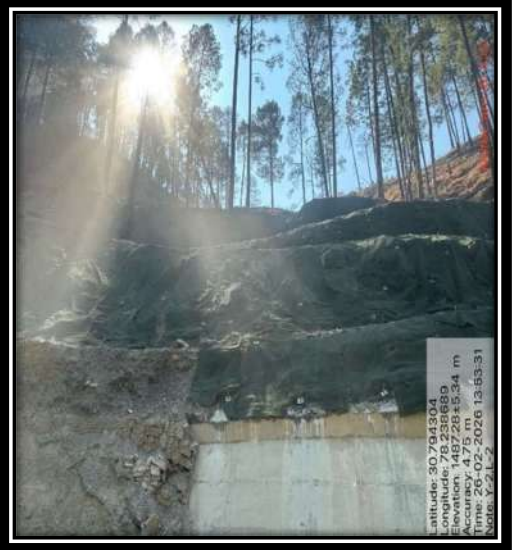
20	49.468 to 49.535	30.794304 78.238689  Landslide	1. Scaling / removal of loose debris, 2. Anchoring with SDRA, 3. HT wire mesh, 4. RCC Toe Wall, 5.Hydroseeding	Work Completed

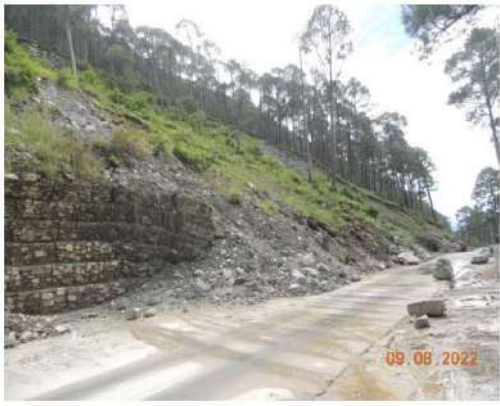
25	58.850 – 58.950	30.8194805556 78.2383305556  Landslide	1. Removal and offloading of overburden 2. Gabion Channel 3. CC Drain 4. Anchored RCC Toe wall	Bid Invited

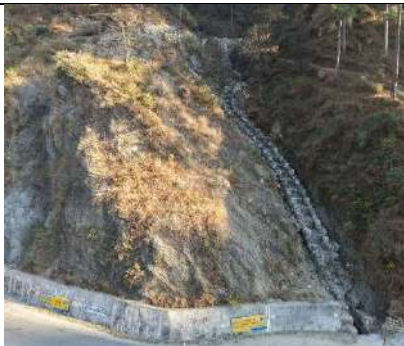
Location No.	Chainage	Latitude / Longitude/ Type of Vulnerability	Proposed / Adopted Treatment Measures	Current Status	Photograph
1	2	3	4	5	6
26	62.150 - 62.350	30.84613056 78.27745278 Landslide	1. Scaling of loose rock mass. 2. Application of HT wire mesh. 3. Anchoring with SDRA 4. Anchored CC Channel. 5. Anchored CC Gravity Tow wall	Work Completed

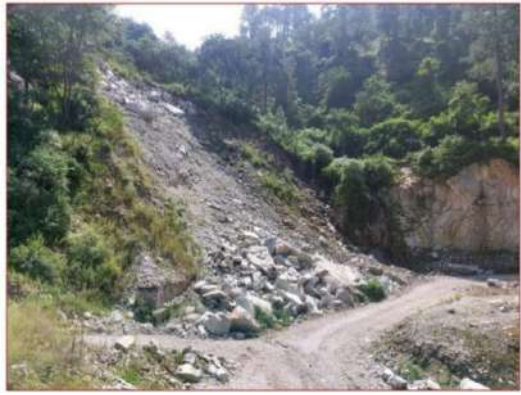
27	63.815 – 63.840	30.8241861111 78.2490694444 Landslide	1. Removal of rock mass and debris. 2. HT rolled cable net with anchors. 3. CC gravity wall over RCC raft. 4. CC wall for toe support. CC channel	Bid Invited

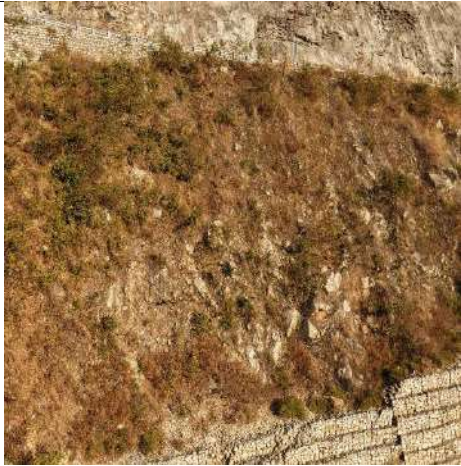
28	64.820 - 64.900	30.86014167 78.28715833 Landslide	1. Scaling of loose rock mass. 2. Application of HT wire mesh. 3. Anchoring with SDRA	Work Completed

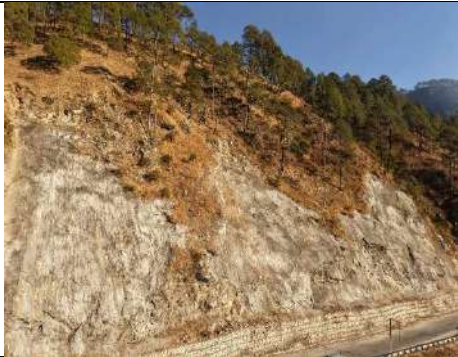
Location No.	Chainage	Latitude / Longitude/ Type of Vulnerability	Proposed / Adopted Treatment Measures	Current Status	Photograph
1	2	3	4	5	6
29	65.250-65.380	30.86014167 78.28715833 Landslide	1. Scaling of loose rock mass. 2. Application of HT wire mesh. 3. Anchoring with SDRA 4. Shotcrete	Work Completed

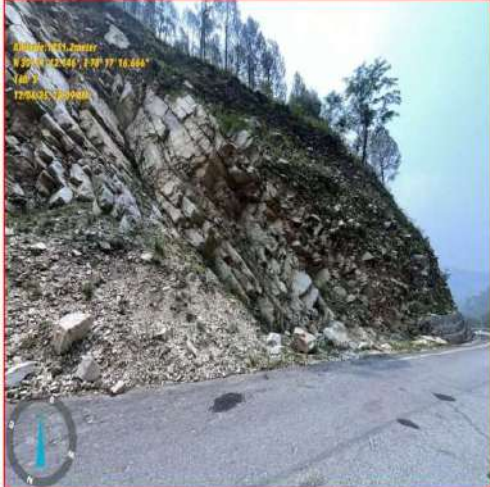
30	65.510 – 65.700	30.8855694444 78.3086527778 Landslide	1. Scaling/removal of loose boulders. 2. HT rolled cable net with DT mesh and anchors. 3. Anchored CC gravity wall. 4. Anchored CC cladding. 5. Shotcrete work with anchors.	Bid Invited

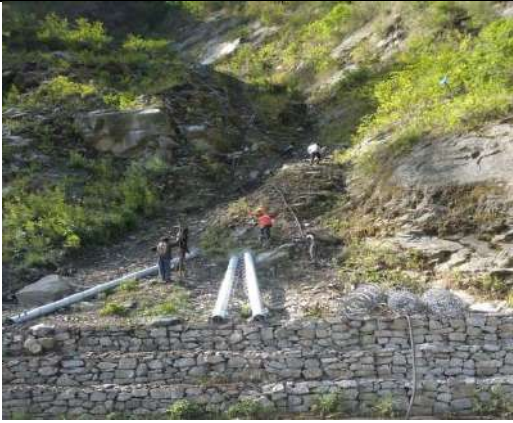
31	65.890 - 65.920	30.85964686 78.2873015 Landslide	1. Scaling / removal of loose debris, 2. Anchoring with SDRA, 3. HT wire mesh, 4. Anchored Cladding RCC Toe Wall. 5. Shotcrete	Work In Progress

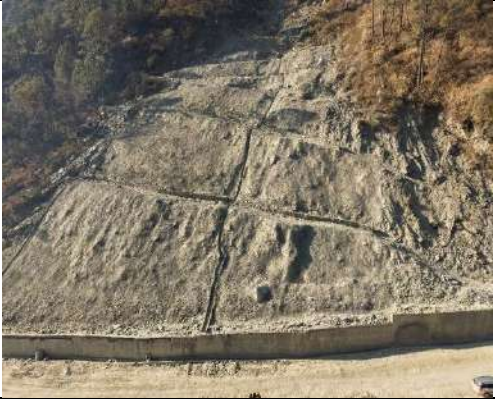
Location No.	Chainage	Latitude / Longitude/ Type of Vulnerability	Proposed / Adopted Treatment Measures	Current Status	Photograph
1	2	3	4	5	6
36	69.085 – 69.345	30.87708611 78.306075  Landslide	1. Terracing and Benching. 2. HT wire mesh 3. Anchoring with SDRA 4. CC Cut Drain 5. RCC Anchored Toe wall.	Work Completed

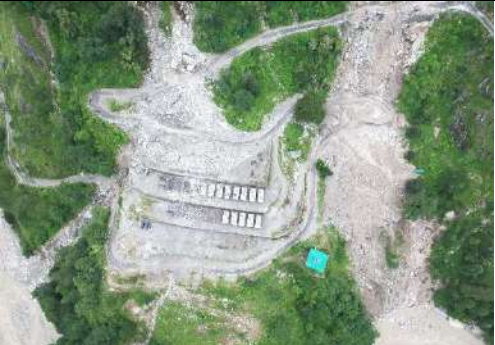
39	73.700 – 73.900	30.89838004 78.32622733	-	DPR Stage

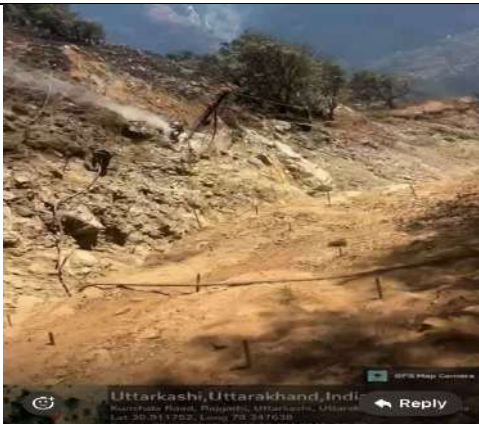
Location No.	Chainage	Latitude / Longitude/ Type of Vulnerability	Proposed / Adopted Treatment Measures	Current Status	Photograph
1	2	3	4	5	6
40	79.850 - 80.300	30.90592778 78.34515556  Landslide	1. Scaling of loose rock mass 2. Threaded rock anchored 3. Anchoring with SDRA 4. HT wire mesh 5. Rockfall barrier.	Work in progress

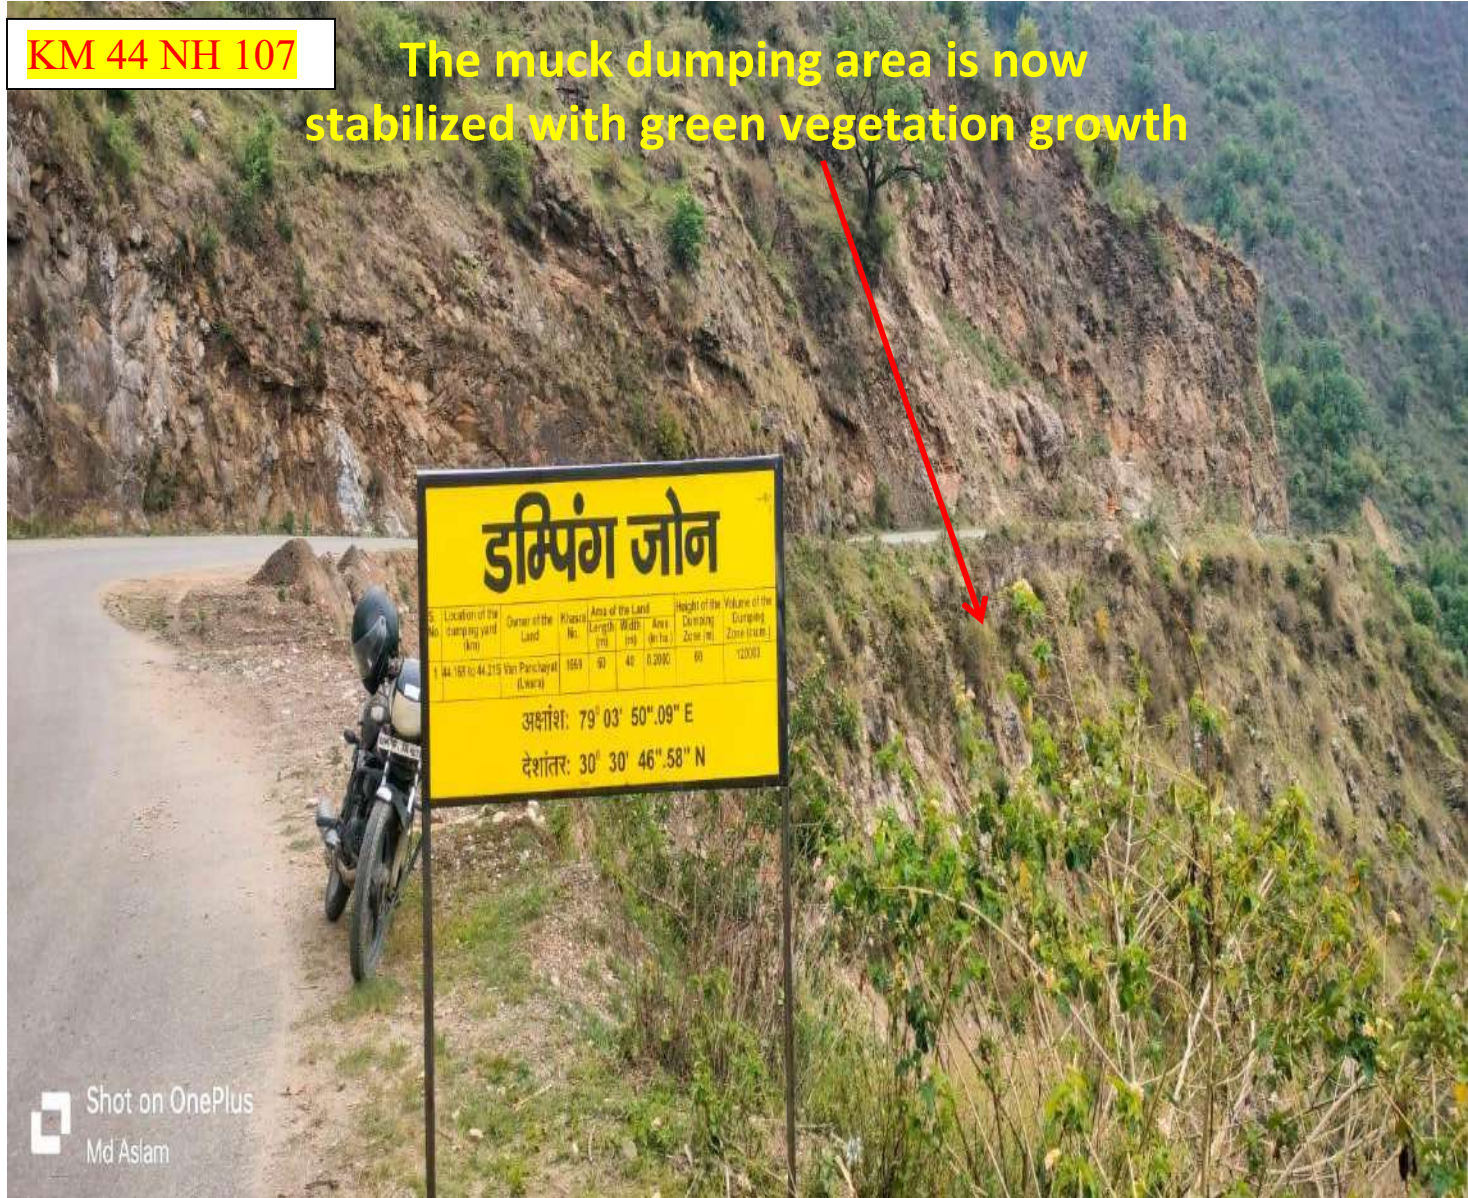
**KM 44 NH 107**

The muck dumping area is now stabilized with green vegetation growth
