GOVERNMENT OF INDIA  
GEOLOGICAL SURVEY OF INDIA

*Preliminary Report on the Recent Event of Ground Subsidence at Joshimath,  
District Chamoli, Uttarakhand*

February 2023

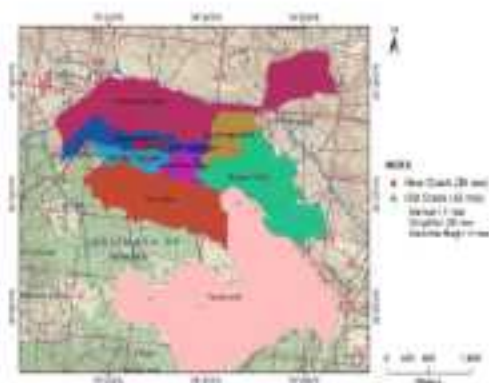
Fig. 1.1 Distribution of Ground Chicks (M and N) in various states

From Table 4.1, it is evident that out of the 41 ground chicks, 27 numbers of chicks are available and the number of chicks are more and out of 44 numbers of forest ground chicks, 12 chicks are available in forest whereas, 27 numbers of chicks are forest chicks (Fig. Chart 4.2A to 4.2C).

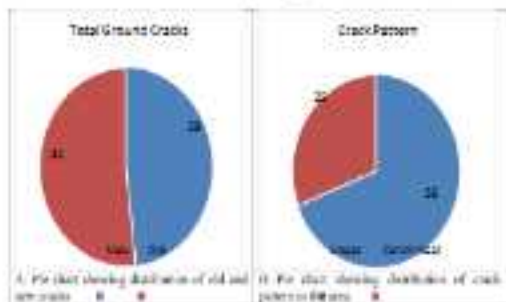
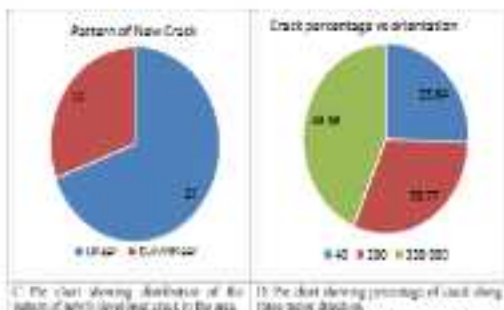
**Figure 4.2** Pie Chart Distribution of Ground Crack in Aramco Area

Another interesting fact that emerges from Fig. 4.1 is that the majority of the recently appeared ground cracks from Suez Canal to the Suez area aligned along a linear array trending NWW - SSE (Fig. 4.1; Fig. Chart 4.20). The other set of ground cracks are aligned in E-W/NNE - ESE direction and are concentrated in Matruh (Fig. and Fig. Chart 4.21).

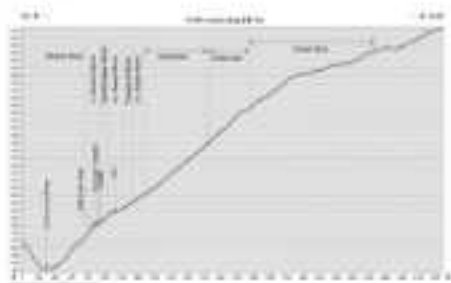
Figure 3.1.1. Profile tracing Marleigh Mounds Area

A longitudinal profile has been developed using Datas Data data with 10 m spatial resolution, along a line joining Aivalikata River at the bottom and Auli at the top (Fig 5.1). A cross-section of the same profile, around the Narvaigh Maudfjella area has been prepared (Fig. 5.2) for better appraisal. A close study of these two profiles reveals that there is a sharp break in topography, marked by a vertical steep face of about 5–6 m, which indicates the presence of a paleo landslide scar in this area. The height of big boulders in the down slope area (Photo 5.2 and Photo 5.6), is a testimony to this inference. During the field inventory in and around the Narvaigh Maudfjella complex and the surrounding area, prima-facie, signatures of recent ground distress (associated with the onset of 2021-22 FY) were not noticed and people were still residing in the hill slope in this area (Photo 5.1). The absence of signatures of ground distress, prima-facie, indicates that the

development area of Marleigh Mounds has assumed a certain degree of activity in the past few years. From here, the exposures of the polar thin bed (Plate 3.5) has also not been assumed on the ground.
