# Seismic vulnerability of lifeline buildings in Himalayan province of Uttarakhand in India

## ABSTRACT

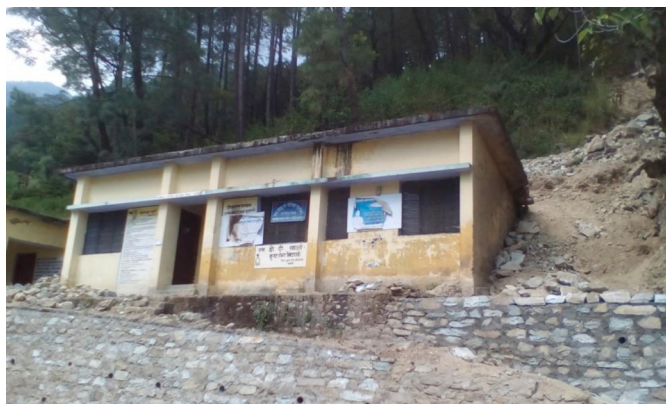
Fig. 3. Primary school at Upkendra Tangsa, Dasholi (Chamoli district) located on high sloping ground.

Codal provisions in India [33] recommend footing to be placed adjacent to a sloping ground when base of the footing are at different levels. In order to avoid damage to an existing structure, the code recommends (i) footing to be placed at a minimum distance of  $S$  from the edge of the existing footing, where  $S$  is the width of larger footing, and (ii) the line from the edge of the new footing to the edge of the existing footing to make an angle of less than 45°. Slope of 5.03% masonry and 7.24% RCC building units is observed to be more than 45° (Fig. 3).

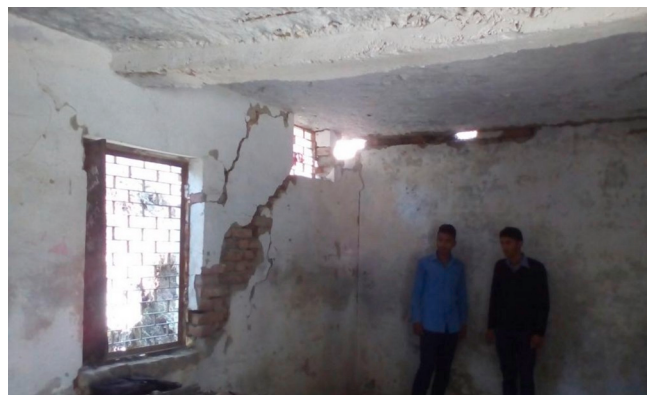
Fig. 4. Wide shear cracks in masonry wall of Government Inter College, Pitrdhar (Rudrapur district) together with poorly constructed beam of non-uniform shape showing deflection.

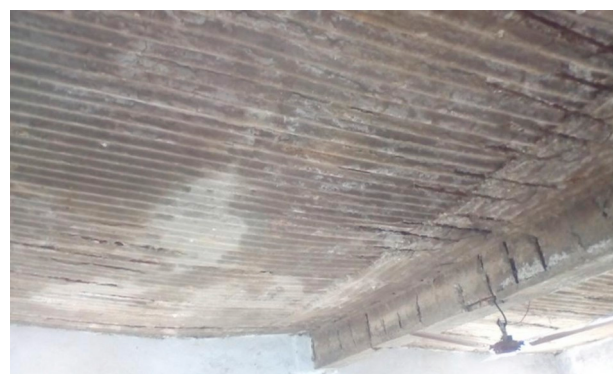
Fig. 5. Poorly constructed roof with clearly visible reinforcement at Government Primary School Mhalchora in Bageshwar district.

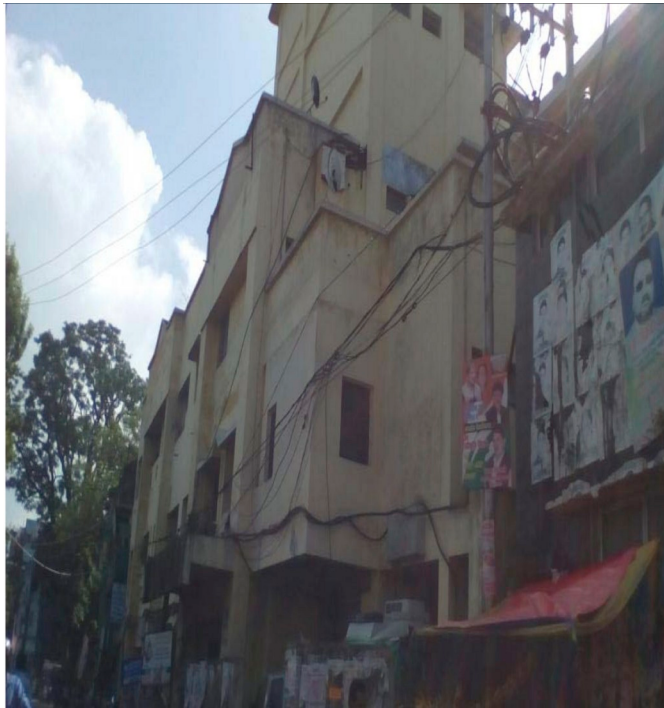
Fig. 6. Reverse-T shaped hospital at Hawalabagh in Almora district.

Most surveyed building units are observed to be free of vertical irregularities but 5.0% of both masonry and RCC building units have irregularity in shape. Classified as L, T and Reverse-T type, most L-type irregularities are observed in the surveyed building units in Chamoli, Bageshwar, Pithoragarh, Rudraprayag, Pauri, and Almora districts, T-type largely in Chamoli and Pithoragarh districts while Reverse-T type dominantly in Almora and Champawat districts (Fig. 6).

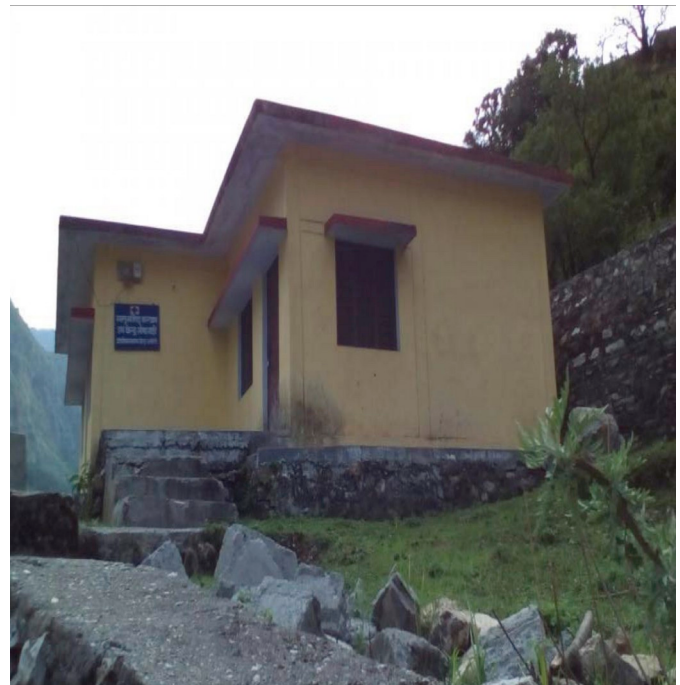
Fig. 7. Re-entrant corners in Upkendra, Gauna, Dasholi in Chamoli district.

Irregularities introduced in the building plan largely due to aesthetics related considerations result in re-entrant corners that are often badly damaged during seismic shaking because of the introduction of stresses for which these are not designed. Presence of re-entrant corners is a major plan irregularity that tends to produce differential motion between different wings of the building resulting in local stress concentration at the re-entrant corner, or “notch”. Moreover center of mass and centre of rigidity of such building forms do not geometrically coincide for all possible earthquake directions causing torsion which results in rotational motion.

Vulnerability due to re-entrant is observed to be maximum in the surveyed buildings of Chamoli, Dehradun, Pauri, Pithoragarh, Rudraprayag, and Uttarkashi districts (Table 5). The defect is more in masonry buildings than RCC buildings (Figs. 7 and 8).

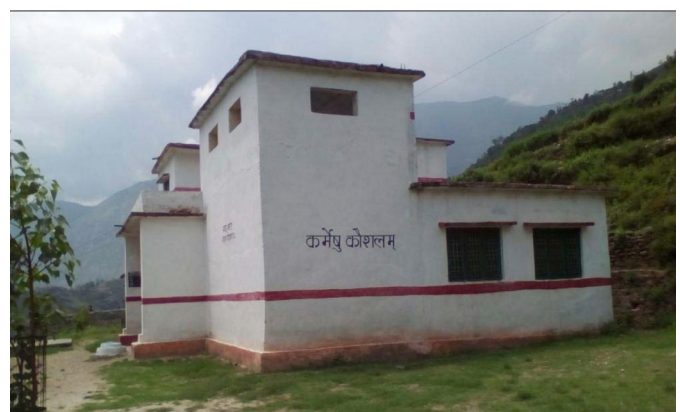
Fig. 8. Re-entrant corners Upper Primary School Balidhar, Dasholi in Chamoli district.

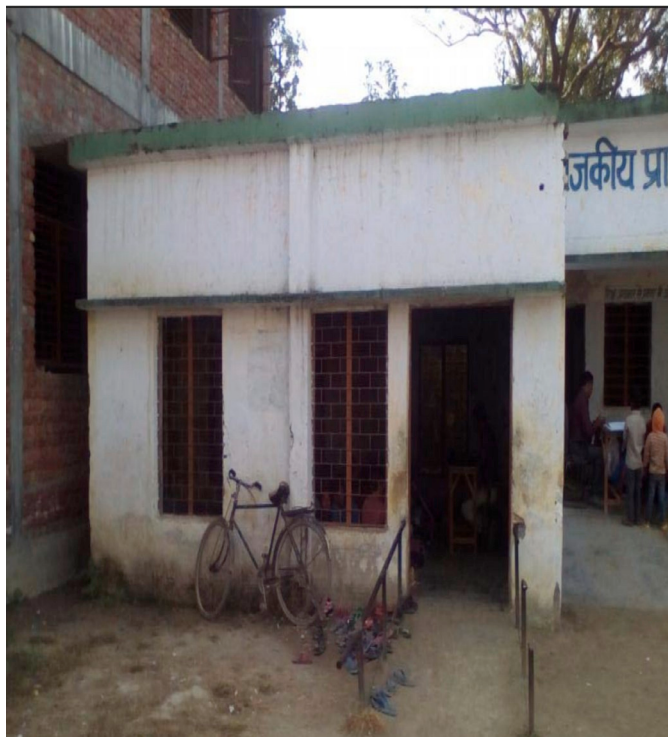
Fig. 9. Government Primary School, Bajpur in Udham Singh Nagar district is vulnerable to pounding during seismic shaking.

As regards pounding codal provisions in India recommend adjacent units or buildings to be separated by a distance which is equal to response reduction factor (R) times the sum of calculated storey displacements, so as to avoid damage to the structures when these deflect towards each other during seismic shaking [11]. When two buildings are at the same elevation level, the factor R may be replaced by R/2. Safe separation distance or gap as recommended by the code between two building is 15, 20 and 30 mm for masonry, RCC frame and steel structure respectively. 26.81 and 19.33% of the surveyed masonry and RCC building units are respectively observed to be vulnerable to pounding (Fig. 9).
