## **A Hydrogeological Investigation Report on Land Subsidence in Joshimath Town, Chamoli District, Uttarakhand**

**By**  
**Central Ground Water Board,**  
**Department of Water Resources, River Development and**  
**Ganga Rejuvenation, Ministry of Jal Shakti**  
**Govt of India, Dehradun**

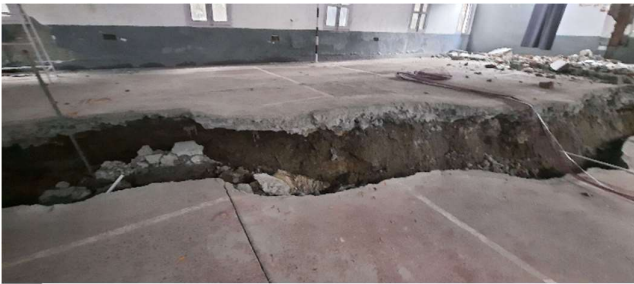
**(A) Badminton Indoor Stadium, J P Colony**

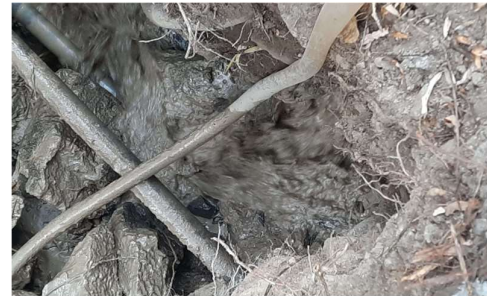
**(B) Sudden Gush of Water near Badminton Indoor Stadium, J P Colony**

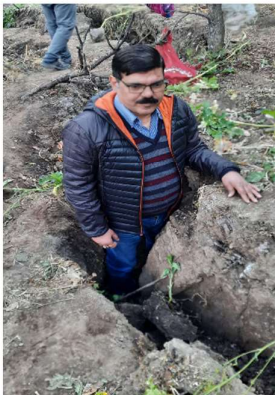
**(C) Vertical Cracks (about 3 ft) at Manohar Bagh**

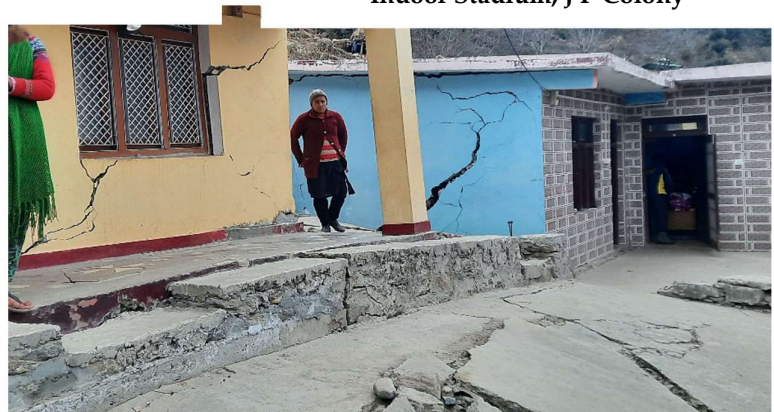
**(D) Cracks Developed in House of Sh Vinod Saklani, Sunil Village**

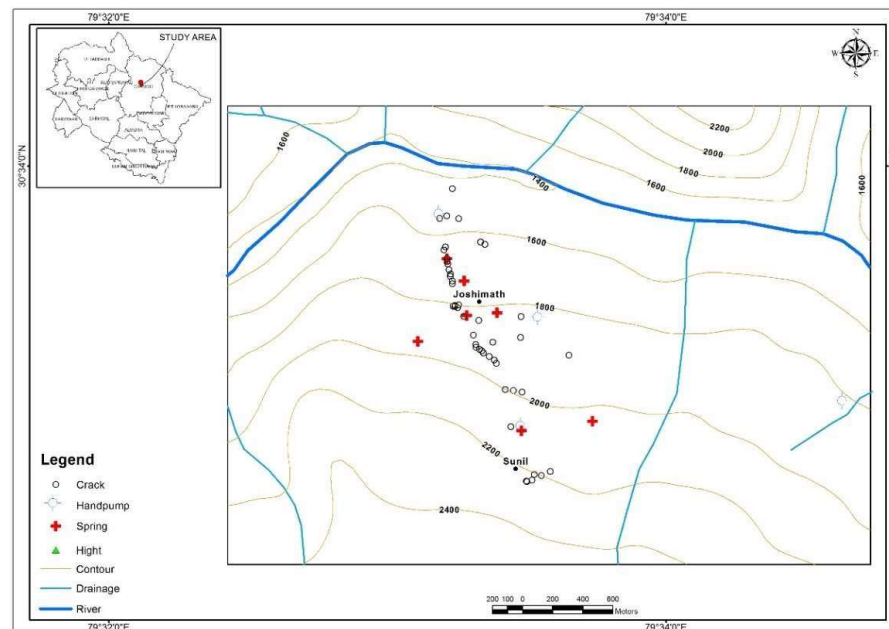
**Figure- 3 A Location of Cracks, Springs and Hand pumps in the Joshimath Town, Chamoli District, Uttarakhand.**

A total of 46 cracks/subsidence zones are observed which are oriented in North-West to South-East direction (Figure- 3 A) (Annexure- I). The slope direction of the study area is South to North. (Figure- 3 B) The crown of the subsidence marks at house of Sh Vinod Saklani, Village Upper Sunil and extend upto JP township at Marwari village. The intensity of the cracks is increasing from south to north and it maximum observed in Manohar Bagh area where one of the hotels building lean over adjoining hotel building. The depth of the cracks observed in the agriculture land is upto 03 ft deep and 1-2 ft wide.

- Cracks, spring location and handpumps constructed in the area are plotted (Figure 3 A and 3 B). It is observed that they are aligned in the same zone. Occurrence of all three in the same zone may indicate that strata saturated with the ground water may prone to land subsidence. In the area, zone tapped for handpump is 65 -80 m below ground level which indicates that formation saturated with ground water may located at a depth of 65 -80 m bgl. The decline in depth to water level at Singhdhar handpump indicates that water bearing strata is linked with the land subsidence. Land subsidence may be extended in and around Singhdhar Handpump.

- It is suggested that trench along with the retention wall may be constructed at different topographic level so that ground water pressure may be dissipated and cracks in futures will be cease. Construction activities in spring zone area should be immediately stopped. Emergence point of the springs which are covered with any concrete material should be cleared immediately.

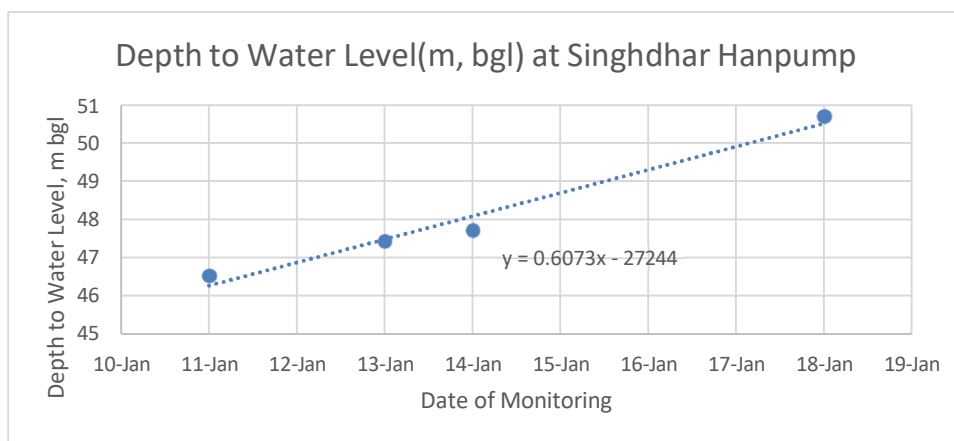
**Figure 4 – Hydrograph of Singhdhar Handpump Joshimath Town, Chamoli District**

Joshimath town is situated on morainic deposit, comprising thick Quaternary loose sediment. Big boulders are embedded in this deposit. The morainic deposit is both porous and permeable and hence suitable for groundwater development. The ground water is mainly developed through handpumps. The topography is highly undulating and geological formations are moderately to steeply dipping. Due to frequent undulations of high magnitude a continuous water table doesn't exist. However, permeable formation overlays an impermeable one, the water table exists, its extension depends upon the distribution of the aquifer forming rocks and topography. A total of 04 number of handpumps are present in the study area (Figure 3 A & 3 B) and as per the data available with Jal Sansthan, Joshimath, the handpump are drilled upto the depth of about 80 m and the zone tapped ranges from 65-80 m bgl. The depth of water level in these handpumps ranges between 18 to 48 m. Daily depth of water level has been monitored and it is observed that water level is declining in Singhdhar area, with various rate. 20- 60 cm per day, (Figure- 4) while in other handpumps the water level is almost content. (Table-2) The decline in Singhdhar handpump indicates that water bearing strata is linked with the land subsidence. Land subsidence may be extended in and around Singhdhar Handpump. The discharge of these handpumps was taken manually which is 17.65-20.27 lpm

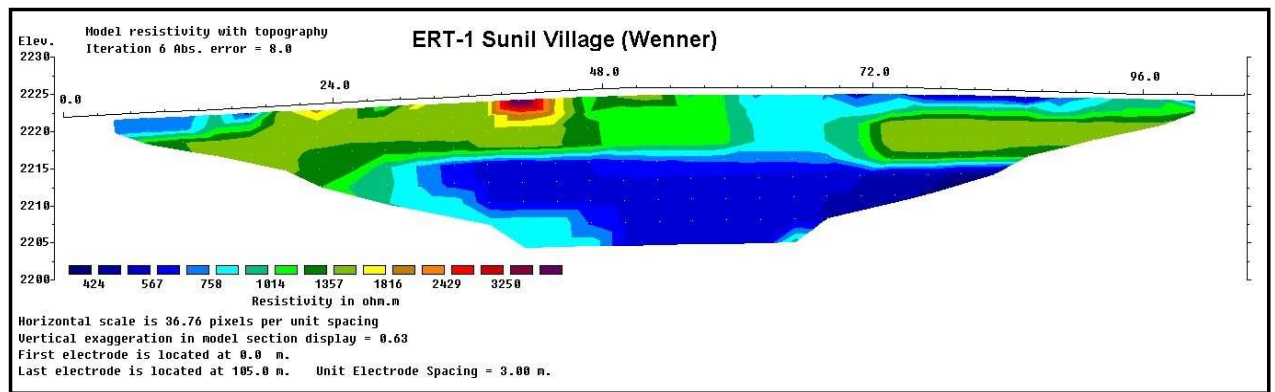
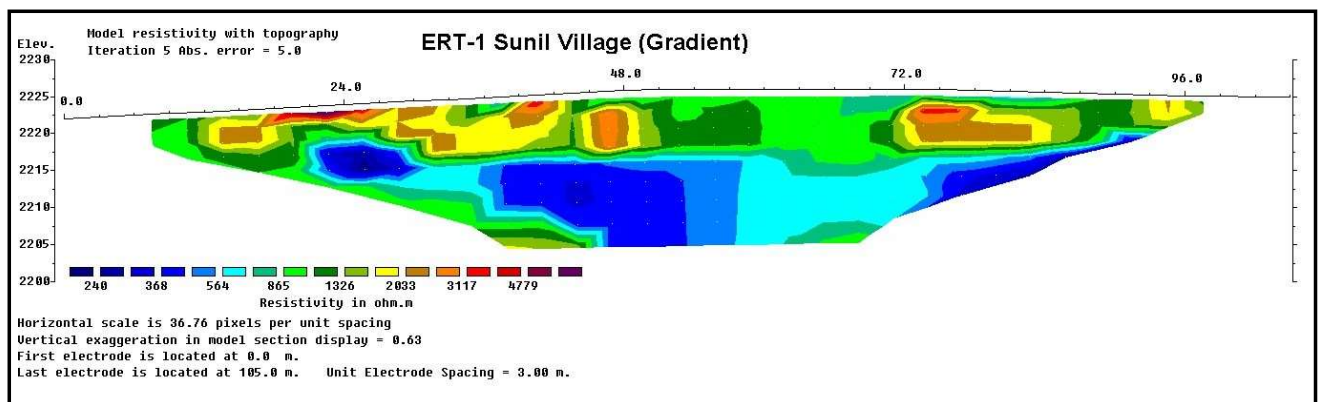
**Figure 7 A: 2-D Electrical Resistivity Tomography Section (Wenner) at Upper Sunil Village, Joshimath (ERT-1), Chamoli District**

First 2D electrical resistivity tomography (ERT-1) has been carried out across the cracks developed in agricultural land of Sh Vinod Saklani Joshimath area, District Chamoli, Uttarakhand. Length of ERT profile was 105 m. Resistivity value received during ERT indicates that boulders are embedded into loose sediments. Saturated formation occurs at a depth of 15 m below ground level (Figure 7A & 7 B).

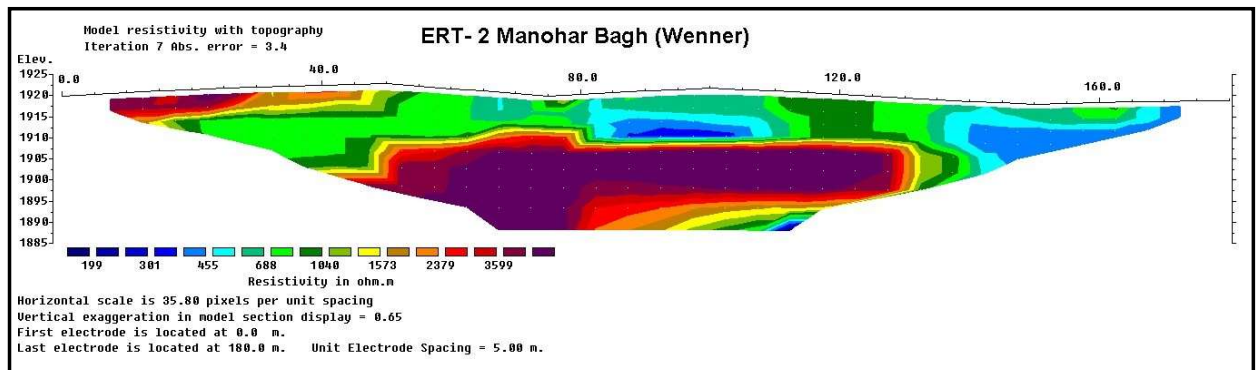
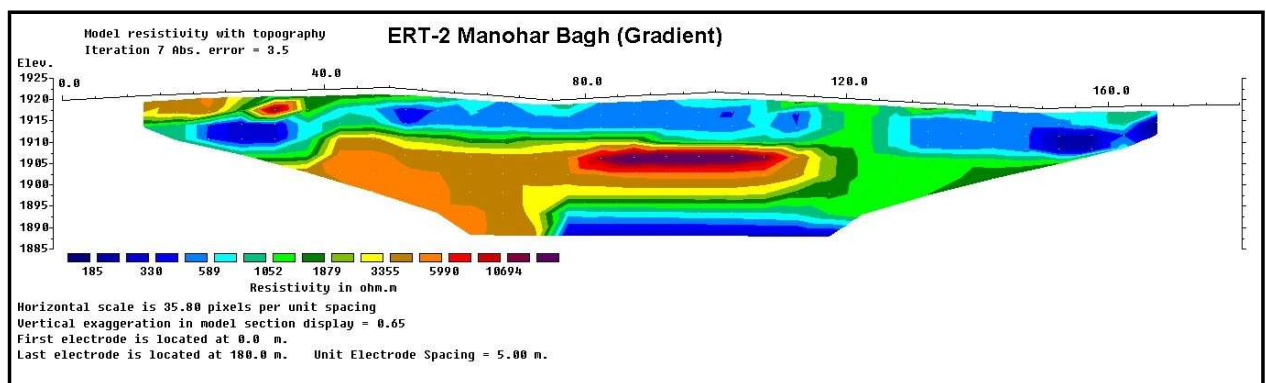
Figure 8A: 2-D Electrical Resistivity Tomography Section (Wenner) at Manohar Bagh, Joshimath (ERT-2), Chamoli District

Second ERT has been conducted at Manohar Bagh area of Joshimath town where intensity of cracks is maximum. Length of ERT profile was 180 m and maximum depth of investigation is about 35 m bgl. Altitude of the ERT point is 1920 m amsl and it is about 500 m distance towards north from ERT-1. The ERT results shows that the loose formation and boulders are present under saturation with water below the depth of 30 m bgl (Figure 8A & 8 B).

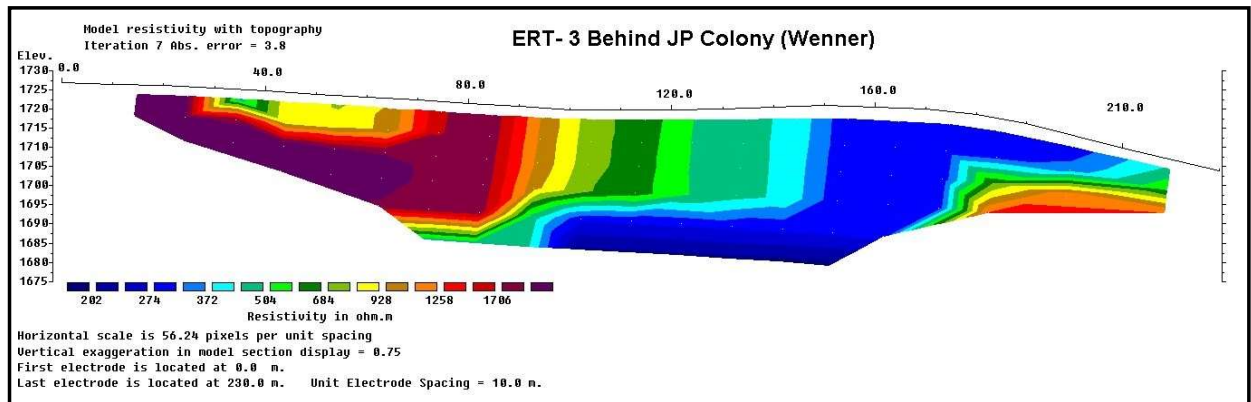
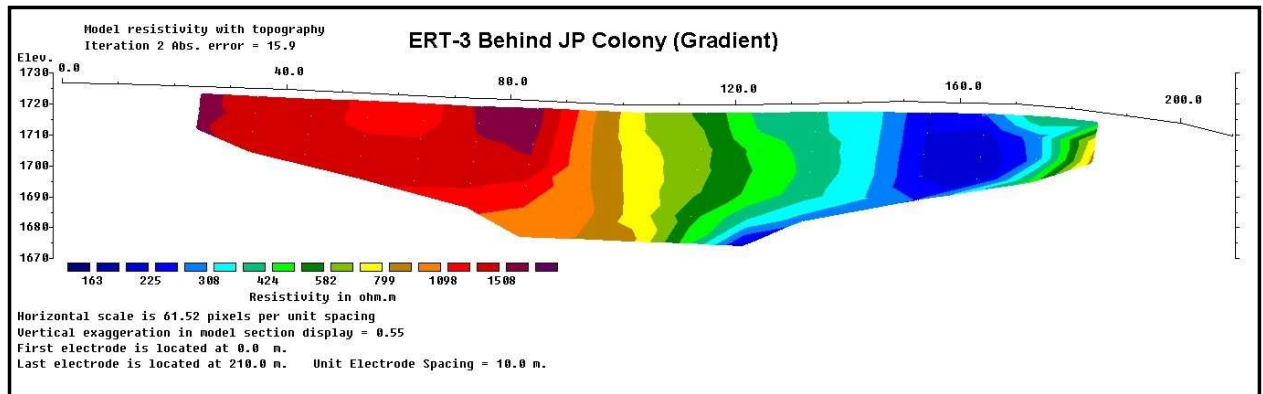
**Figure 9 A : 2-D Electrical Resistivity Tomography Section (Wenner) between Singhdhar and JP Premise, Joshimath (ERT-3), Chamoli District**

Third ERT was conducted 200 m south of the spot where sudden gush of water occurred on 2 / 3<sup>rd</sup> of January 2023. Here, the spread of ERT profile was 230 m and maximum depth of investigation was about 50 m (Fig.9A & 9B). ERT-3 results shows that area lying west of the cracks zone is consolidated in nature. East of the cracks zone have resistivity values in range of 200 – 300 ohm.m at a depth of 10 m to 50 m bgl which indicates the formation encounter in this depth range is saturated with water on the ERT profile between distance 100 and 170 m. It has the 70 m in horizontal extends which may act as path of the subsurface water flow.

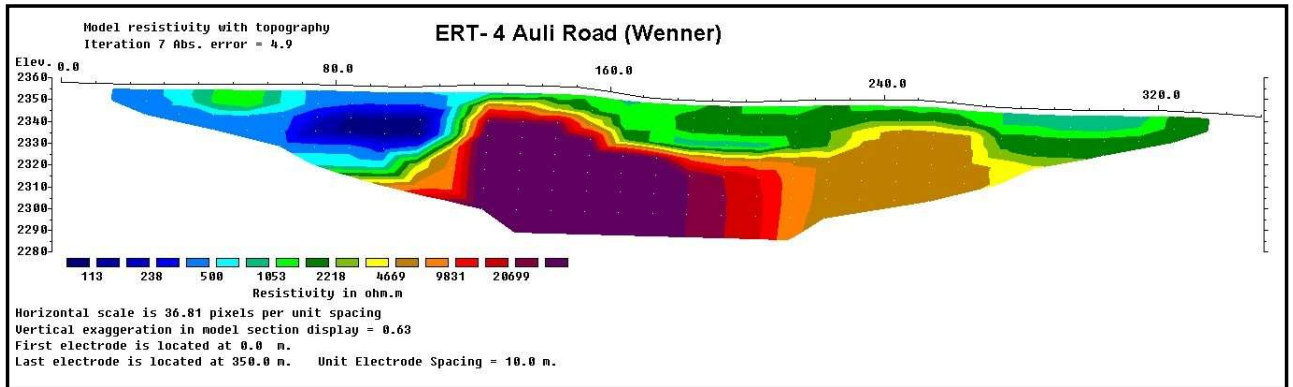
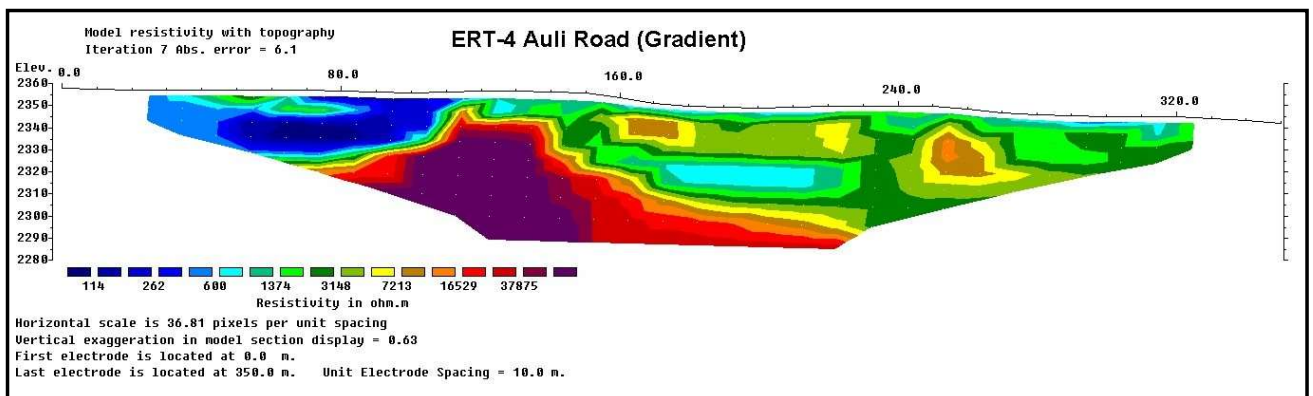
**Figure 10 A: 2-D Electrical Resistivity Tomography Section (Wenner) at Auli Road above the crown of subsidence, Joshimath (ERT-4)**

ERT-4 carried out along the Auli road in NW-SE direction about 200 m towards SW of the Sunil Village (Fig. 10 A & 10 B). A patch of low resistivity (100-300 ohm.m) was observed on the ERT-4 profile line between the distance of 50 and 100 m indicates the presence of saturated loose formation with boulders up to depth of about 25 m bgl.

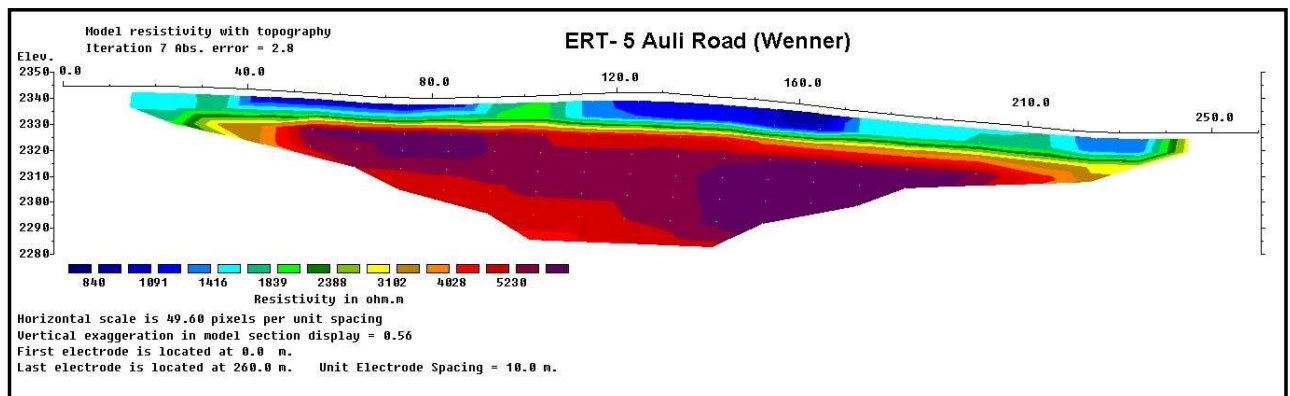
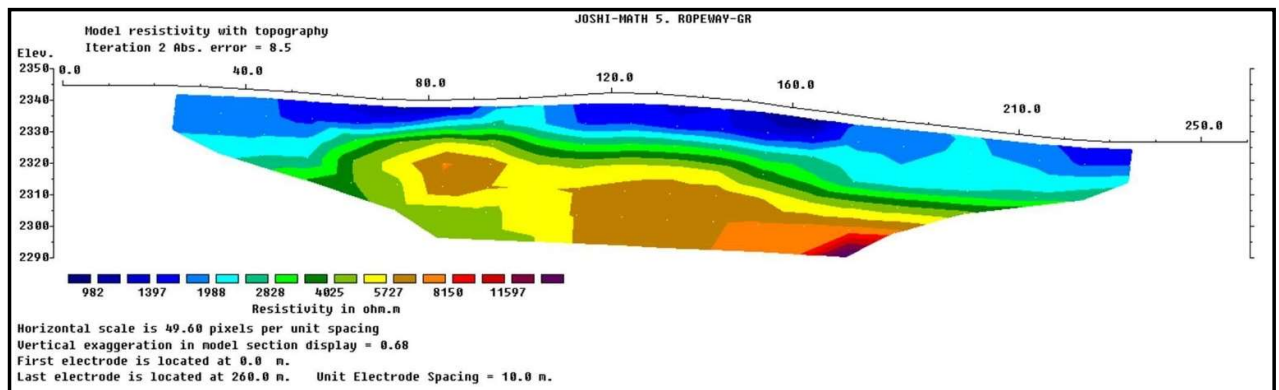
**Figure 11 A: 2-D Electrical Resistivity Tomography Section (Wenner) at Auli Road above the crown of subsidence, Joshimath (ERT-5), Chamoli District**

ERT-5 conducted as a roll along of ERT-4 towards east covering profile length of 250 m distance (Fig. 11A & 11 B). A patch of relatively low resistivity (800-900 ohm.m) was also observed compared to the surrounding resistivity values (more than 2000 ohm.m) on ERT-5 profile between 120 and 170 m distance on profile line. It may be indication of fracture in consolidated rock up to the depth of about 10 m bgl.

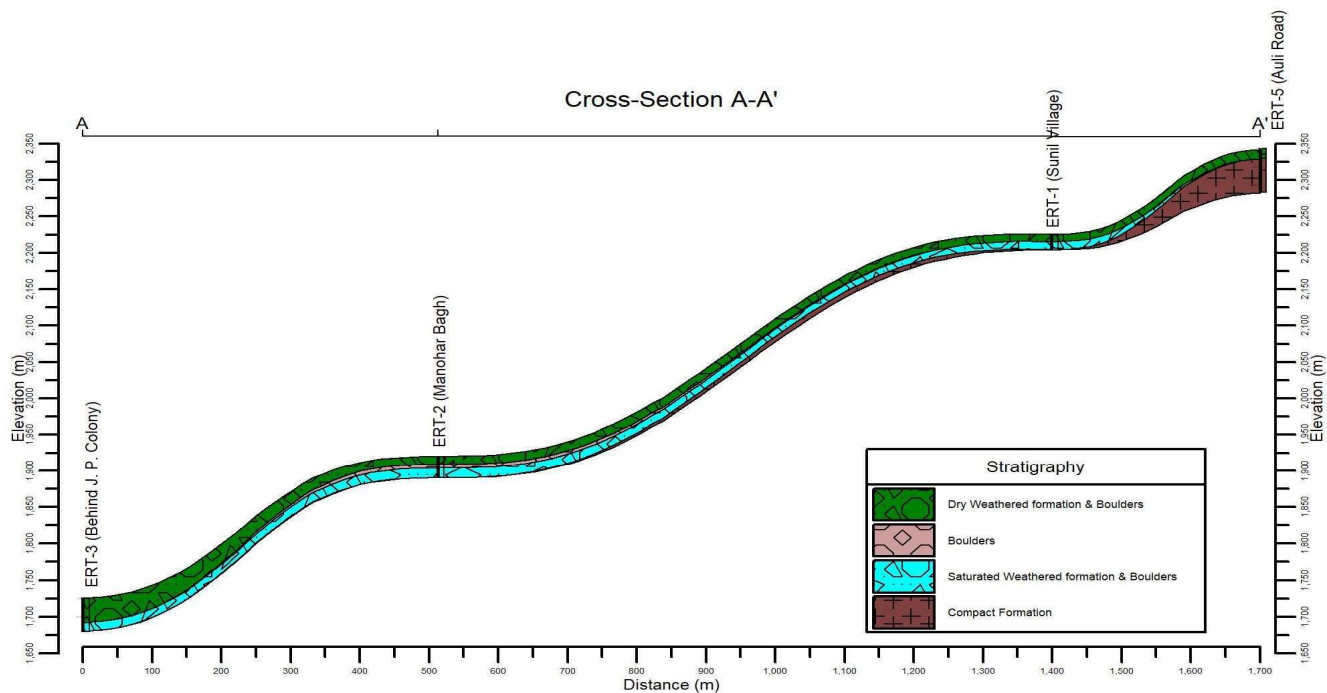
**Figure – 12 A - lithological section from J P colony in North to about 300 m away from Sunil Village, Joshimath, Chamoli District**

On perusal of the Figure 12 A, it is observed that thickness of the unconsolidated material increasing from Auli Road to J P Colony. Occurrence of water saturated formation becomes deeper from Auli Road to J P Colony. Ground water flows towards North direction (Fig 13). Large boulders are embedded in loose material especially in and around Manohar bagh. Findings of hydrogeological and geophysical studies conducted in the area reveals that the thickness of overburden (loose material) and saturated zone are comparatively more in Manohar Bagh-Singhdhar area, which may causes this area becomes susceptible to land subsidence. Further, the crack and subsidence in the area have relation with low resistivity shallow zones with groundwater flow occurring within 50 m depth.
