Subject: School building structural stability audit report.

## Structural stability report

- (a) Name of building – Kendriya Vidyalay no.1, Sagar, Cantt (MP)
- (b) Ward/Area – Cantt Sagar
- (c) No. of stories – G + 1
- (d) Year of construction –1976 (As reported)
- (e) Type of structure – Combination of RCC and stone masonry
- (f) History of repair - Not reported.

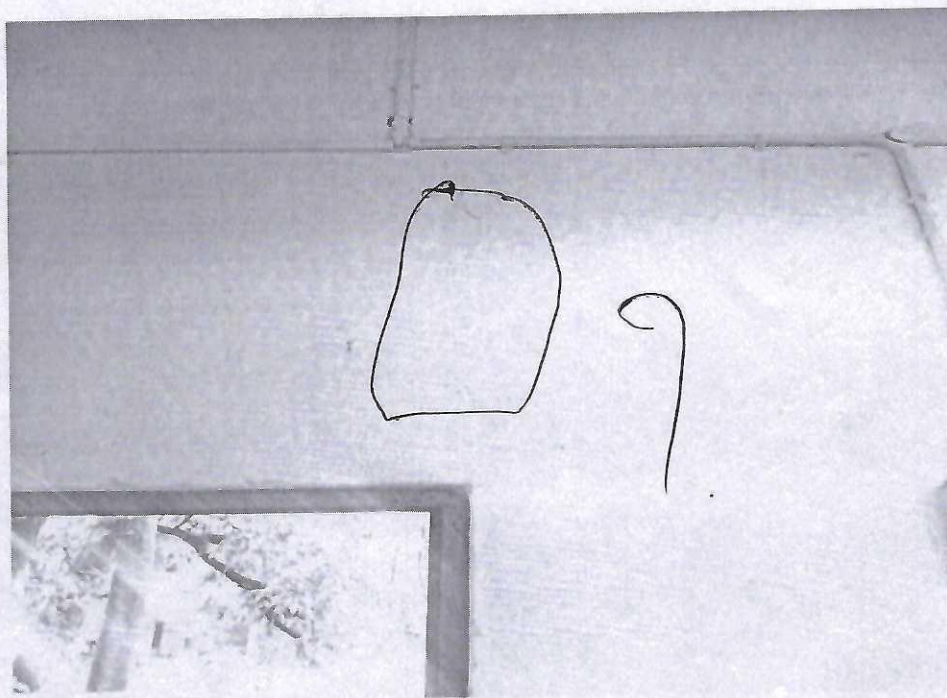
**Near room no. 07**  
**Distress: - Fine cracks noted**

1. It is a sample audit and not a full audit. Structure stability of the structure will not collapse under expected design load. This does not guarantee that an individual component of the structure will not collapse due to any eventuality.
2. Our responsibility ceases from the moment the structure is over loaded due to any of the reasons including natural calamities.
3. The report shall be valid for a period of five years from the date of issue of this report.
4. The support conditions shall not be altered and roof slab and plinth of the building shall be protected against accumulation of water in all weather conditions.
5. All cracks shown in the photographs must be patchup fully and water seepage treatment is needed in the area as shown in the photographs.

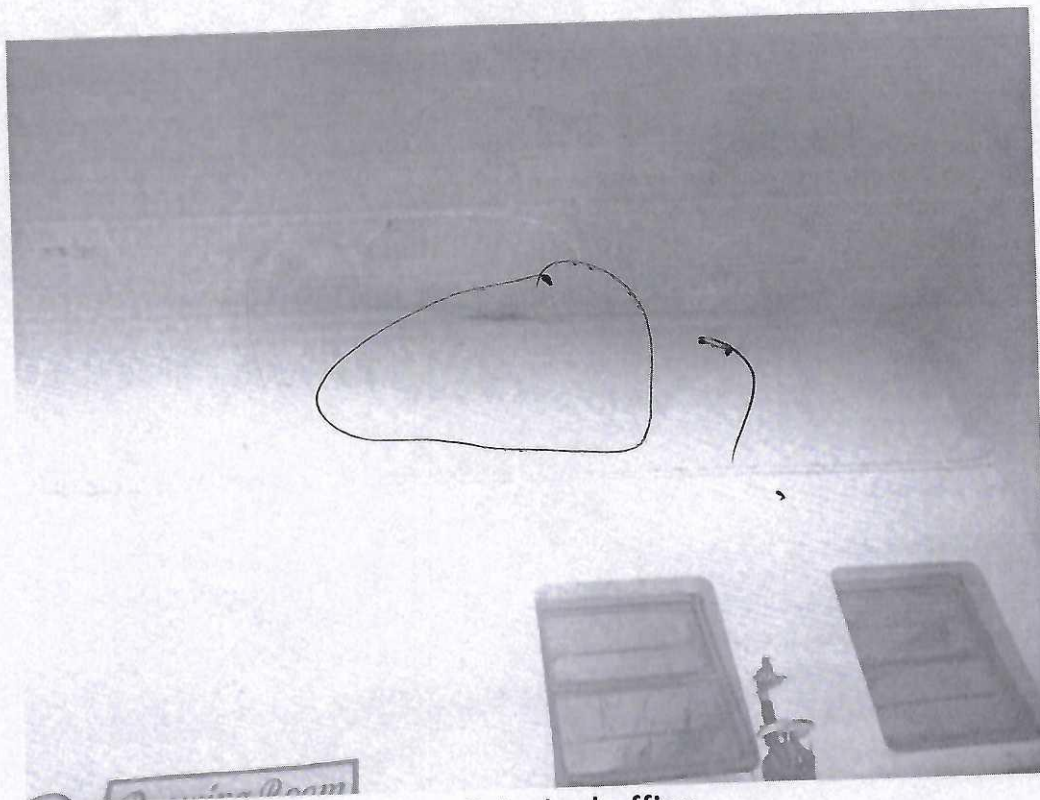
**Near Principal office**  
**Distress: - Seepage noted**

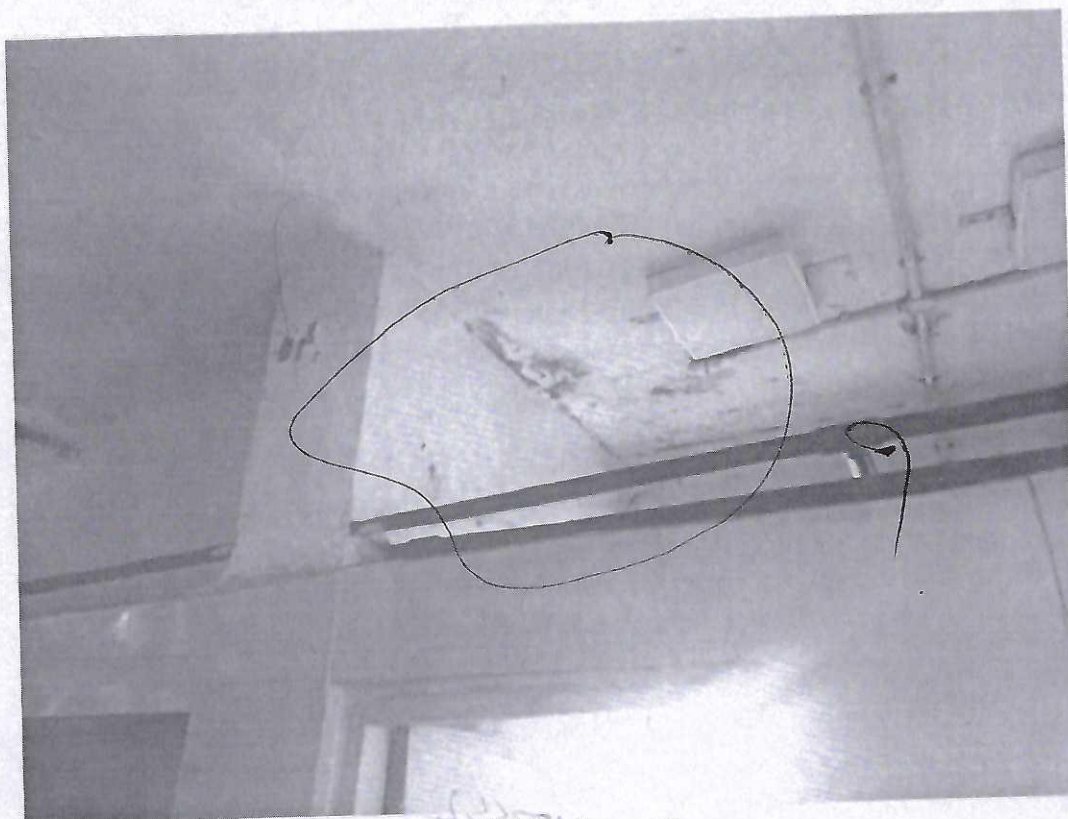
**Staff Washroom**  
**Distress: - Very fine cracks and Seepage noted**

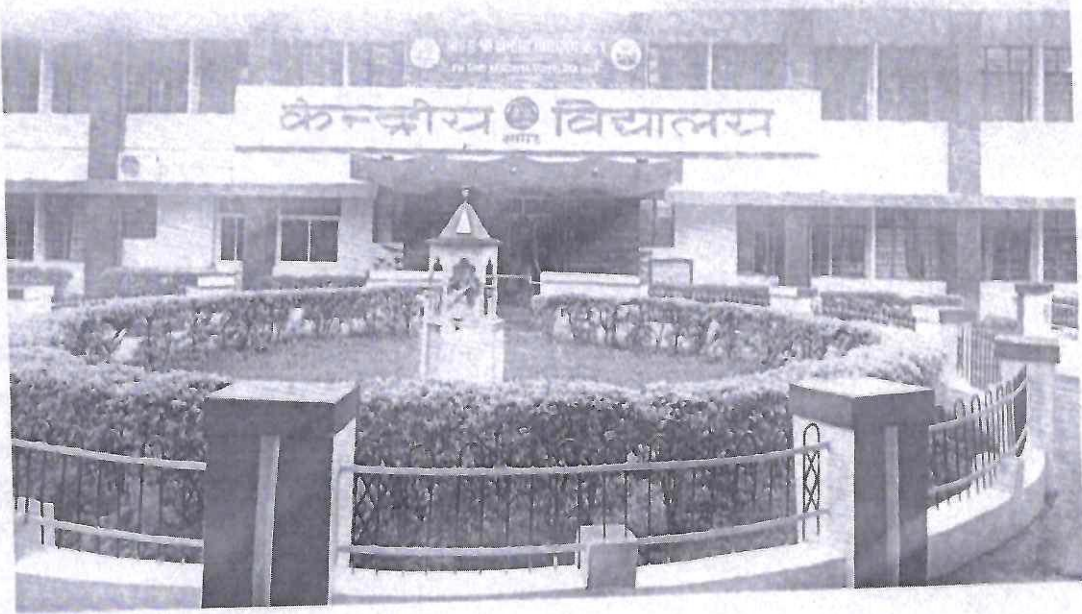
**Front elevation of school building**

**Distress: -** No major distress noted in the front side of school building
