Subject: Structural audit of school buildings

Name of Work: - Structural safety audit of PM Shri Kendriya Vidyalaya No.1 Devlali Buildings

Date of Inspection: - 19th March 2025

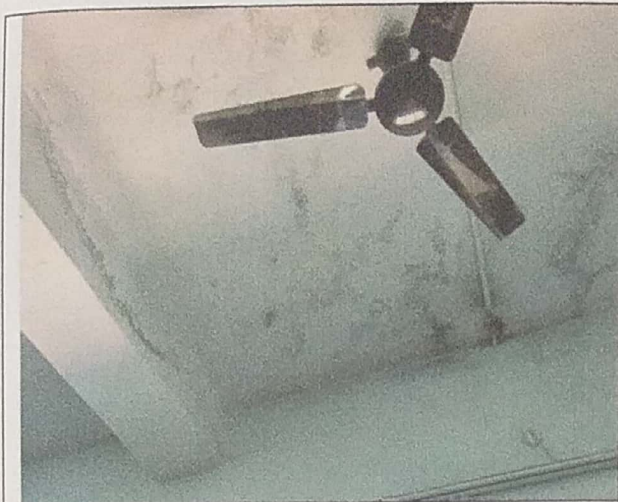
Classroom no. 33 (VII-C)

6.	Flooring	<ul style="list-style-type: none"> Flooring is in good condition.
7.	Leakages & dampness in walls	<ul style="list-style-type: none"> Seepage observed in Room no. 25 [Class VI-C] : slab corner, 27 [Class VI-A], 33 [VII C], 37 [IX-B], Passage of Junior Science lab

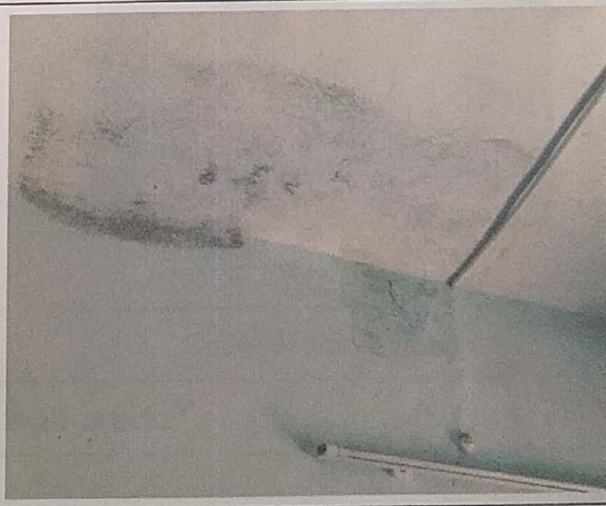
Sr. No.	DESCRIPTION	REMARKS
8.	Toilet leakages, cracks	<ul style="list-style-type: none"> Seepage observed in Girls toilet as well as in Boy's toilet of primary section Vegetative growth observed on external wall of toilet block of primary section. Seepage observed in Classroom 64 [V-B] in Nurse building
9.	Electrical line	<ul style="list-style-type: none"> Good condition
10	Other	<ul style="list-style-type: none"> Fall of concrete from Chajja. Reinforcement bars are open. Some reinforcement bars are also cut. Construction joints are open Water tank (unused) is corroded at bottom, spalling off concrete, cracks in container wall

Dampness and seepage observed in the walls and ceiling

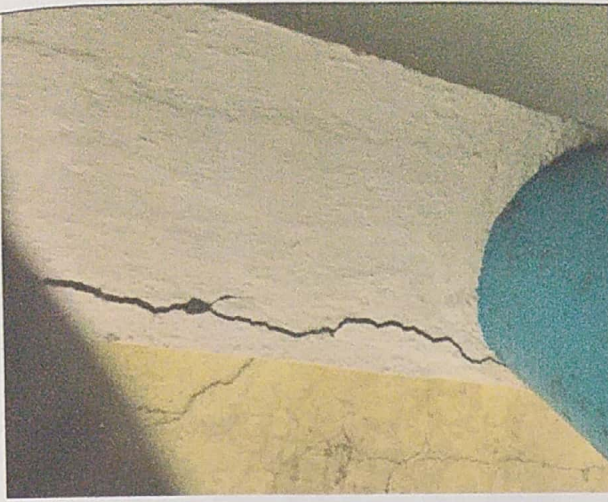
Beam near Gents toilet on ground floor

Structural cracks observed in beams

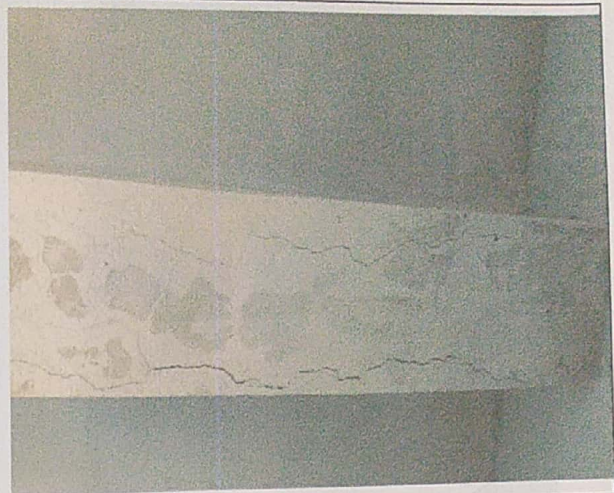
2.	Columns	<ul style="list-style-type: none"> Average Strength observed: 24.4 N/mm² Columns are in good condition
3.	Beams	<ul style="list-style-type: none"> Average Strength observed: 17.2 N/mm² Beams are in good condition Spalling off beam concrete and cracks due to corrosion as observed in Room no.s 25 [Class VI-C], 27 [Class VI-A] and 28 [Class IX-B], passage near 41 [X-A]

Crcks in beam in Classroom no. 25 [VI-C]

- Dampness and leakages observed at most of the Toilet Blocks need urgent repairs.
- Spalling of Beam concrete (Classroom 27 [VI-A]) needs repairing measures.

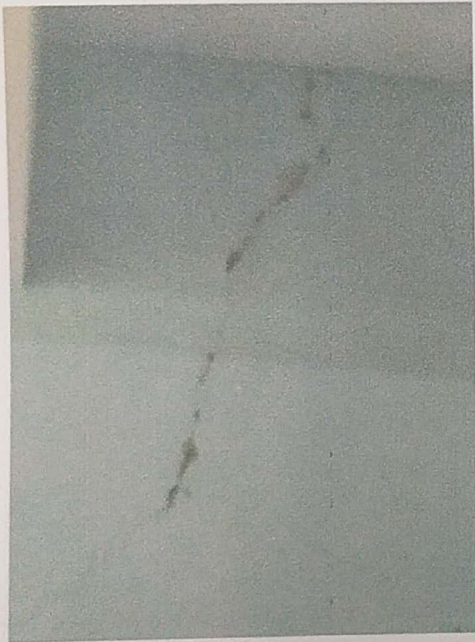
Classroom 57 [AV room]

4.	Slabs	<ul style="list-style-type: none"> Slabs are in good condition Bottom slab reinforcement got exposed at Ground Floor Boy's Toilet.
5.	Walls	<ul style="list-style-type: none"> Cracks in the southern side parapet wall observed. Vegetative growth observed on passage walls at few places Structural cracks observed on the walls at slab level in Class X-A, Passage of Junior Science lab, 57 [AV room],

Masonry/ Wall cracks

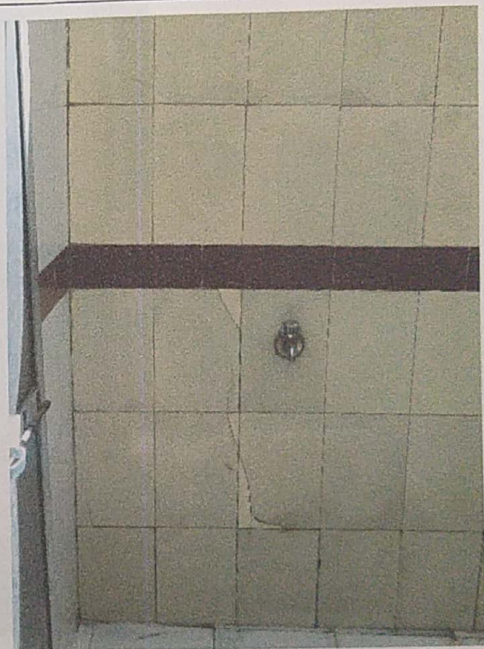
Toilet of Nurse room

Sr. No.	DESCRIPTION	REMARKS
1.	Visual inspection	Building condition is good
2.	Settlement of columns	No settlement is seen
3.	Settlement of walls	Observed in Nurse building
4.	Cracks in col., walls, joint at plinth	Cracks in the walls observed in toilet of Nurse building.

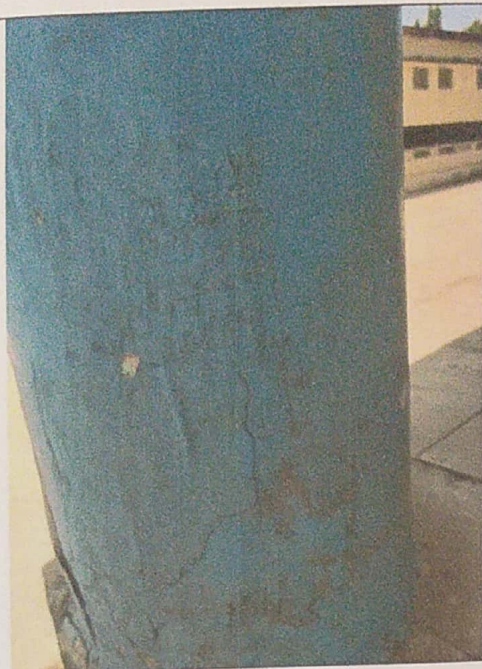
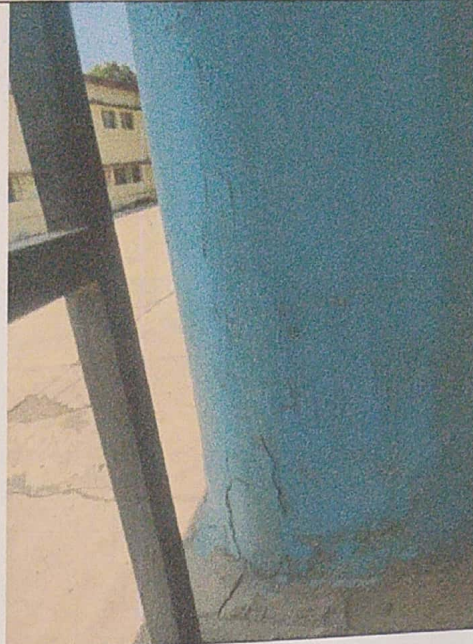
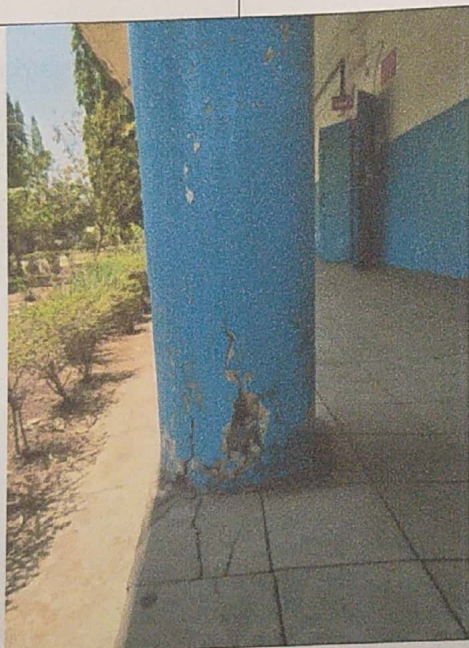
Columns near ground floor near Boys toilet

Sr. No.	DESCRIPTION	REMARKS
1.	Distressed Column	<ul style="list-style-type: none"> Average Strength observed: 15.18 N/mm² for columns near Girls Toilet on First Floor and near Boy's Toilet on Ground Floor; also for the column nearby Classroom [14] of IX-C. Heavy Cracking and Corroded reinforcement observed in these columns affecting their load carrying capacity. Immediate strengthening is required for these columns.

Sr. No.	Level	Element Type	Direction	Mean Concrete Compressive Strength MPa
7	Ground floor	Column (Distressed)	Horizontal	11.9
8	Ground floor	Column (Distressed)	Horizontal	16.9
9	Ground floor	Column (Distressed)	Horizontal	17.2
10	Ground floor	Beam	Horizontal	16.9
11	Ground floor	Beam	Horizontal	18.2
12	First storey	Column	Horizontal	35.1
13	First storey	Column	Horizontal	30.7
10	First storey	Column	Horizontal	25.4
11	First storey	Column	Horizontal	40.8
12	First storey	Column	Horizontal	17.7
13	First storey	Column	Horizontal	22.0
14	First storey	Column	Horizontal	37.1
15	First storey	Column (Distressed)	Horizontal	14.2
16	First storey	Column (Distressed)	Horizontal	15.7
17	First storey	Beam	Horizontal	10.9
18	First storey	Beam	Horizontal	16.9
19	First storey	Beam	Horizontal	23.1

Distressed Ground floor Columns which need urgent repairs and strengthening

- Three columns at Ground Floor near Gents and Boy's toilet and on first floor near Girl's toilet have been observed in distressed condition. They need urgent repair and strengthening at both Ground and First Floor level.

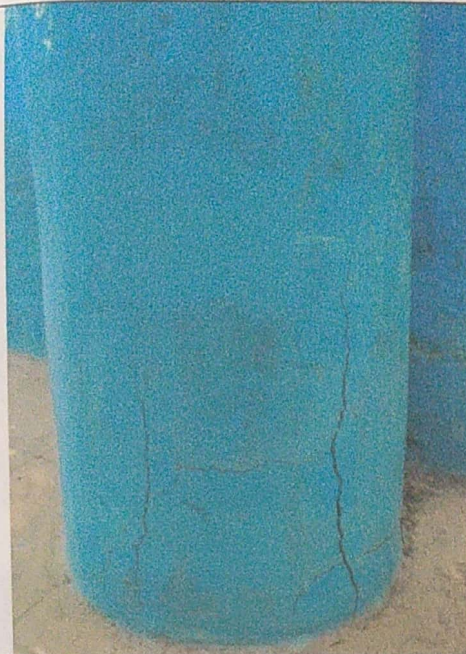
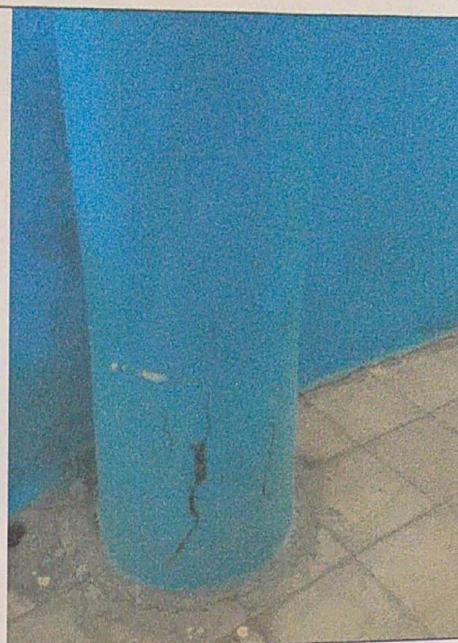
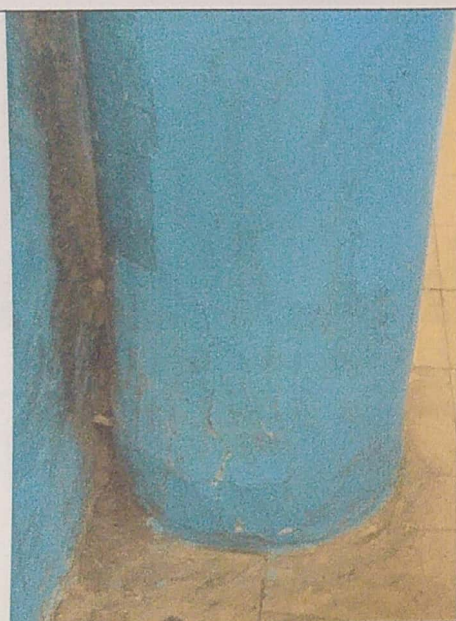
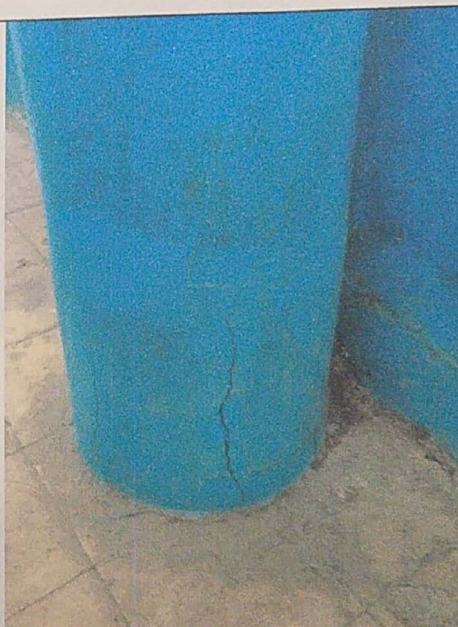
Distressed Columns on first floor near girl's toilet

Distressed first floor Columns which need urgent repairs and strengthening

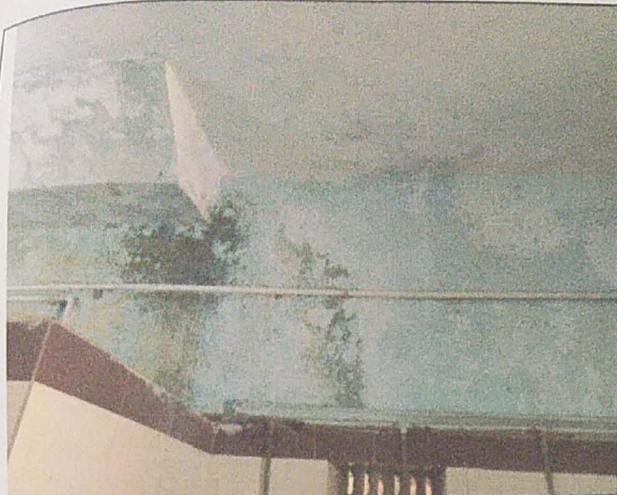
Ground floor Gents washroom

8.	Toilet leakages, cracks	<ul style="list-style-type: none"> Ground Floor: Gents Washroom and Boy's toilet -heavy leakage from the sunken slab above, cracks in Dado Ground floor Boy's Toilet: Bottom slab reinforcement got exposed First Floor Girls toilet: diagonal masonry cracks observed; need urgent repairs. Seepage on walls and slab.

Seepage/Dampness in toilets

- It is suggested that regular repairs of all toilet blocks need to be done in order to stop seepage.
- All construction joints shall be properly filled in so as to stop leakages through them.

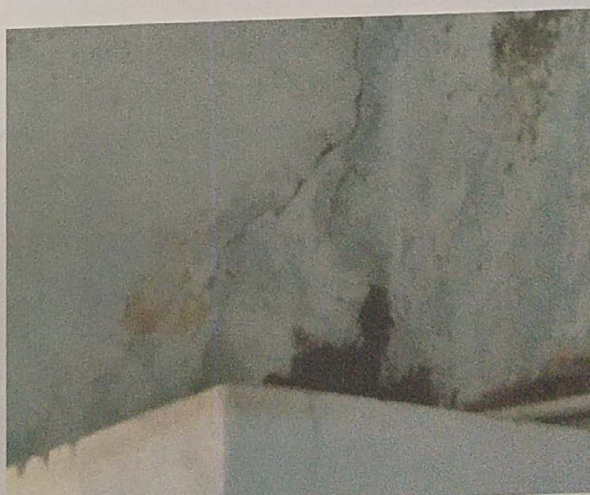
Cracks in first floor Girls washroom

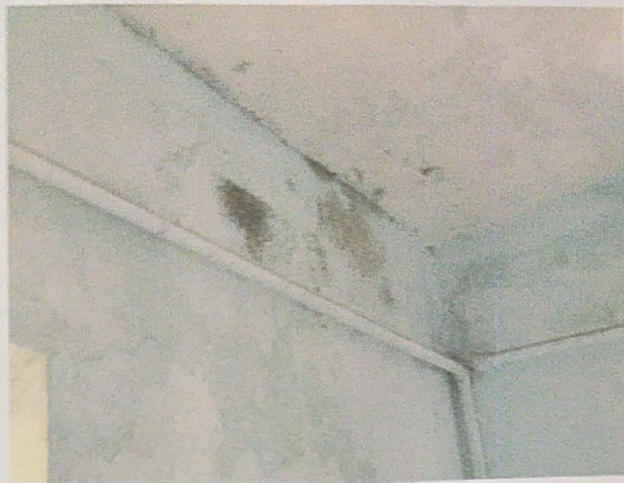
Seepage in toilet of primary section

Seepage/Dampness in toilets

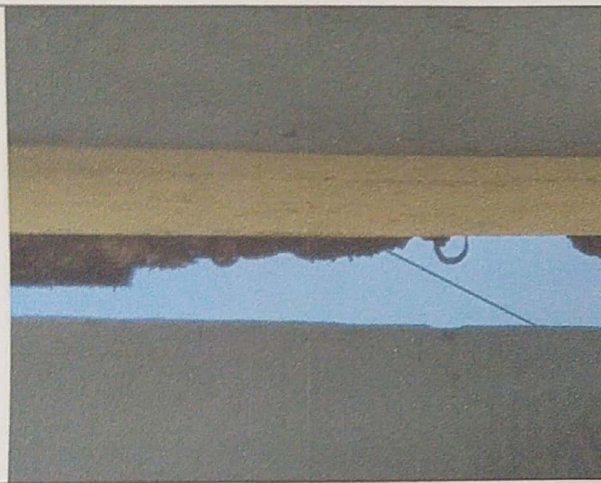
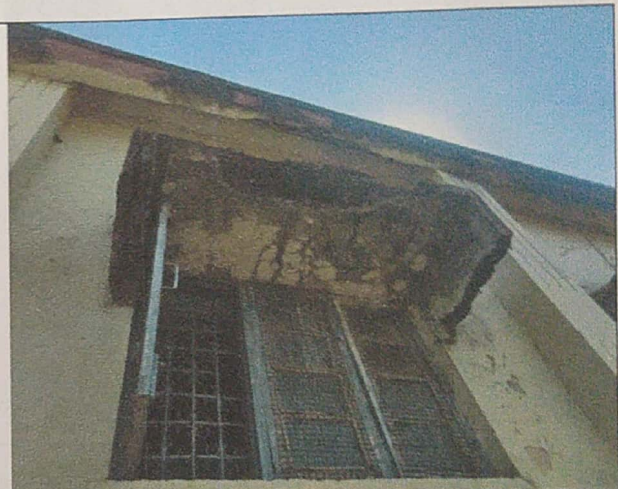
Sr. No.	DESCRIPTION	REMARKS
		<p>[14] of IX-C. Near this column, strength of column 17.5MPa; need strengthening.</p> <ul style="list-style-type: none"> Waterproofing needs to be re-done on the terrace Chajjas are in broken condition with spalling off concrete with exposed corroded reinforcement. Cracks observed in the slab of the entrance porch

Broken chajja with spalling off concrete and exposed corroded reinforcement

- Major leakages due to rainwater (Primary Wing) shall be repaired.
- Most chajjas are broken with fall off concrete and exposed corroded reinforcement. These need to be removed/repared with proper techniques.

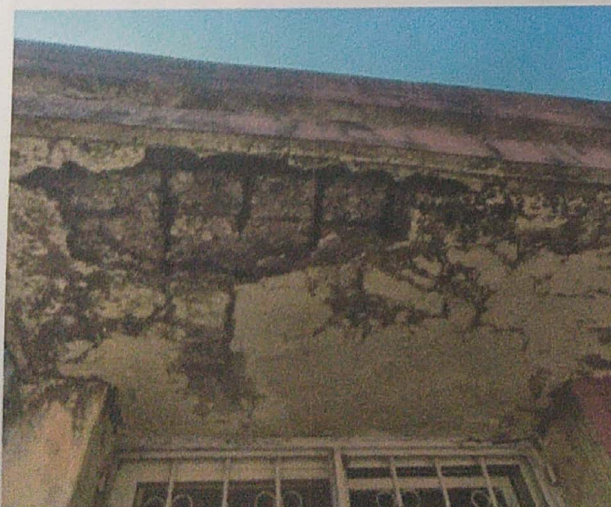
Spalling off concrete and exposed corroded reinforcement

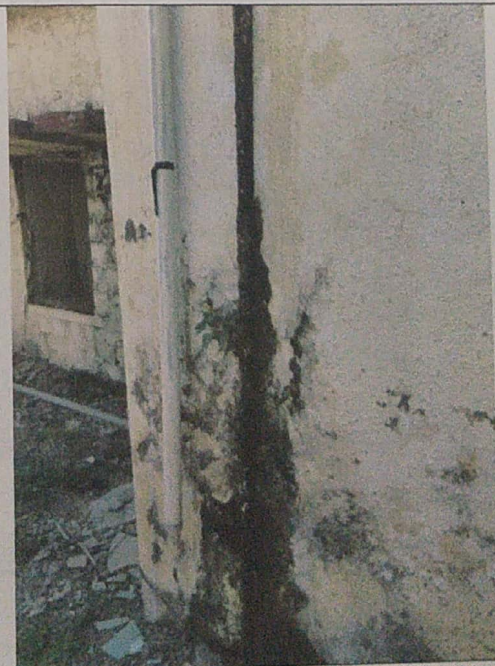
9.	Electrical line	<ul style="list-style-type: none"> Good condition
10.	Exterior face of walls	<ul style="list-style-type: none"> Vegetative growth observed on the exterior face of walls Masonry wall cracks observed Leakages observed through plumbing line

Vegetative growth and leakages through plumbing lines

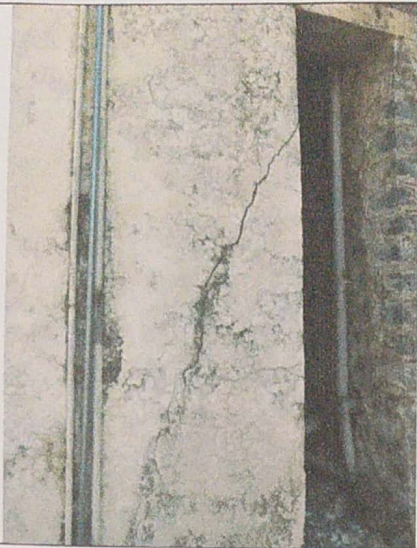
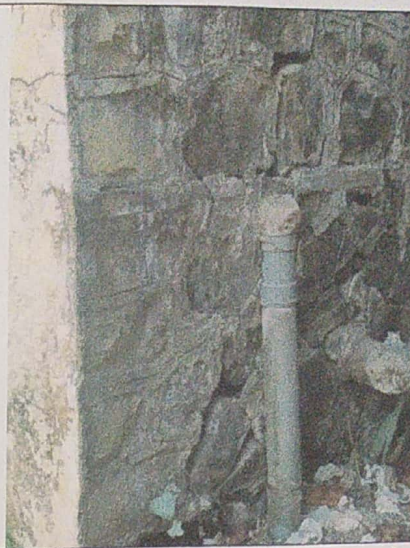
Masonry crack in exterior face of wall

Masonry cracks in exterior face of wall

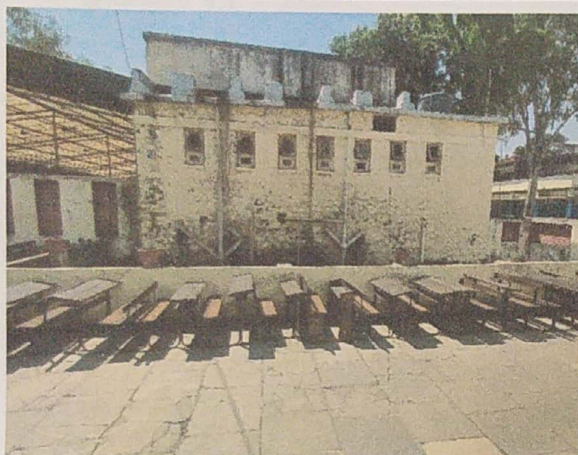
Vegetative growth and leakage in plumbing lines

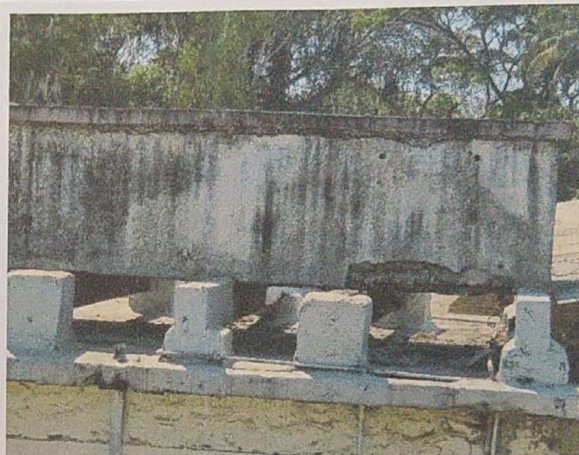
Spalling off concrete and Exposed corroded reinforcement of water tank (not in use)

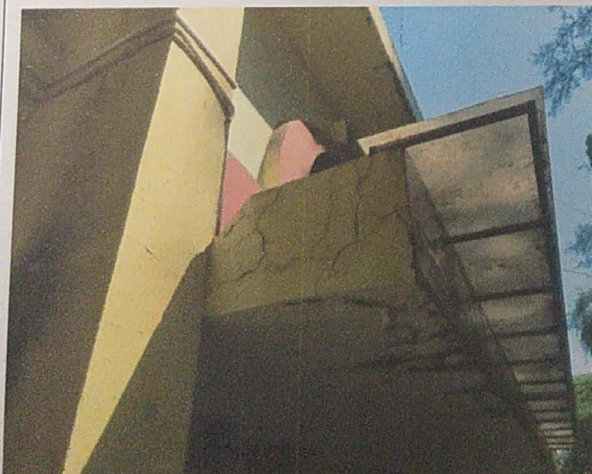
- Stagnation of water above the entrance porch. Spalling of plaster and exposed bottom reinforcement is seen at patches. Cracks observed on the porch slab.

Cracks in the slab of the entrance porch

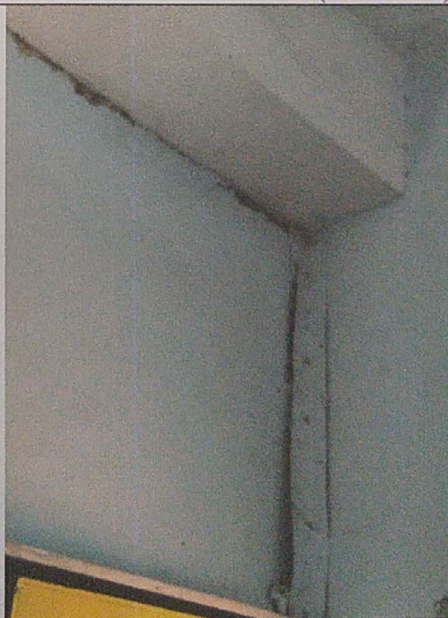
Open construction joint
