# STUDY OF GROUND SUBSIDENCE IN JOSHIMATH FOLLOWING THE EVENTS OF JANUARY 2023

**WADIA INSTITUTE OF HIMALAYAN GEOLOGY**

**Uttarakhand State Disaster Management Authority**

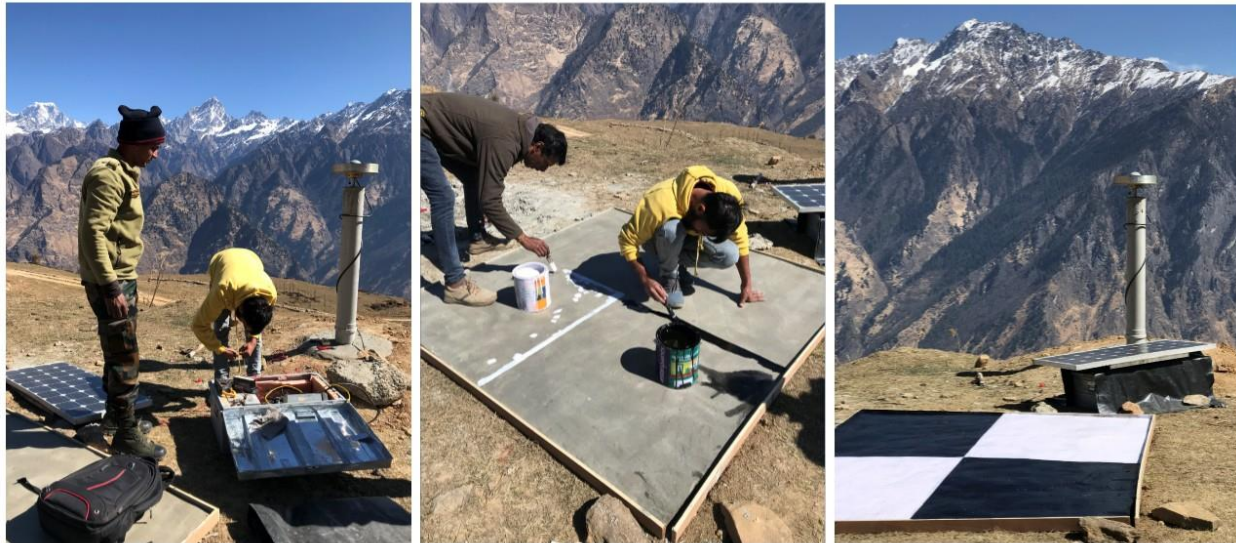
Setting up of Auli GCP & Base Station

Figure 2: Setting up of Base Stations and GCPs

The ground team started on-site establishment of Ground Control Points by constructing slabs of 6 X 6 feet concrete slabs at 6 locations, painted in black and white, and two pillar base stations, around the survey area (figure 1) starting from 23 February 2023. The airborne data collection
