# Economics of seismic resilience of educational infrastructure in high earthquake hazard prone Himalayan province of Uttarakhand in India

Seismic vulnerability assessment of around 63.87% of the state owned school buildings in the Himalayan province of Uttarakhand in India that falls in identified high earthquake risk zone; Zone V and Zone IV of Earthquake Zoning Map of India, reveals 78.51% to be put to disuse immediately after an earthquake. Particularly high vulnerability of school buildings in Haridwar, Bageshwar, Pithoragarh and Almora districts of the province is to pose challenges of various sort on the aftermath of a major earthquake incidence. Based on damageability assessment of the surveyed buildings earthquake is estimated to result in losses to the tune of US\$ 219.55 million to the surveyed school infrastructure alone. An investment of US\$ 206.42 million is estimated for ensuring seismic safety of the surveyed school buildings by way of demolition and reconstruction of Grade 5 buildings (US\$ 52.50 million) and seismic retrofitting of buildings falling in Grade 4 (US\$ 107.29 million) and Grade 3 (US\$ 46.62 million). US\$ 323.19 million is estimated as being the c

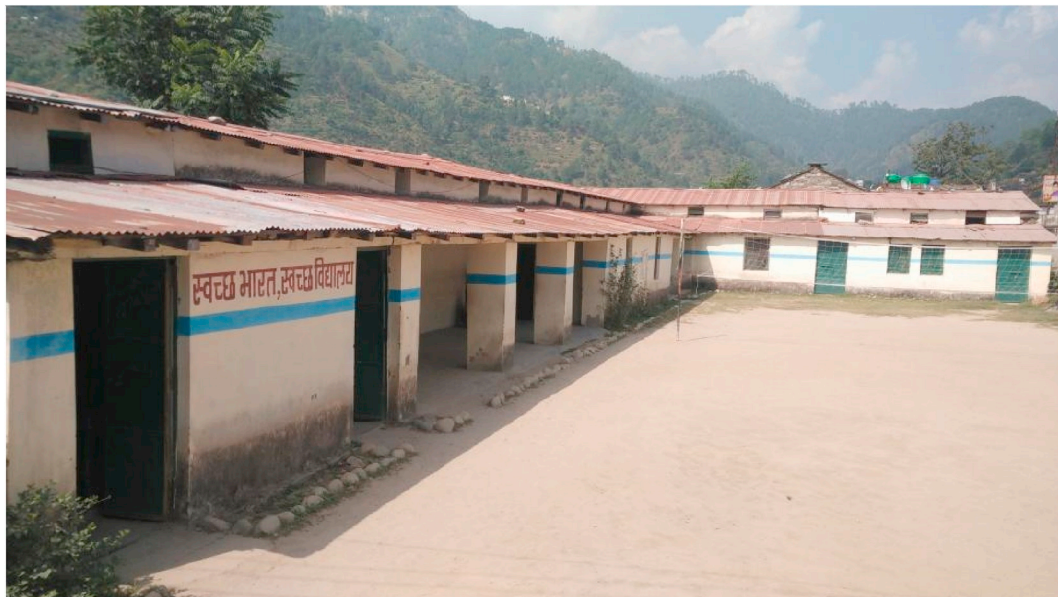
**Fig. 3.** Single storeyed irregular masonry building of Government Inter College at Syunsi in Pauri Garhwal district having CGI roof.

Large majority of surveyed school buildings are observed to be single storied (Fig. 3), while only 10 masonry and 19 RCC buildings are triple storied (Fig. 4) with one building each of masonry and RCC being four storied (Table 3). More than 90% of the masonry buildings in all the districts of the province are single storied while double storied RCC buildings are less than 25% in Almora, Bageshwar, Chamoli, Dehradun, Pithoragarh, Rudrapur and Uttarkashi districts.

RCC slab is the most prevalent roofing material amongst the surveyed buildings (81.96%) while 17.58% have CGI sheets (Figs. 3 and 4). Only a few buildings are observed have tiles, wooden and asbestos sheet as roofing material (Table 5).

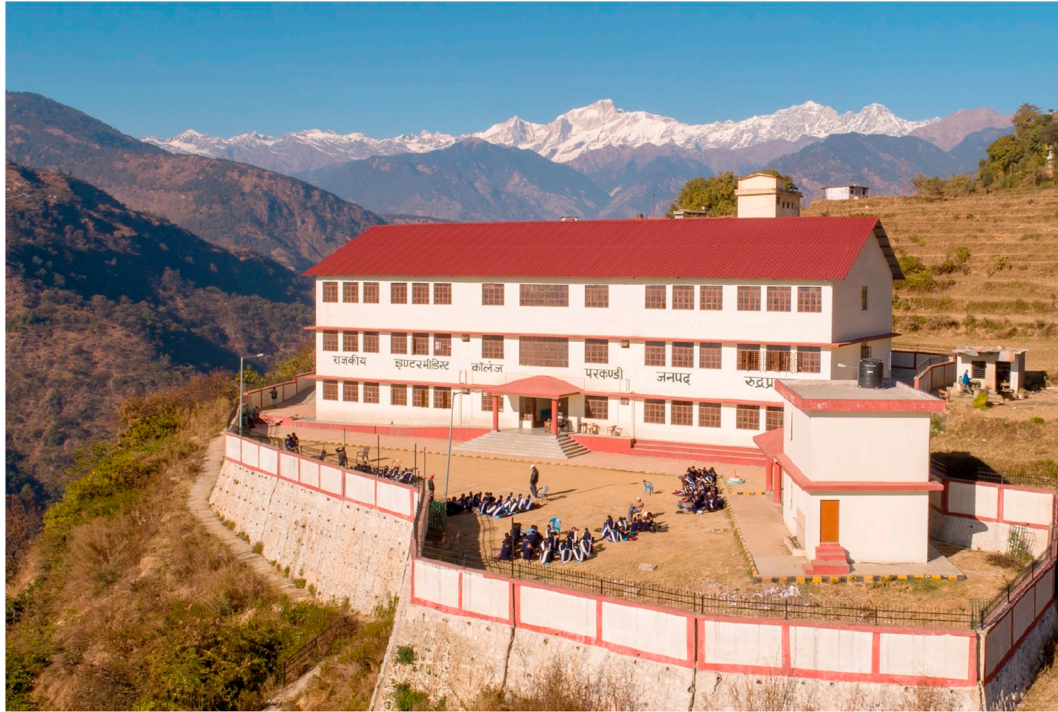
**Fig. 4.** Recently constructed three storeyed RCC Government Inter Collage building at Parkandi in Rudraprayag district having CGI sheets as the roofing material.**Table 3**

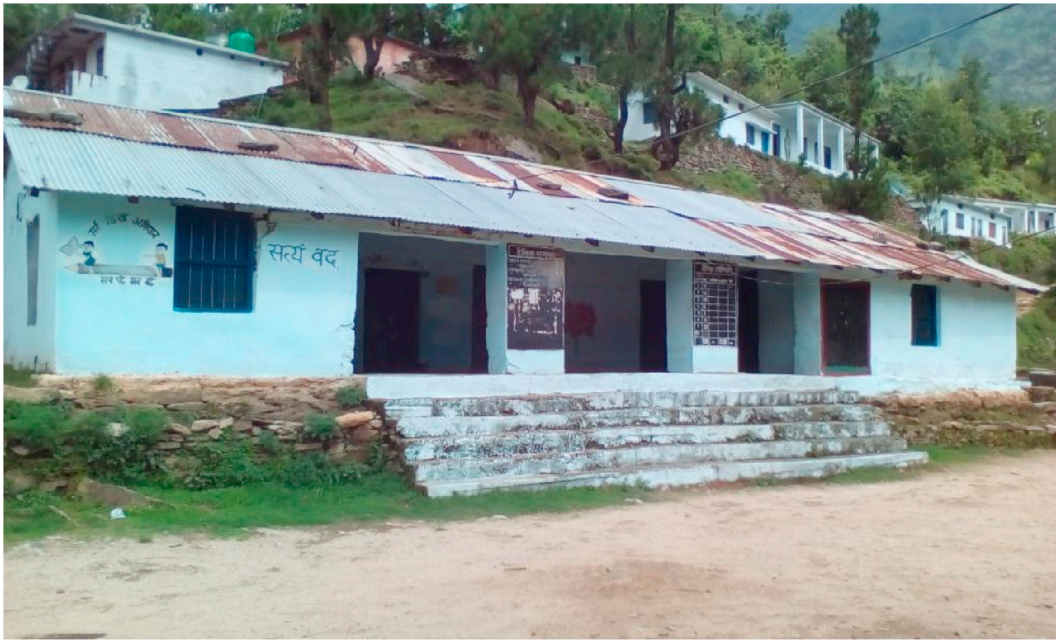
Fig. 5. Single storeyed Government Inter College building with CGI sheet as roofing material at Rau Lekh in Rudrapur district is built using stone foundation.

Economic and abundant availability in the hills makes stone a favourite for foundation works (80.69%; Fig. 5). Brick (9.85%), RCC (6.25%) and cement concrete (3.21%) are other foundation materials observed to be utilised in the surveyed buildings (Table 8).

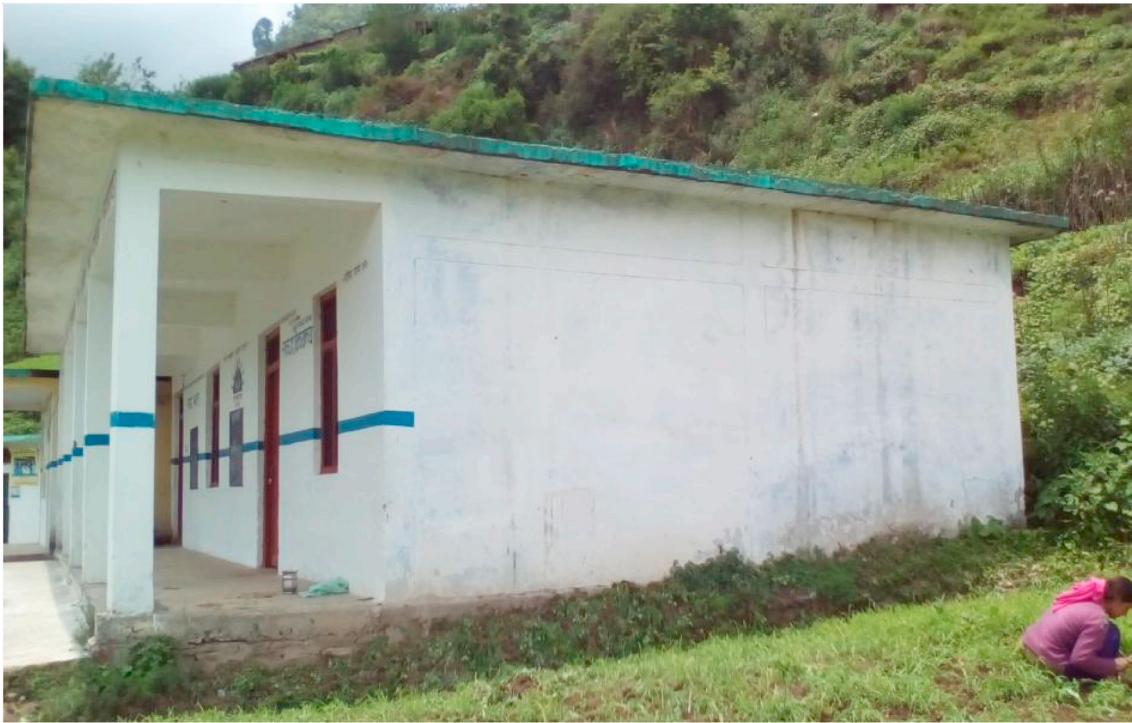
**Fig. 6.** Government Inter Collage at Trijugi Narayan in Rudraprayag district having RCC slab as the roof and built over soft soil.

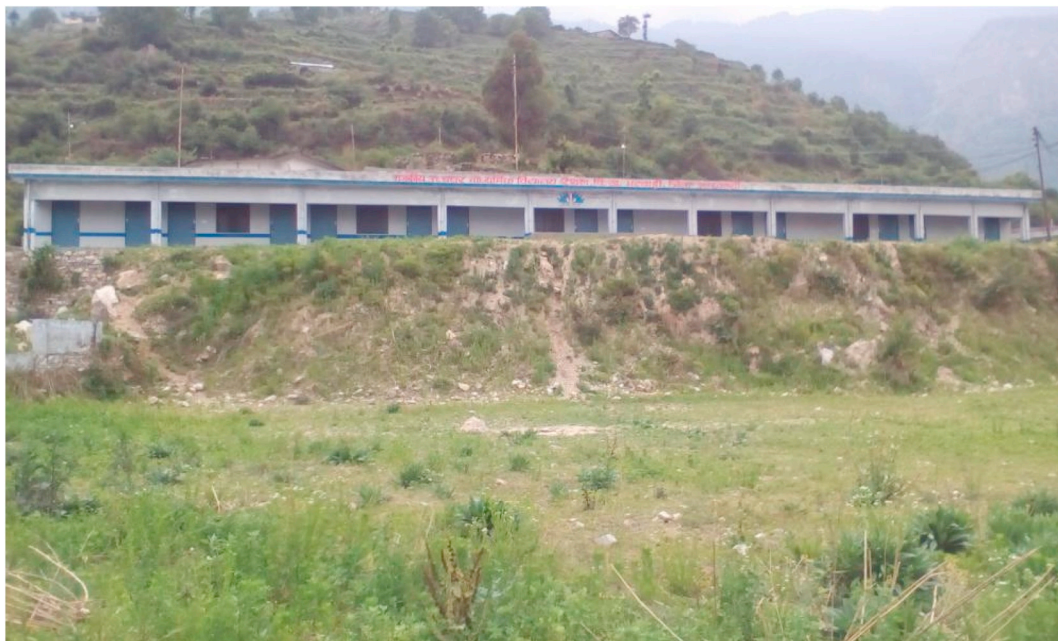
**Fig. 7.** Single storeyed Government Higher Secondary School at Raithal in Uttarkashi district having RCC slab as roof and built over sloping ground.

Building codes applicable in India [25] recommend that the footing be placed adjacent to a sloping ground when base of the footing are at different levels. In order to avoid damage to an existing structure, the code recommends (i) footing be placed at least at a distance 'S' from the edge of the existing footing where 'S' is the width of larger footing and (ii) the line from the edge of the new footing to the edge of the existing footing should make an angle of less than 45°. Slope of 5.14% of the surveyed masonry and 8.15% of the RCC buildings is observed to be more than 45° (Fig. 7).

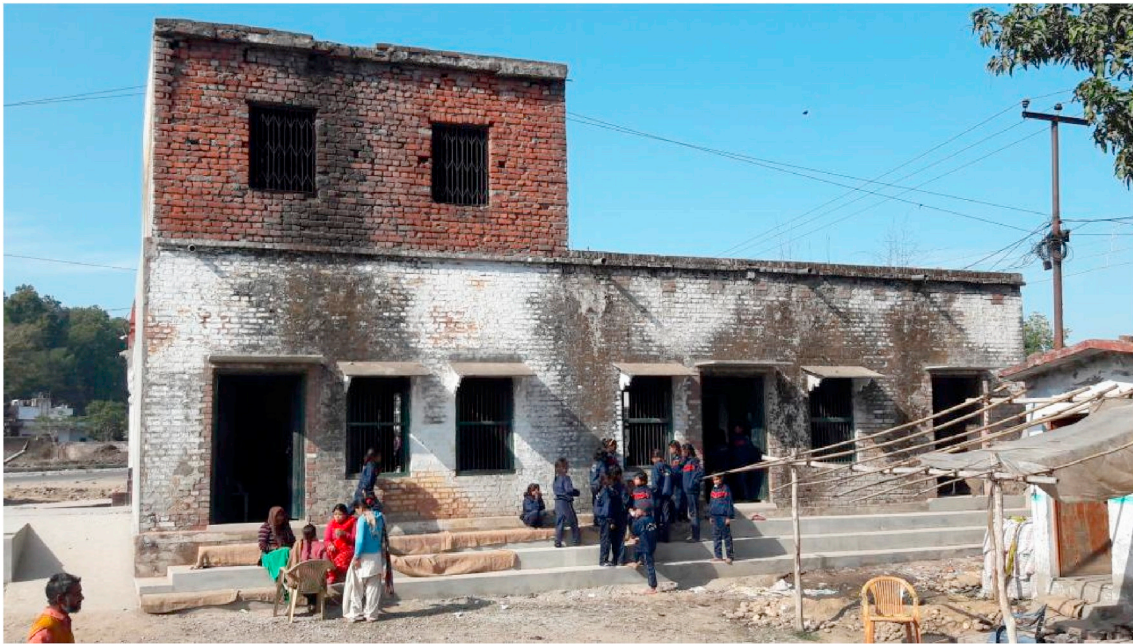
Fig. 8. Primary School at Motichoor in Dehradun representing a non-engineered double storeyed masonry structure.

The buildings designed and constructed accordingly to the desired codes are engineered buildings while spontaneously and informally constructed buildings without any engineering input are non-engineered buildings [26]. 82.6% of the surveyed buildings are observed to be non-engineered (Fig. 8). Only 7.09% of the surveyed masonry and 50.00% of the RCC buildings are observed to be engineered.

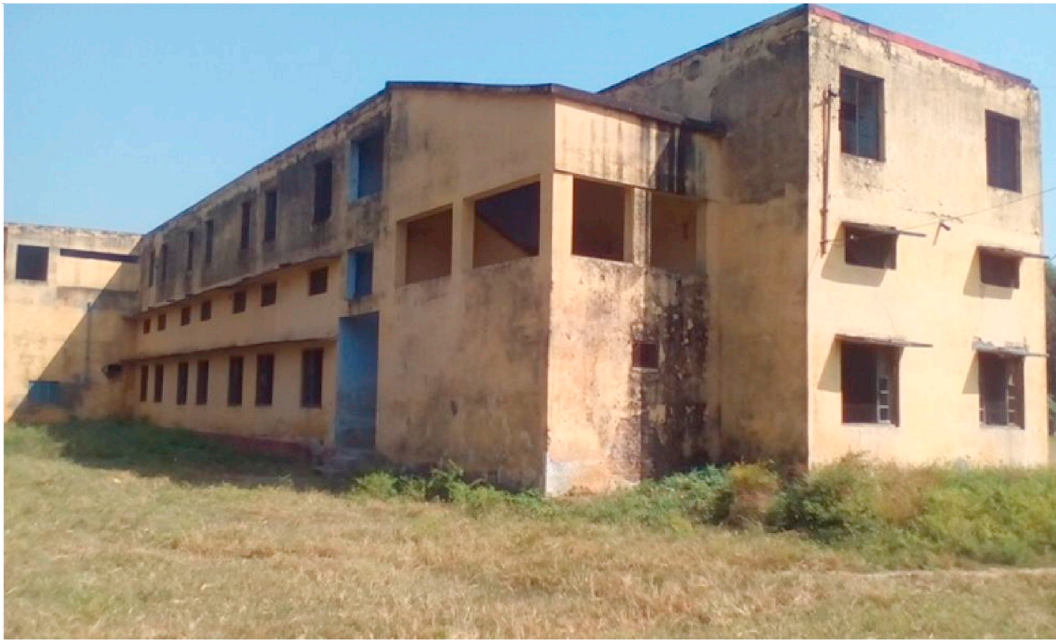
2.81 and 4.31% of the surveyed masonry and RCC building are respectively observed to have irregularity in shape (Fig. 11). Classified as L, T and Reverse-T type most buildings are observed to have L type irregularity.

Fig. 11. Asymmetric building of Inter College at Jawalapur in Haridwar district.

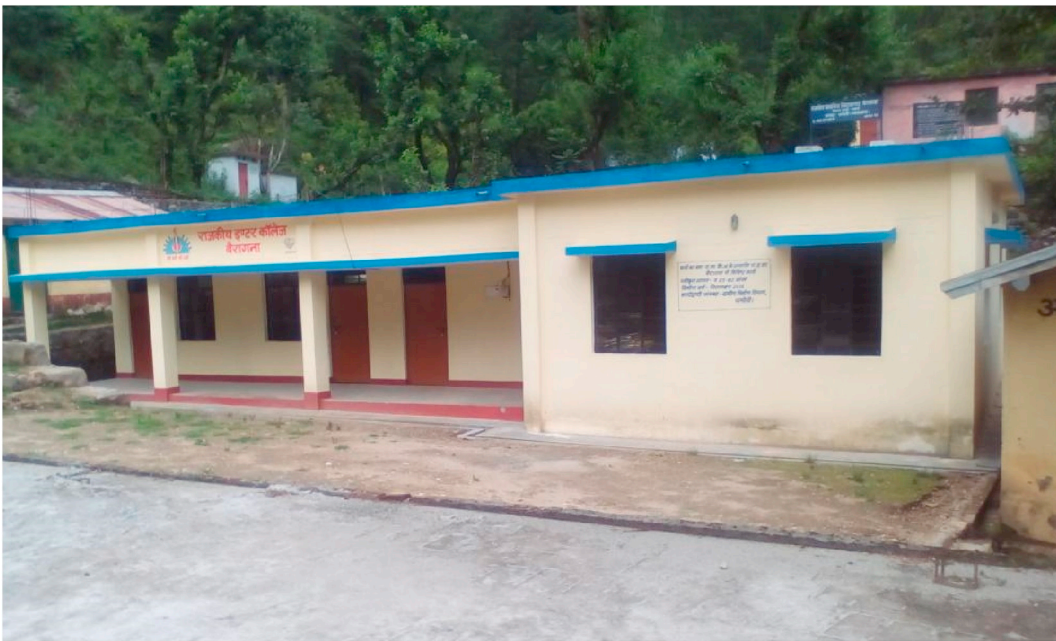
Plan configuration of a structure and its lateral force resisting system contain re-entrant corners, where both projections of the structure beyond the re-entrant corner are greater than 15% of its plan dimension in the given direction [27]. Vulnerability due to re-entrant is observed in 7.87% masonry and 13.13% RCC buildings (Figs. 12 and 13).

Fig. 12. Single storeyed Government Inter Collage at Bairangana in Chamoli district having RCC slab as the roofing material and exhibiting re-entrant corner.

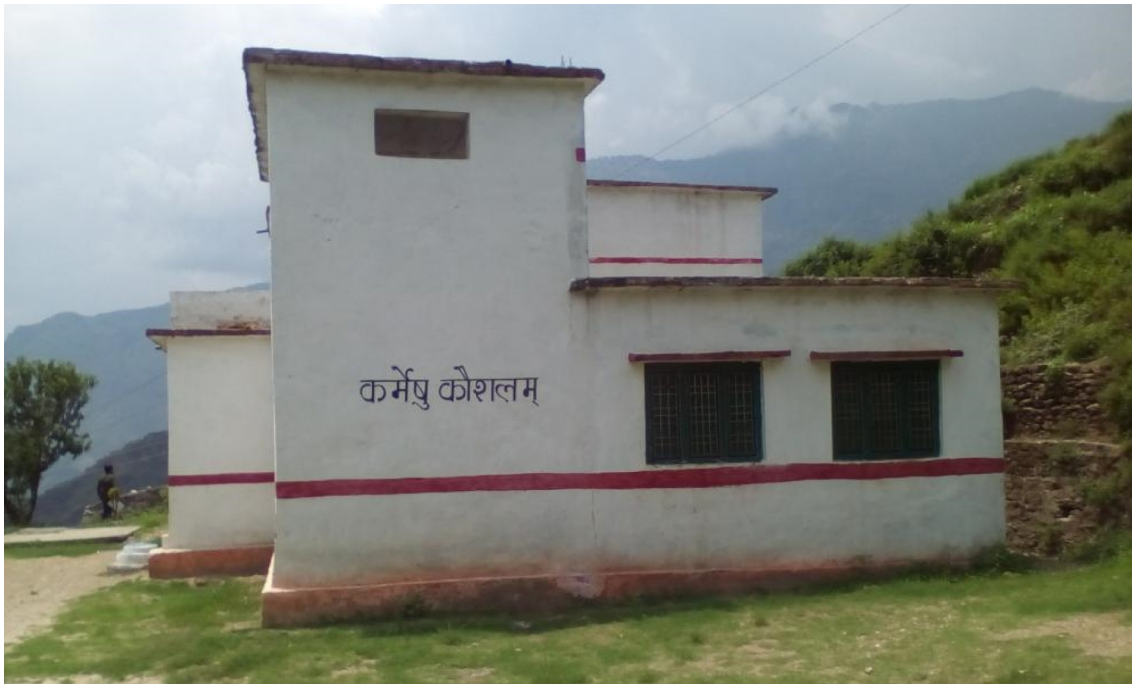
Fig. 13. Re-entrant corners in Upper Primary School at Balidhar in Chamoli district.

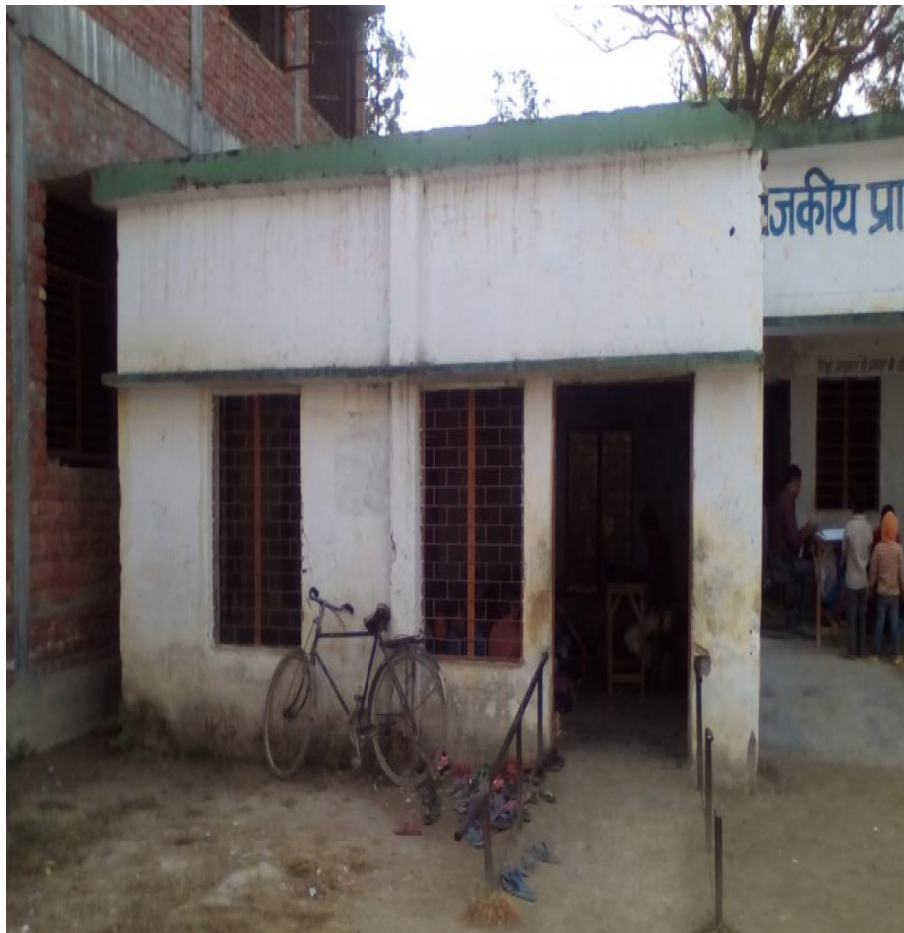
In order to avoid damage to the structures when these deflect towards each other during seismic shaking, building codes applicable in India recommend adjacent buildings to be separated by a distance which is equal to response reduction factor (R) times the sum of calculated storey displacements [27]. In case of buildings at the same elevation level, the factor R may be replaced by R/2. Safe separation distance or gap as recommended by the code between two building is 15, 20 and 30 mm for masonry, RCC frame and steel structure respectively [22,27]. 26.79 and 18.53% of the surveyed masonry and RCC buildings are respectively observed to be vulnerable to pounding (Fig. 14).

Fig. 14. Government Primary School at Bajpur in Udham Singh Nagar district; vulnerable to pounding during seismic shaking.
