16/17 June 2013 disaster of Uttarakhand, India and lessons learnt

Piyoosh Rautela

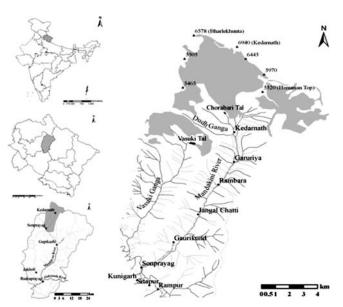
Fig. 3 Location map of Kedarnath area. To the left are maps of India, Uttarakhand and Rudraprayag district

reaching Kedarnath one had to trek upstream along the course of Mandakini from Gaurikund for a distance of 14 kilometers (Fig. 3).

Originating from Chorabari glacier Mandakini river forms the western boundary of the temple township while abandoned channel of Saraswati, that had confluence with Mandakini to the south of the temple forms the eastern boundary. Dudh Ganga meets Mandakini to the south of Kedarnath and thereafter till Gaurikund, Mandakini maintains a tectonically controlled NNE–SSW course (Fig. 3).

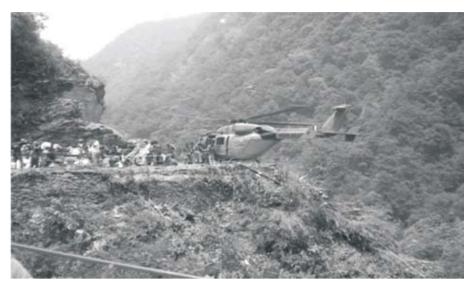
Fig. 7 View of the aerial evacuation of pilgrims stranded on Rambara - Kedarnath track by Indian Air Force

With improved weather and visibility aerial rescue operations were initiated in early hours of 18th June 2013 and 2007 persons were evacuated on the same day from Kedarnath. Realising the constraints being faced in aerial rescue operations 69 permanent and temporary helipads were quickly activated across the state and besides 17 civilian choppers hired by the state government 54 Indian Air Force (IAF) choppers and fixed wing crafts, 7 Army Aviation choppers and 4 choppers of other states were pressed into service (Fig. 7). Due to limited stock of aviation turbine fuel (ATF) in the disaster affected area and inability to immediately move in bowsers due to road disruption precious time was however lost in refueling. Despite constrains of various sorts more than 39165 persons were evacuated by air alone and this proved out to be the biggest aerial evacuation ever attempted.
