Report on

Silkyara-Barkot Tunnel (Uttarkashi)  
Collapsed Disaster

Uttarakhand State Disaster Management Authority,  
Uttarakhand, India

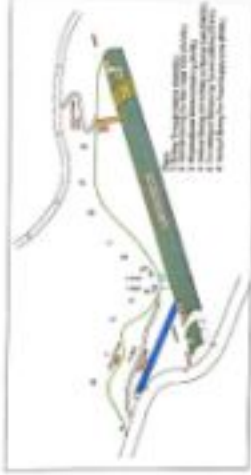
Figure 11: Parallel-Branch Plane

This plan was most optimistic, and a 22-meter length of pipe was already inserted within a week. Moreover, the rescue operation proceeded further by taking more safety and precautionary measures. To provide safe passage to the workface of pipe jacking activities, starting from near the pipe jacking machine have been covered by placing the pointed concrete blocks, these pipes, and steel pipes (to a length of around 47.2 meters up to the only joint covering its area which is prone to collapse before (Challenge 10<sup>th</sup> meter to 130 meters) & (Challenge 70<sup>th</sup> meter to 90 meters). Also, a portable gassy monitor has been deployed in situ to cover the pipe jacking machine. Additional safety provisions for the insertion of pipes also from the front of the Tunnel towards the tunnel exit on the Kilgus side to protect the operational area have been adopted (Challenge 130.50 meters to Challenge 147.00 meters).

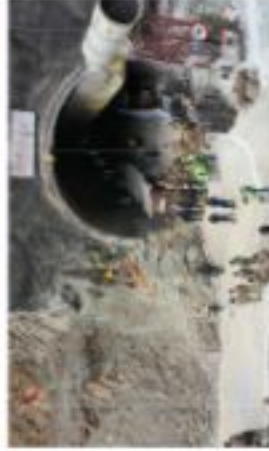
Figure 1. Sample survey of the tunnel entrance, showing the concrete structure and the surrounding area.

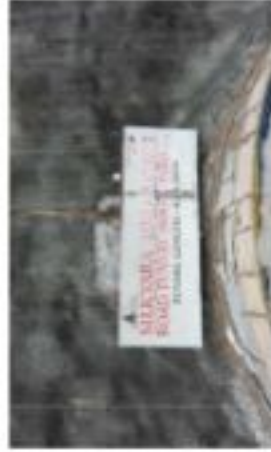
In Figure 5, the location of the upper position of the tunnel provides a visual representation, illustrating the total length of the tunnel at 1500 (50) meters.

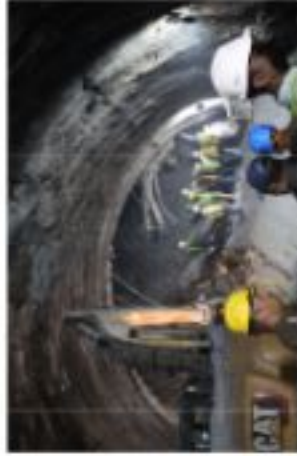
Figure 7 Shows the conditions within the tunnel on December 14, 2012.

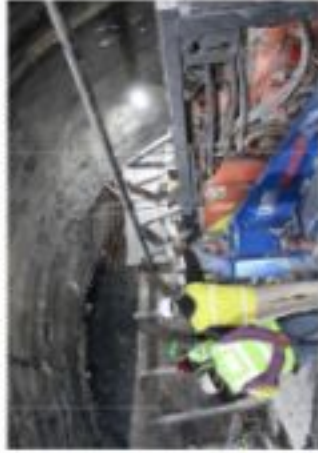
Figure 8 shows the Environmental Super Machine working at the tunnel site and an insight of the relationship.

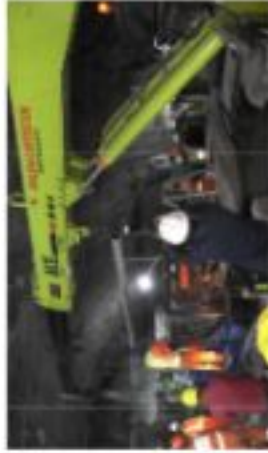
In Figure 10, dated December 14, 2023, the Auger Machine Blade has been positioned to the debris bed (under 10 Whops), working is vigorously trying to the separation of pieces.

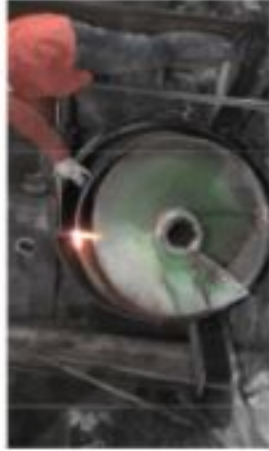
In Figure 14, the heated pipe has been reheated and tensioned. Increased, making a good image in the image process.

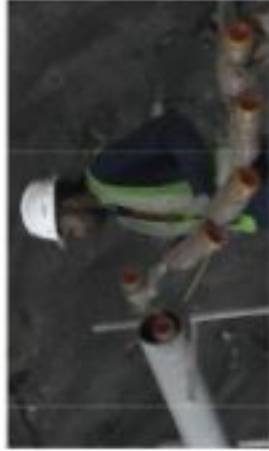
Figure 17 depicts the positions of barrel supply facilitated by the use of packaged barrels.

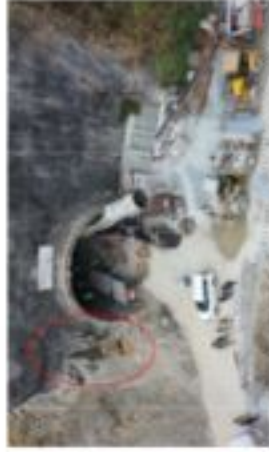
In Figure 18, the sub is positioned with a red colored circle highlighting a white water escape from the ground, this water coming was addressed promptly at that specific moment.

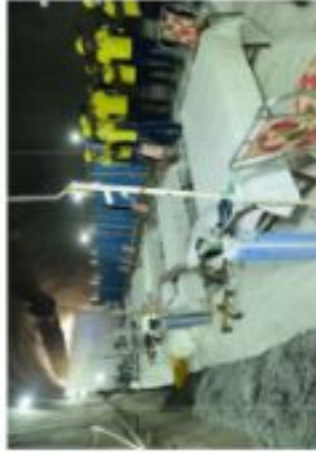
Figure 11, The movement of a material streamlines is depicted during the process of mechanical sorting. This view illustrates a final step in the sorting operation, aimed at a material subject, highlighting the challenges and considerations involved in the sorting process.
