Project No. EQD-6042/22-23

**The Geotechnical Investigations for determining the Shear Strength Characteristics and Bearing Capacity of the Soil in the Joshimath Region**

**Uttarakhand State Disaster Management Authority  
Govt. of Uttarakhand, Dehradun**

**(Final Report)**

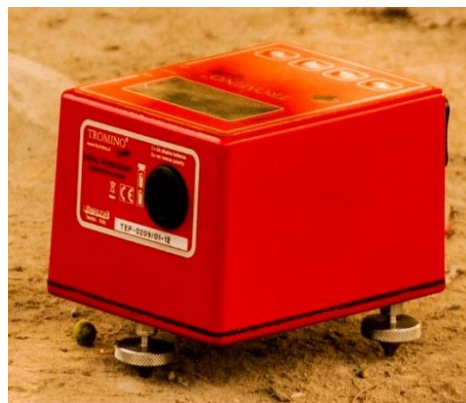
**Fig. 6:** Micromed Tromino for recording microtremors

**HVSr:** MASW can provide data only up to shallow depths, though it is extremely popular. To estimate soil condition at deeper depths, horizontal-to-vertical spectral ratio (HVSr) method has been used jointly with MASW test results. In a single layer one-dimensional (1D) stratigraphy, the analysis of the H/V of the micro tremor allows us to measure the principal S-wave resonance frequency,  $f$  of the sedimentary cover overlying an infinite bedrock with reasonable accuracy. Without any constraint, an H/V curve can be fitted by an infinite number of synthetic models. By using joint inversion of HVSr and MASW, two objectives are achieved: (i) solutions get constrained and (ii) information of deeper layers is obtained. It is a single station method, which requires only one 3-component seismic recorder.
