**Report on  
Silkyara-Barkot Tunnel (Uttarkashi)  
Collapsed Disaster**

**Prepared By:**  
**Uttarakhand State Disaster Management Authority,**  
**Uttarakhand, India**

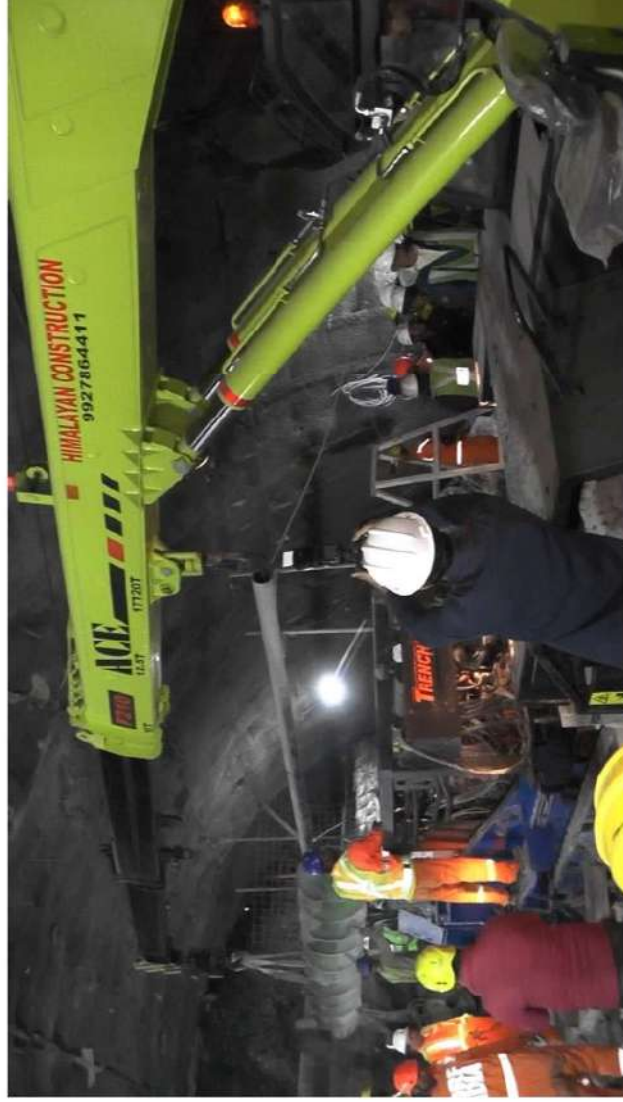
In Figure 10, dated December 14, 2023, the Auger Machine Blade has been positioned to facilitate horizontal drillings, marking a significant step in the operational process.

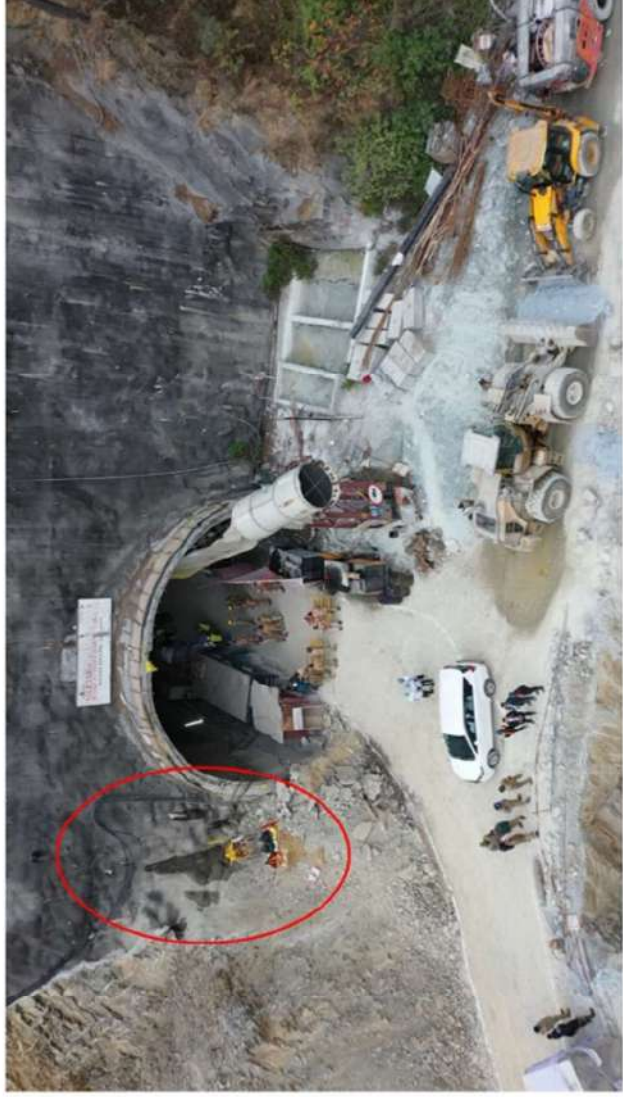
In Figure 18, the site is portrayed with a red-coloured circle highlighting a subtle water seepage from the ground. This minor concern was addressed promptly at that specific moment.

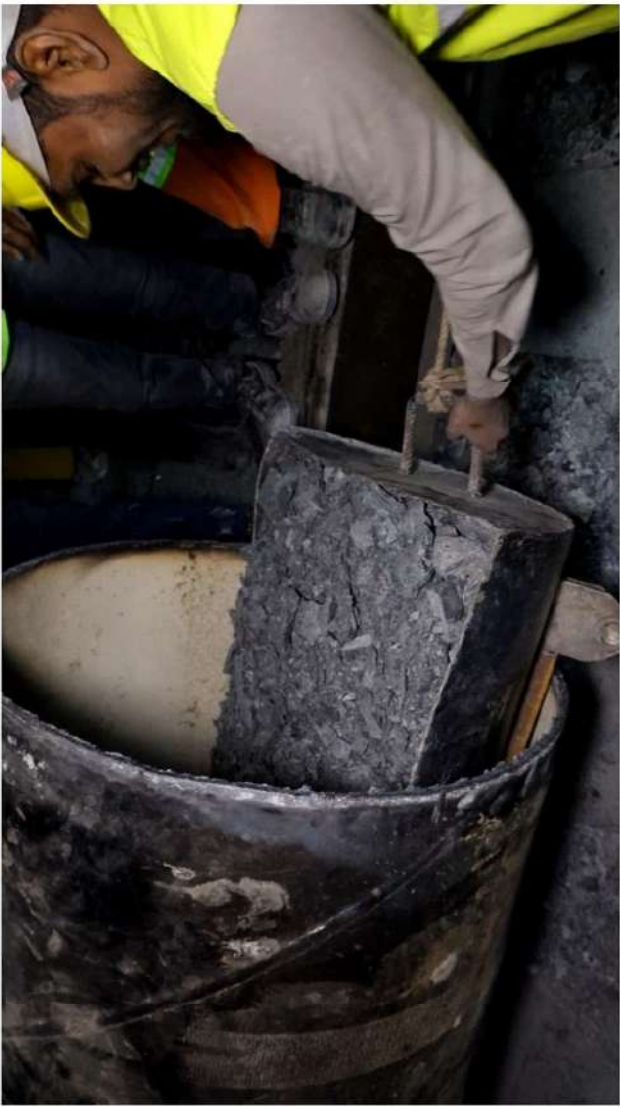
Figure 19 illustrates the final phase of manual mining, providing a visual representation of the mining activities carried out manually in the concluding stage.

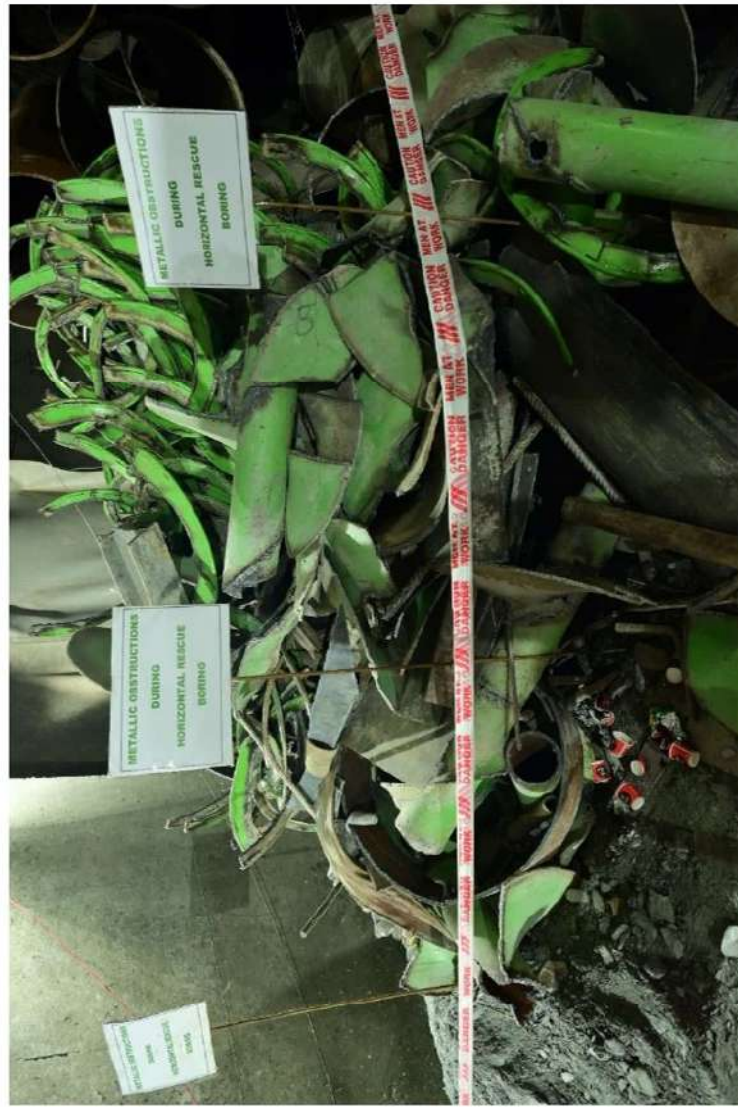
Figure 20, The occurrence of a metallic obstruction is depicted during the process of horizontal drilling. This visual illustrates a hindrance in the drilling operation caused by a metallic object, highlighting the challenges and considerations involved in the drilling process.

Further, the auger was required to pull back completely to assess any other damage to the pipe. On November 24, 2023, the auger was pulled out, and to assess any other metallic obstructions in the line of pushing pipe, the Ground Penetration Radar (GPR) test was carried out. Welder's team again went inside the pipe to cut the bent pipe. After cutting the damaged, bent pipe, auger reassembly was completed, and all augers were inserted. Pushing of the 10th pipe (4.7 meters in length) started on the afternoon of November 24, 2023, and a length of 2.2 meters was inserted by the evening, resulting in a total inserted length of 46.9 meters. The obstruction has again stopped the pushing of pipes.

During the cutting procedure, it was observed that manual cutting using gas cutters is the most efficient working; therefore, the gas-cutting process was resumed. On November 27, 2023, the whole length of the auger was removed. After this visual, the welders found that the cutter of the auger had been entangled with lattice girder bars, which damaged the 1.5-meter length of the 800-meter passage pipe. The remaining pipe length has been removed by gas cutting along with the obstruction caused by lattice girder, reinforcement, etc. The process was completed by the evening of November 27, 2023. After that, the shotcrete lump in front of the pipe has also been broken into pieces manually using a rock breaker.
