## Best Practices of Ground Water Harvesting in Different Parts of India (Central Ground Water Board Initiatives)

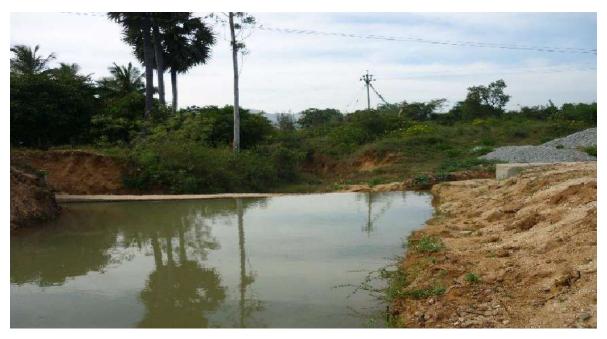
Check Dam at Karvetinagaram Village

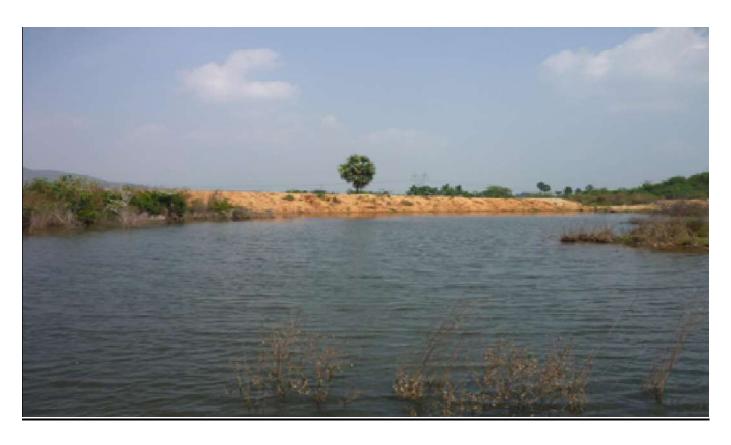
Percolation Tank at Pathapalem Village

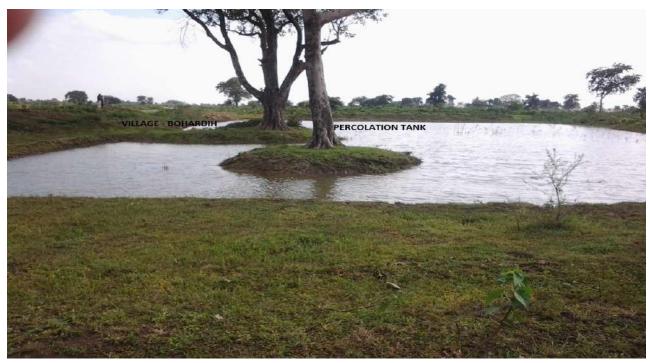
Percolation tank at Bohardih

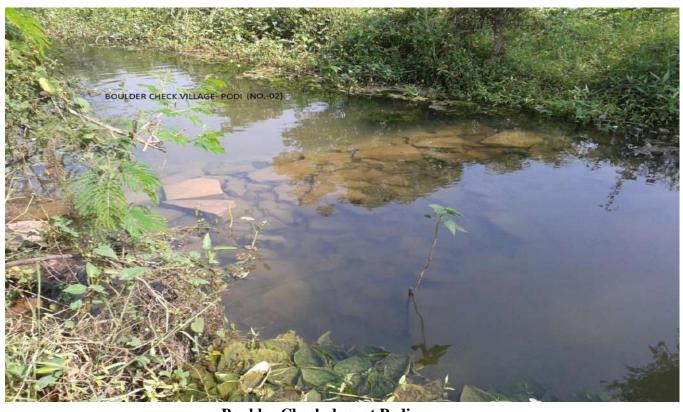
**Boulder Check dam at Podi**

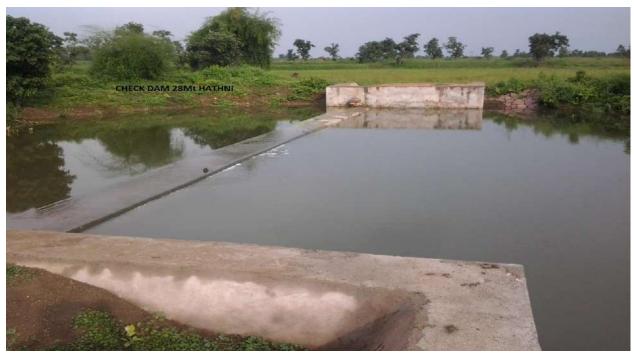
Check dam at Hathni

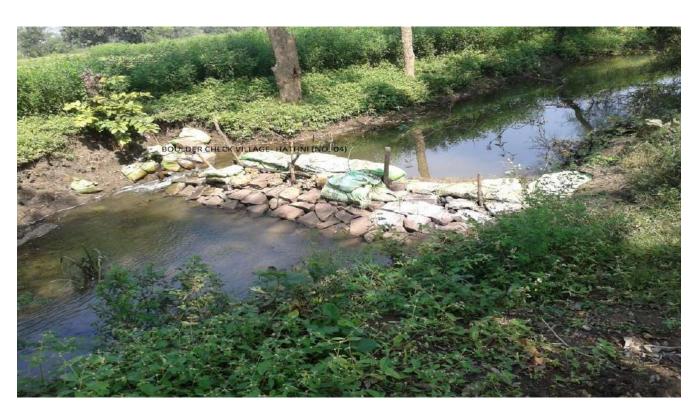
**Boulder Check dam at Hathani**

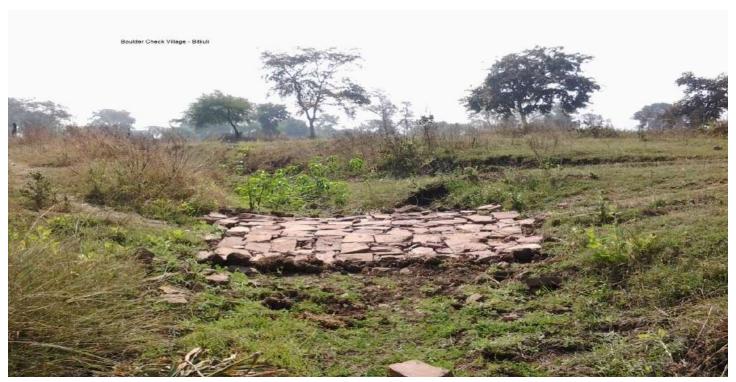
**Boulder Check in village Bitkuli**

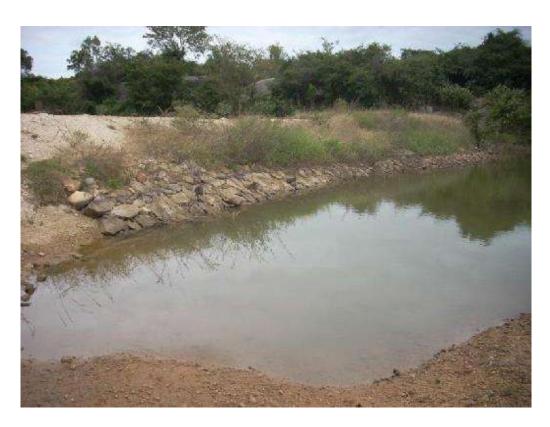
Nala Bund constructed in Malur Taluk

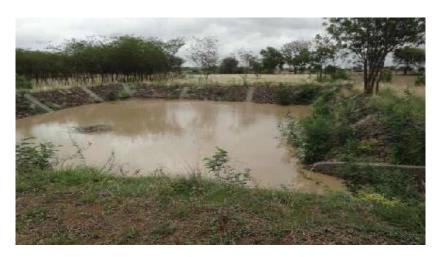
Percolation Pond after construction

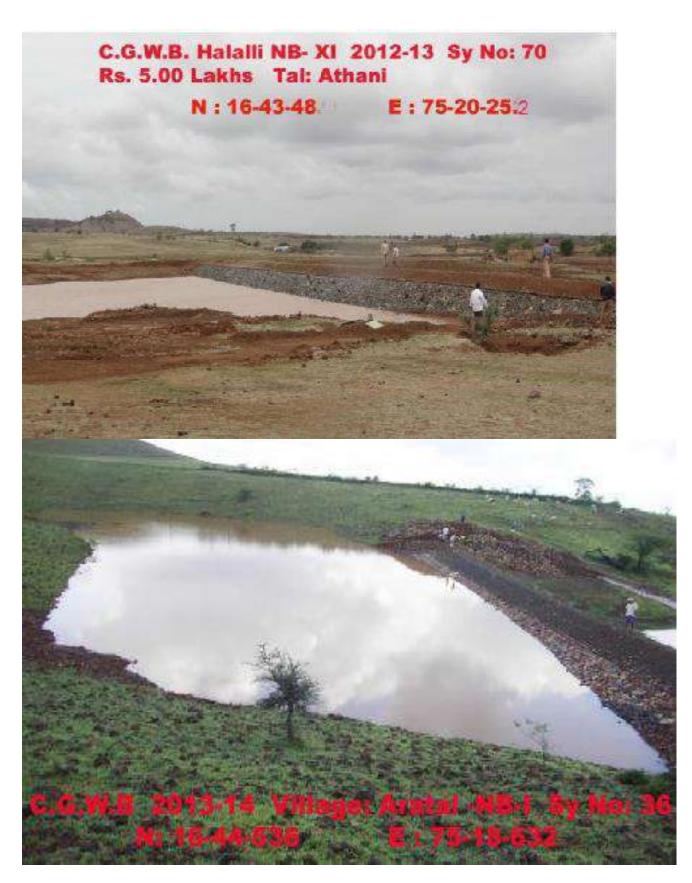
Nala bund constructed in the sub watershed

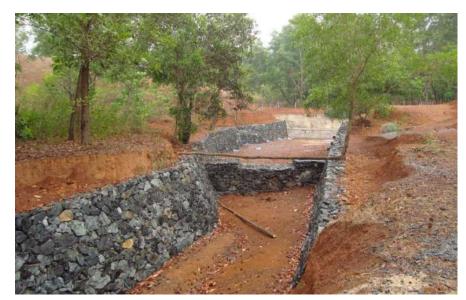
Loose Boulder Check Dam across a small stream

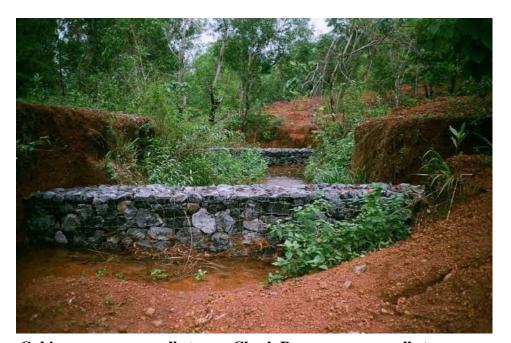
Gabion across a small stream Check Dam across a small stream

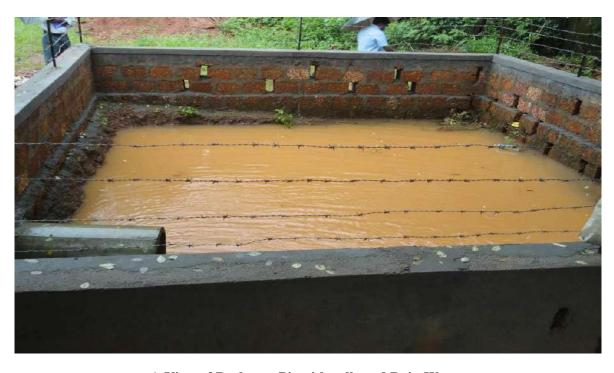
A View of Recharge Pit with collected Rain Water

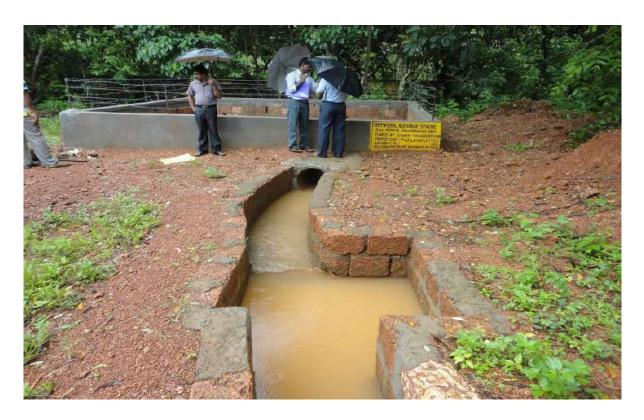
A view of water flowing through drainage channel to Recharge Pit

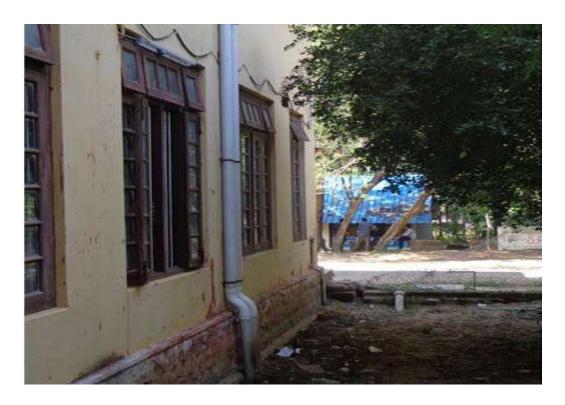
A view of the down-pipe for conveying rainwater to the storage tank

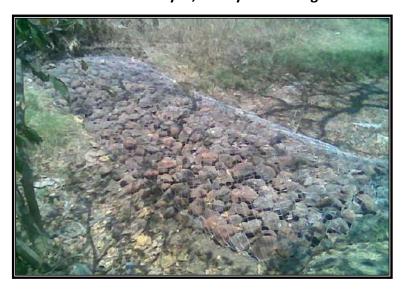
Gabbion Structure , Nanukhera Village

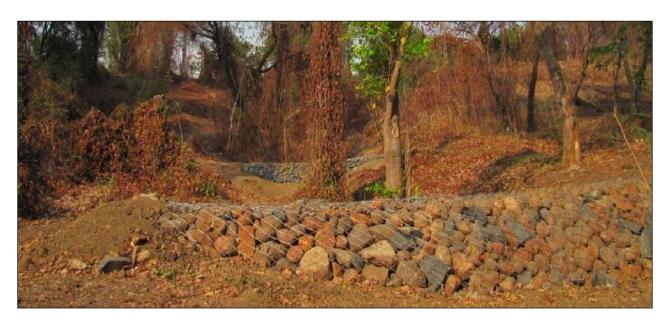
**Gabion Structure-Before monsoon**

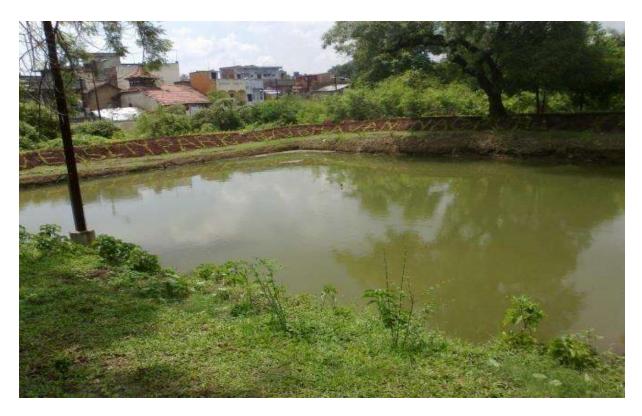
Filled up Farm ponds-Repetitive filling of pond during the monsoon

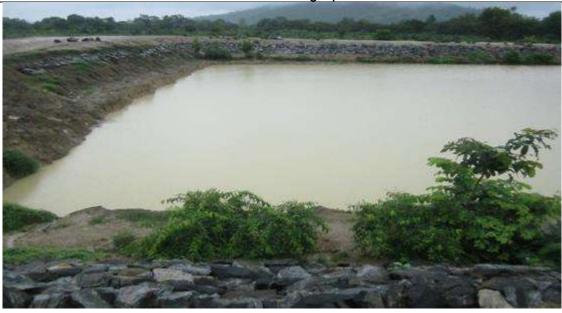
PERCOLATION TANK- Karmeli mini Watershed , Saintala block, Bolangir dist, Odisha

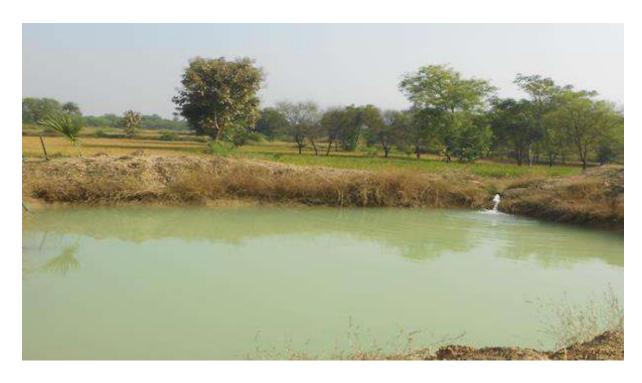
RECHARGE TANK -Karmeli mini Watershed , Saintala block, Bolangir dist, Odisha

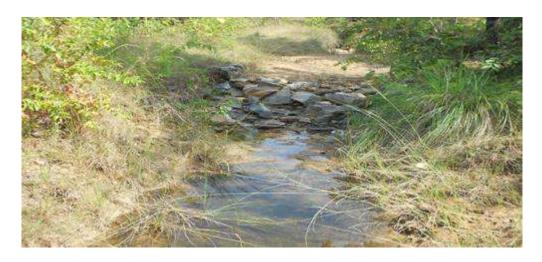
LOOSE BOULDER CHECK DAM--Karmeli mini Watershed , Saintala block, Bolangir dist, Odisha

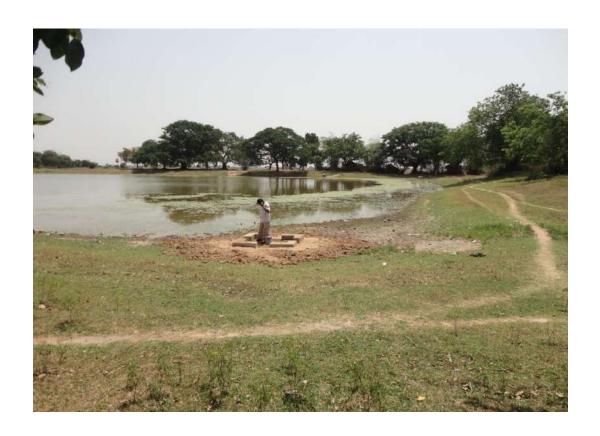
RECHARGE TUBE WELL AT BIRAMANIPUR

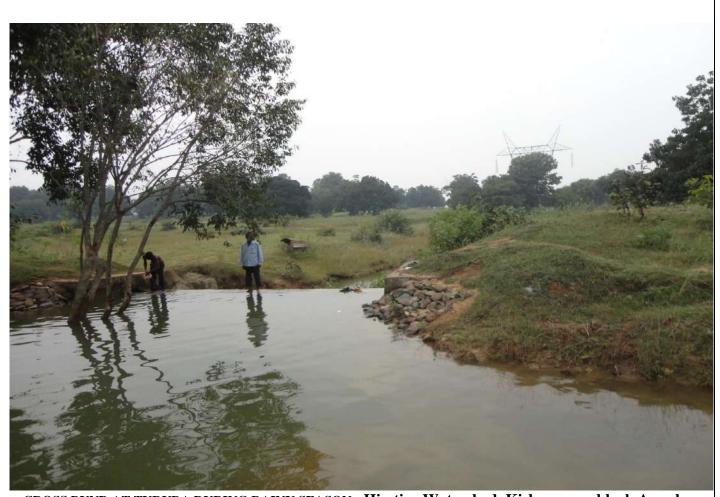
CROSS BUND AT TURUDA DURING RAINY SEASON - Himtira Watershed, Kishornagar block Angul Dist, Odisha

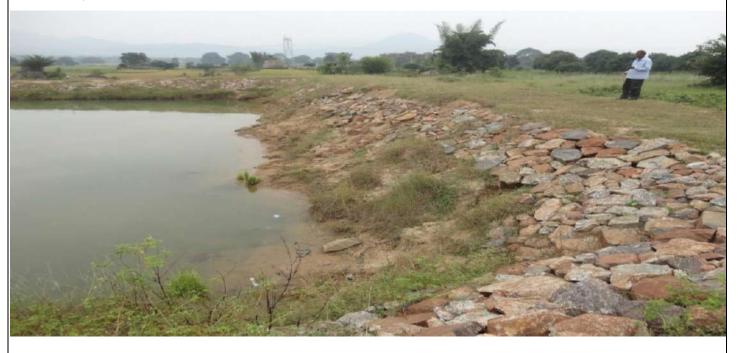
## RECHARGE TANK AT ANGAPADA Himtira Watershed, Kishornagar block Angul Dist, Odisha

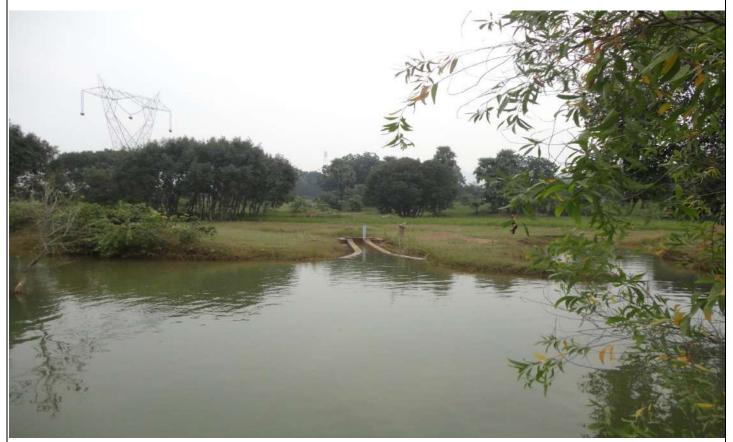
RECHARGE BORE WELL NEAR CROSS BUND AT TURUDA -Himtira Watershed, Kishornagar block Angul Dist,

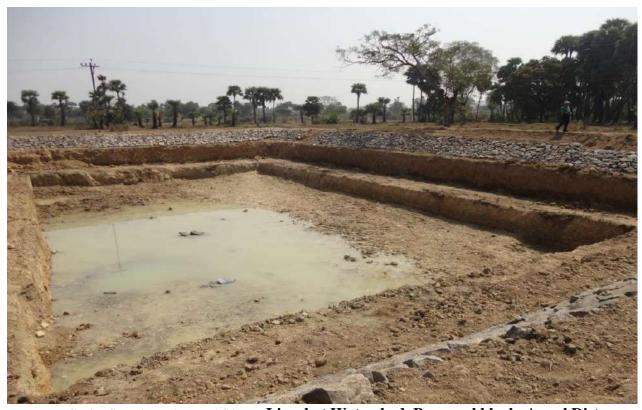
RECHARGE TANK AT NUASAHI - Ligarkat Watershed, Banerpal block, Angul Dist,
Odisha

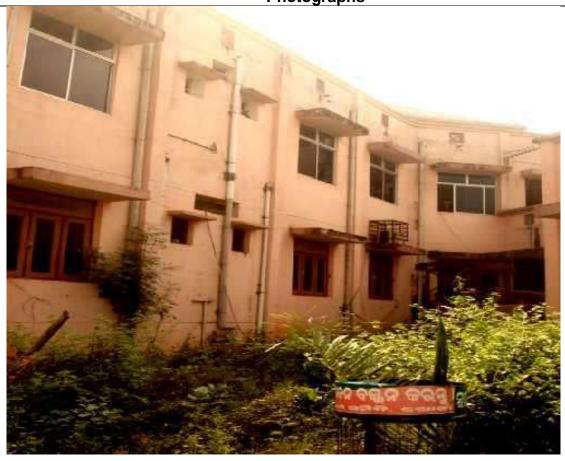
COLLECTION PIPE LINES ON BACK SIDE OF DRDA OFFICE BUILDING, COLLECTORATE CAMPUS, KHURDA DIST.

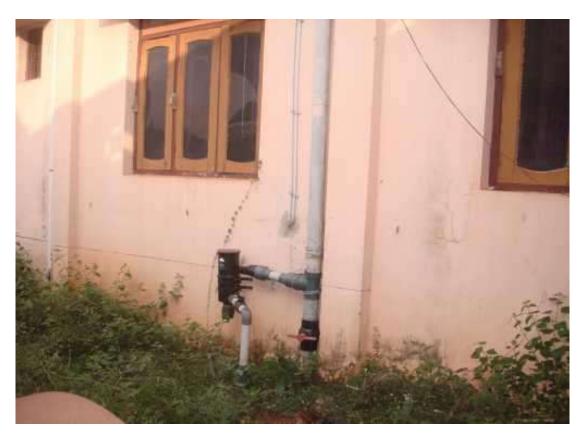
[ON-LINE FILTER INSTALLED] OFFICE BUILDING, COLLECTORATE CAMPUS, KHURDA DIST

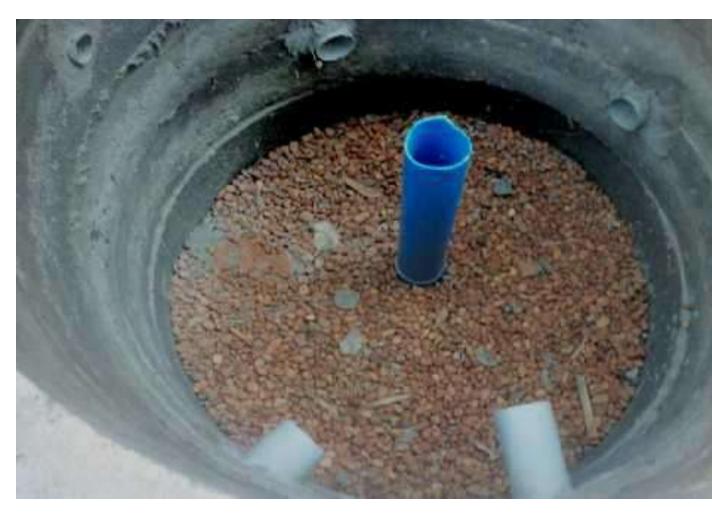
[RECHARGE BORE WELL] OFFICE BUILDING, COLLECTORATE CAMPUS, KHURDA DIST

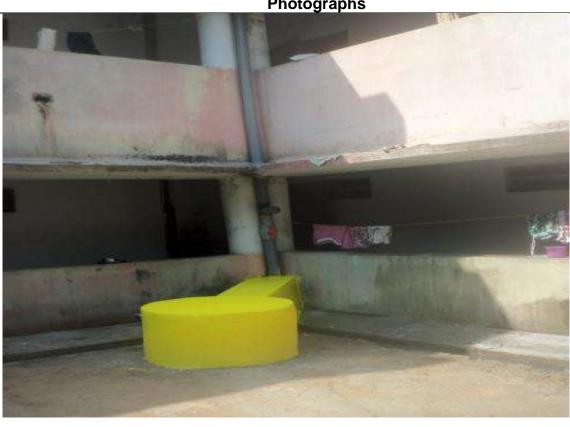
Pipe Line

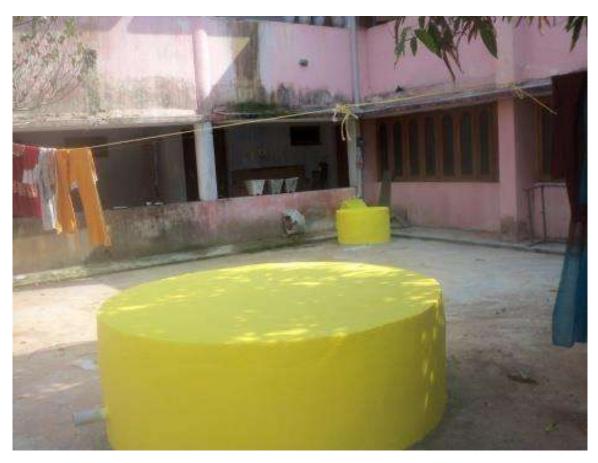
**Filter Cum Collection Chamber**

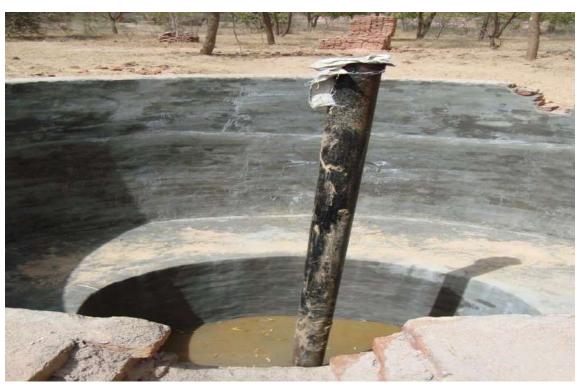
Circular Recharge Pit with filter pit & recharge tube well

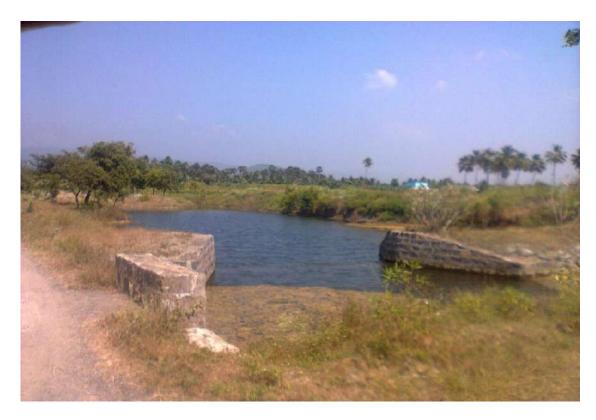
Kattukottai Percolation Pond- Thalaivasal Block, Salem District, Tamil Nadu

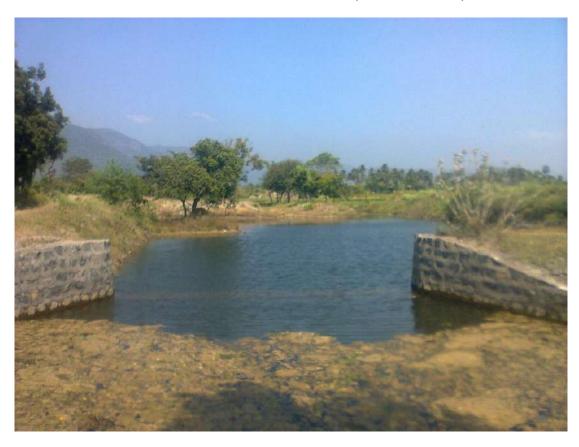
MANIVIZHANDAN PERCOLATION POND- Thalaivasal Block, Salem District, Tamil Nadu

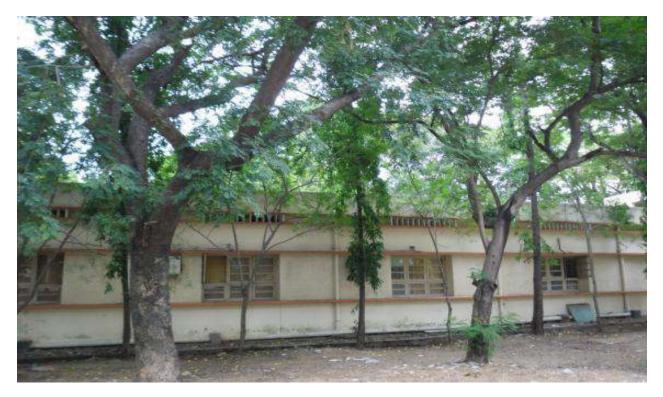
Collection, conveyance and Filtering Unit of roof top rainwater harvesting

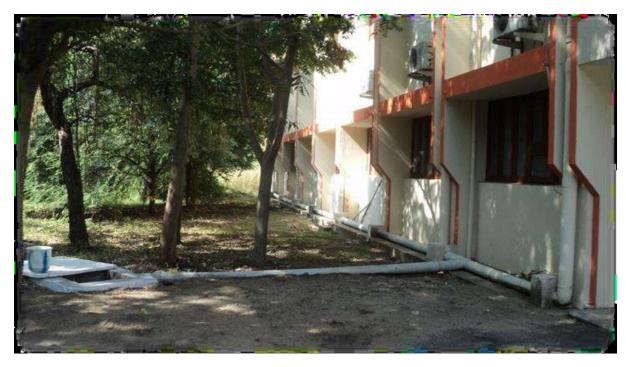
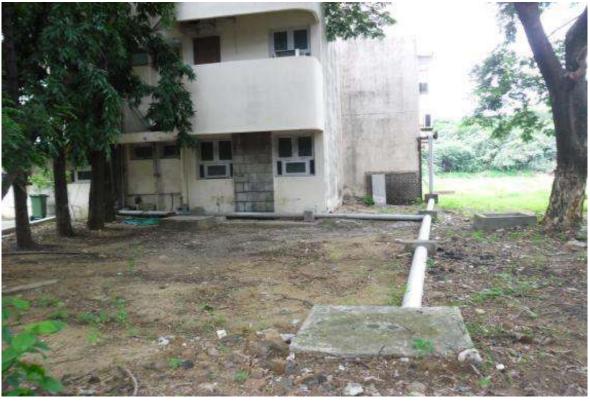
Collection, conveyance and Filtering Unit of roof top rain water harvesting in the premises of the NITTTR, Taramani, Chennai city, Tamil Nadu.

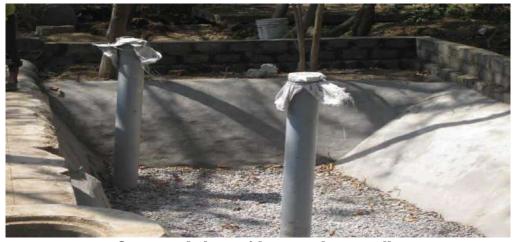
Open pond along with two recharge wells
