# STABILITY REPORT OF PM SHRI KENDRIYA VIDYALAYA, MG RAILWAY COLONY BENGALURU, 560023

# **STABILITY REPORT OF PM SHRI KENDRIYA VIDYALAYA, MG RAILWAY COLONY BENGALURU, 560023**

## **1.0 INTRODUCTION**

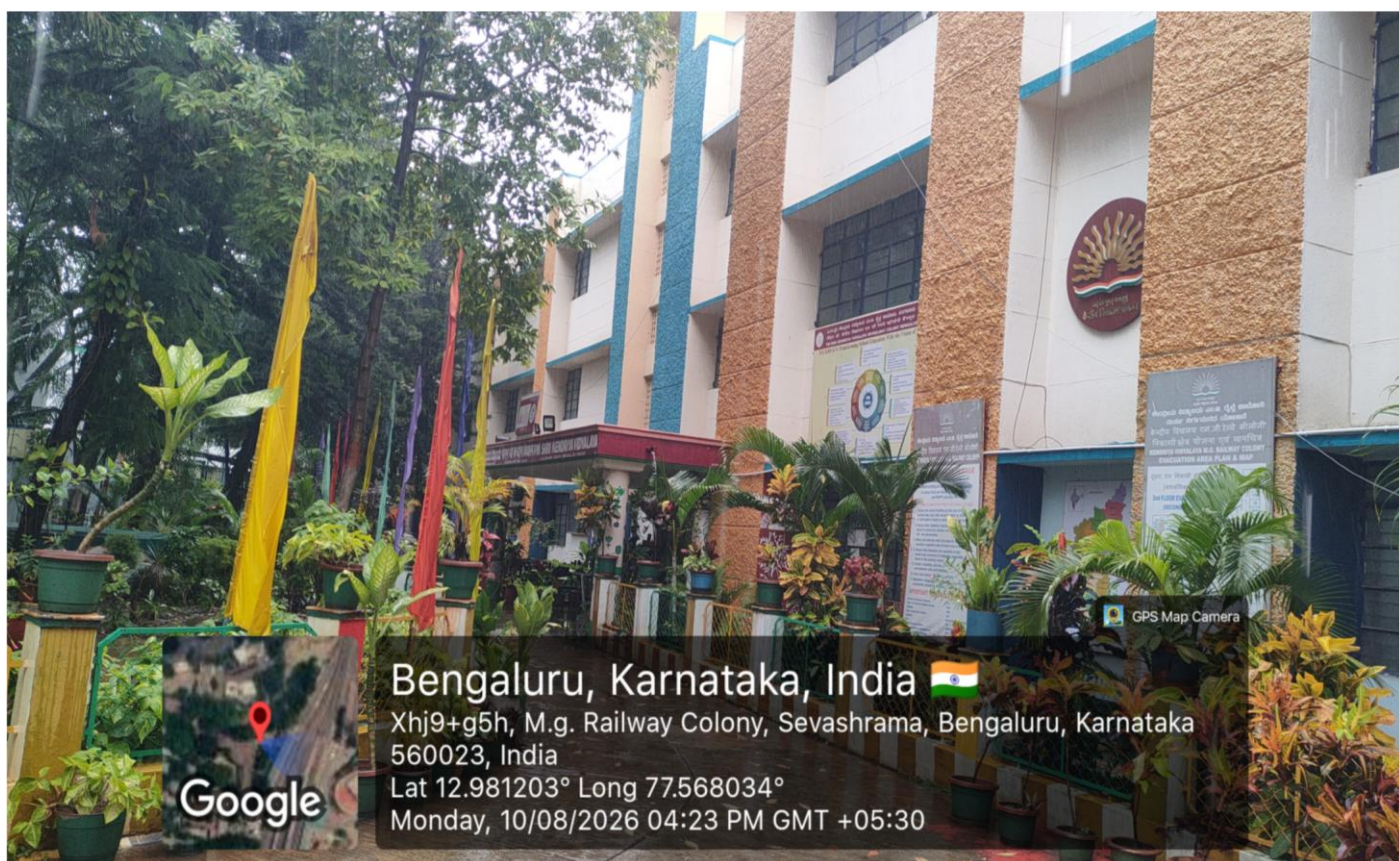
**FIG.NO. 1 & FIG. NO. 2: GENERAL FRONT VIEW AND SIDE VIEW OF PM SHRI KENDRIYA VIDYALAYA, MG RAILWAY COLONY BENGALURU, 560023**

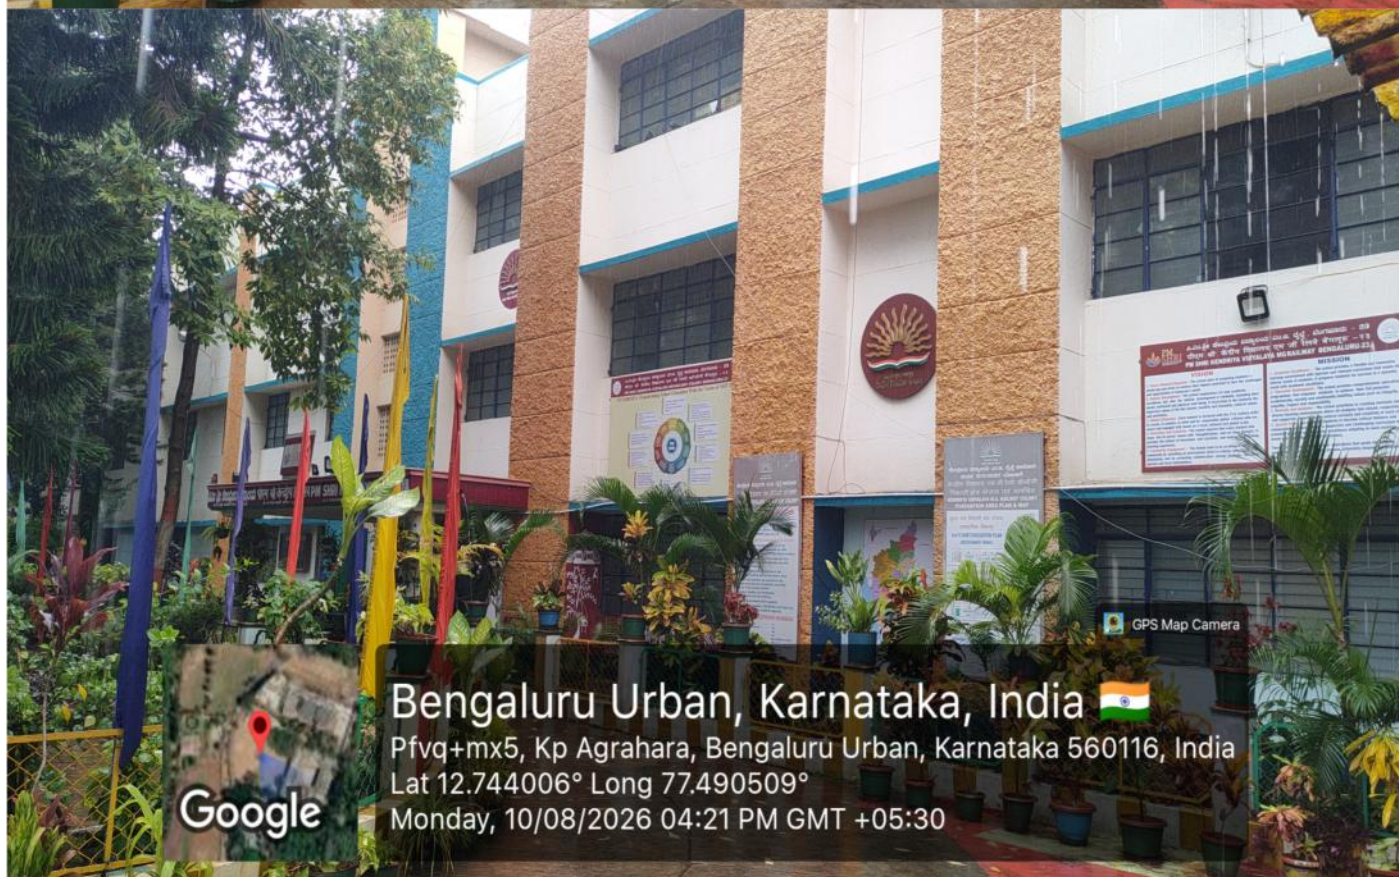
**FIG. NO. 3& FIG. NO. 4: GENERAL SIDE VIEW OF PM SHRI KENDRIYA VIDYALAYA, MG RAILWAY COLONY BENGALURU, 560023**

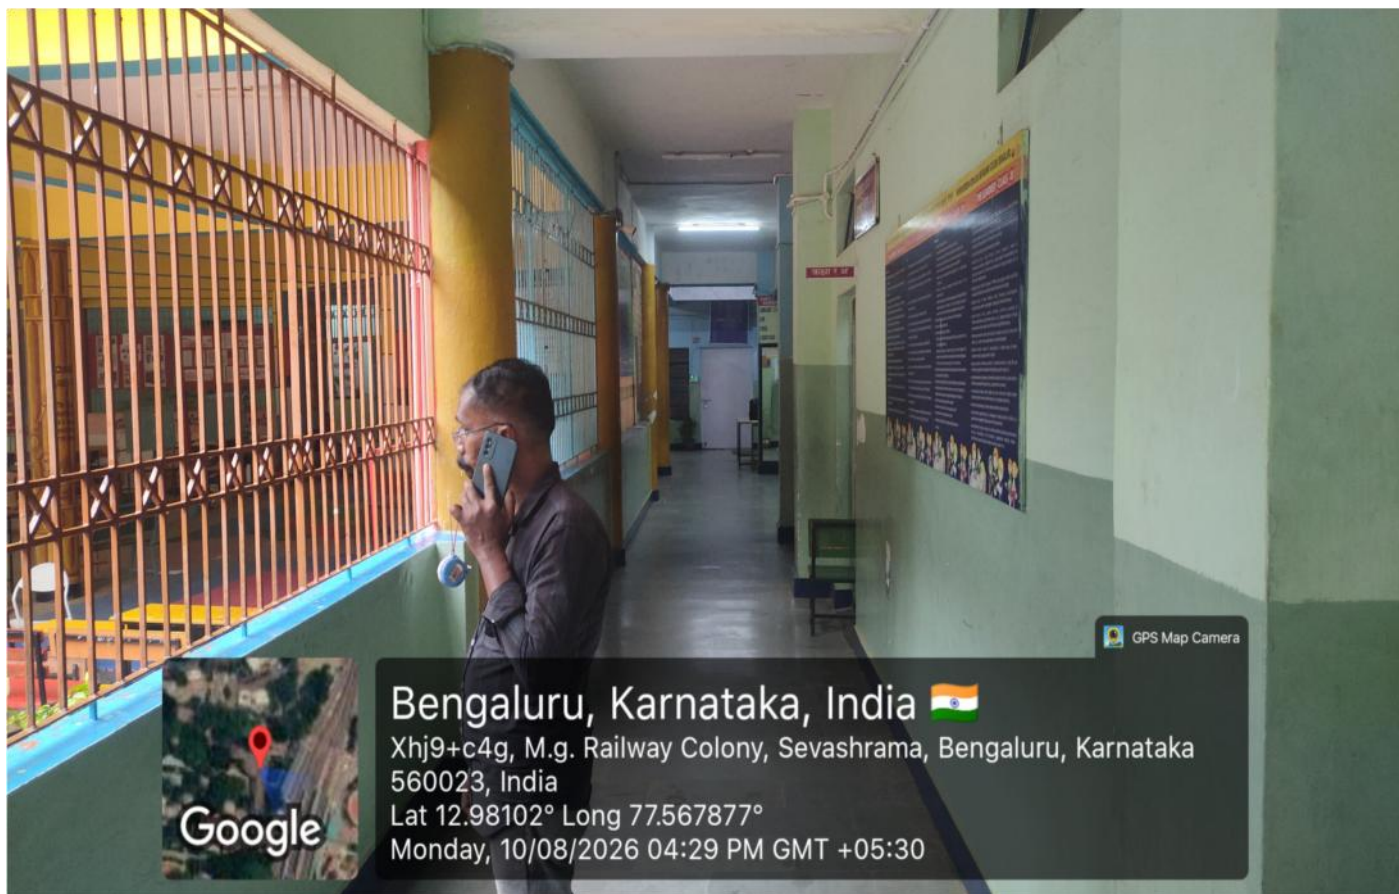
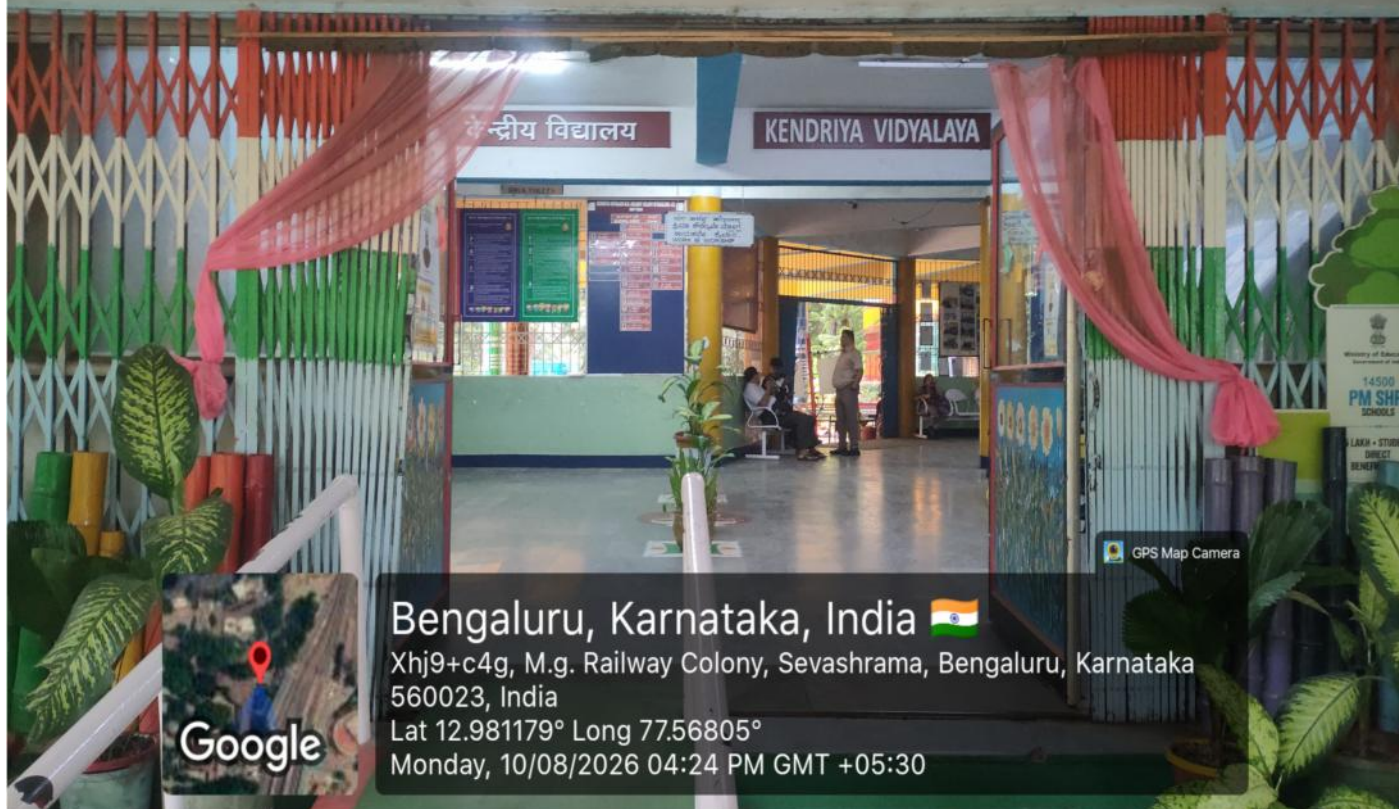
**FIG.NO. 5& FIG. NO. 6: GENERAL CORRIDOR AND FRONT VIEWS AT PM SHRI KENDRIYA VIDYALAYA, MG RAILWAY COLONY BENGALURU, 560023**

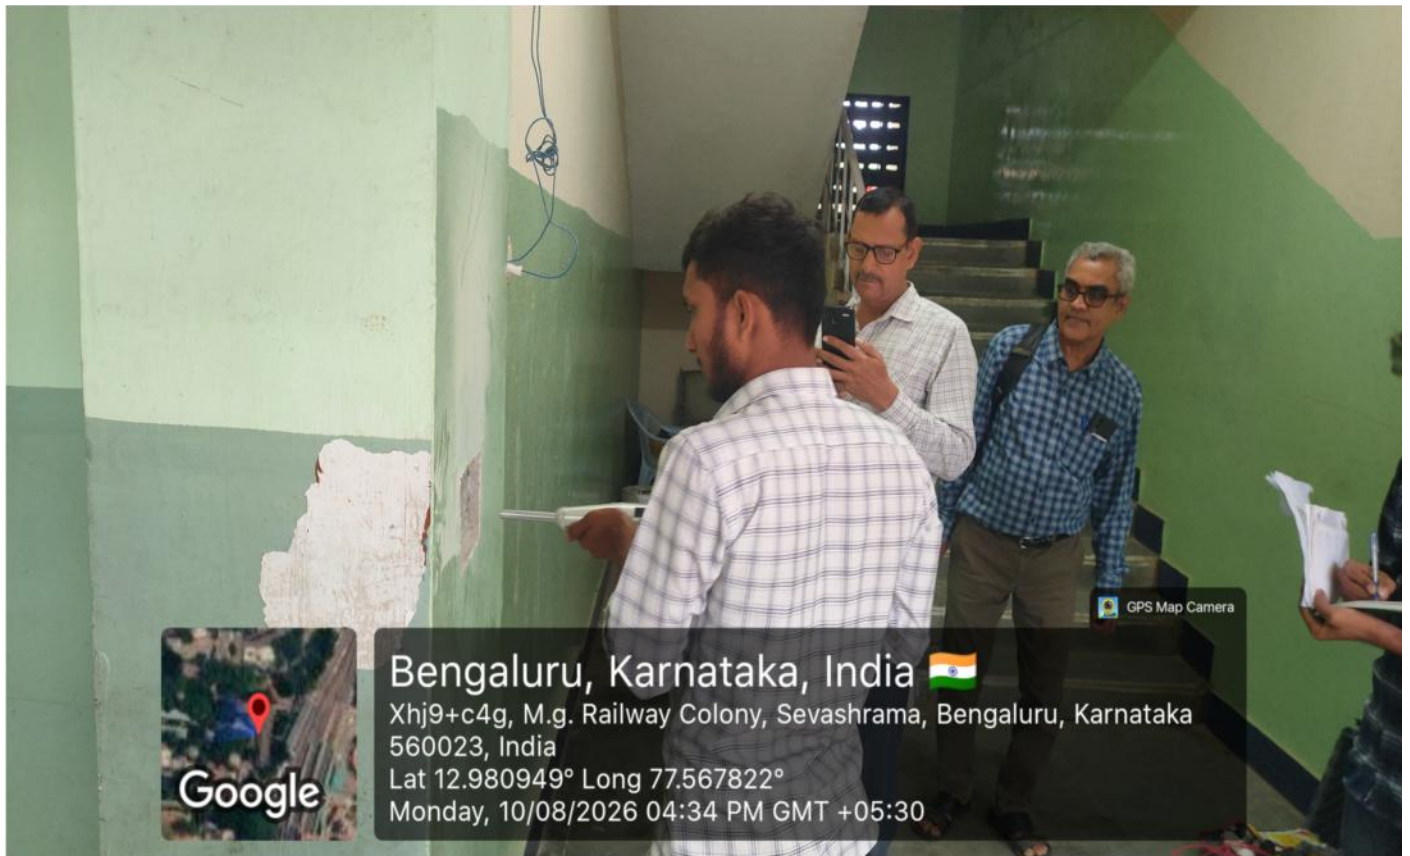
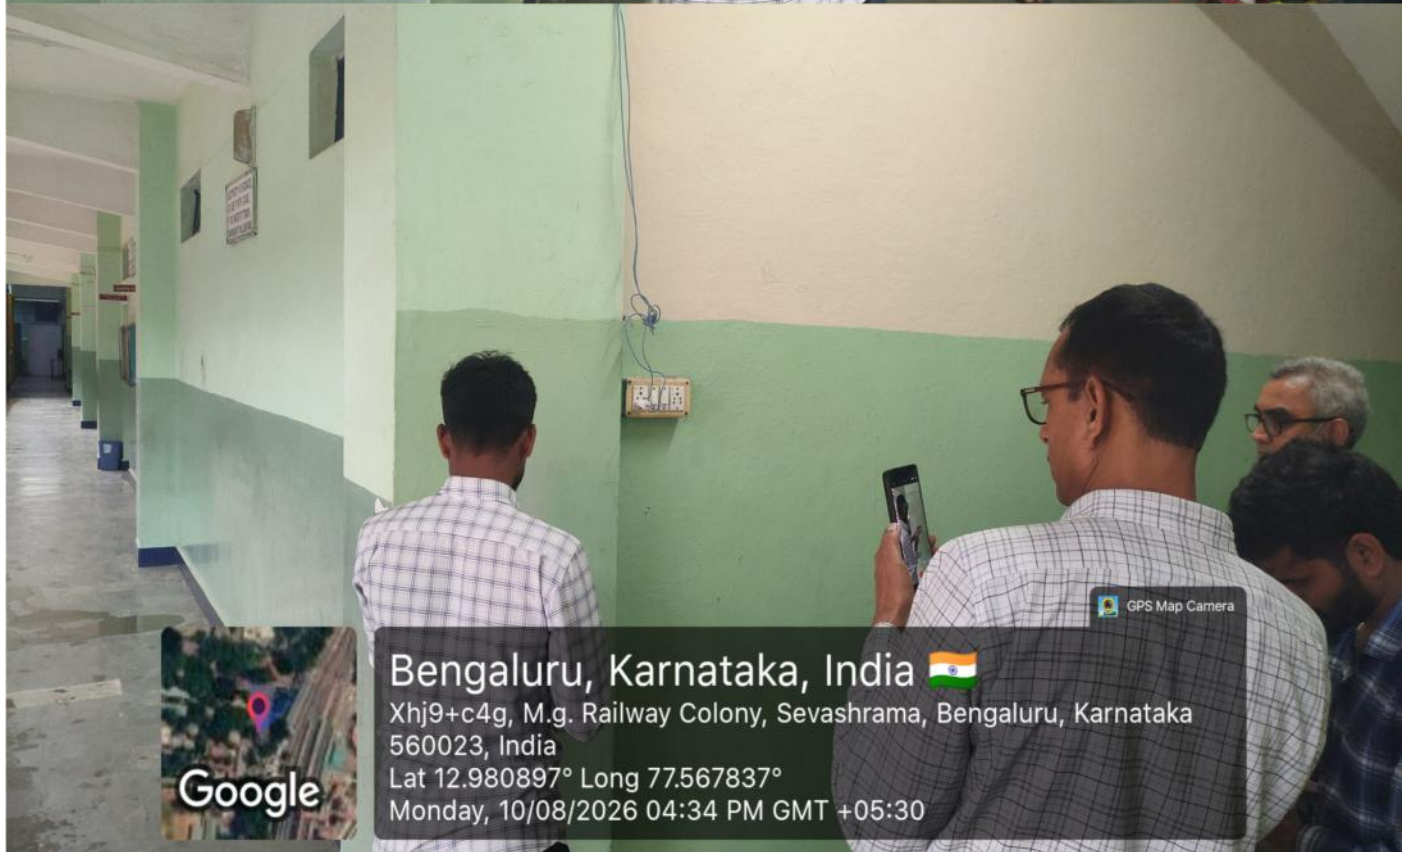
**FIG. NO. 9& FIG.NO. 10: REBOUND HAMMER TEST AT SELECTED COLUMN PM SHRI KENDRIYA VIDYALAYA, MG RAILWAY COLONY BENGALURU, 560023**

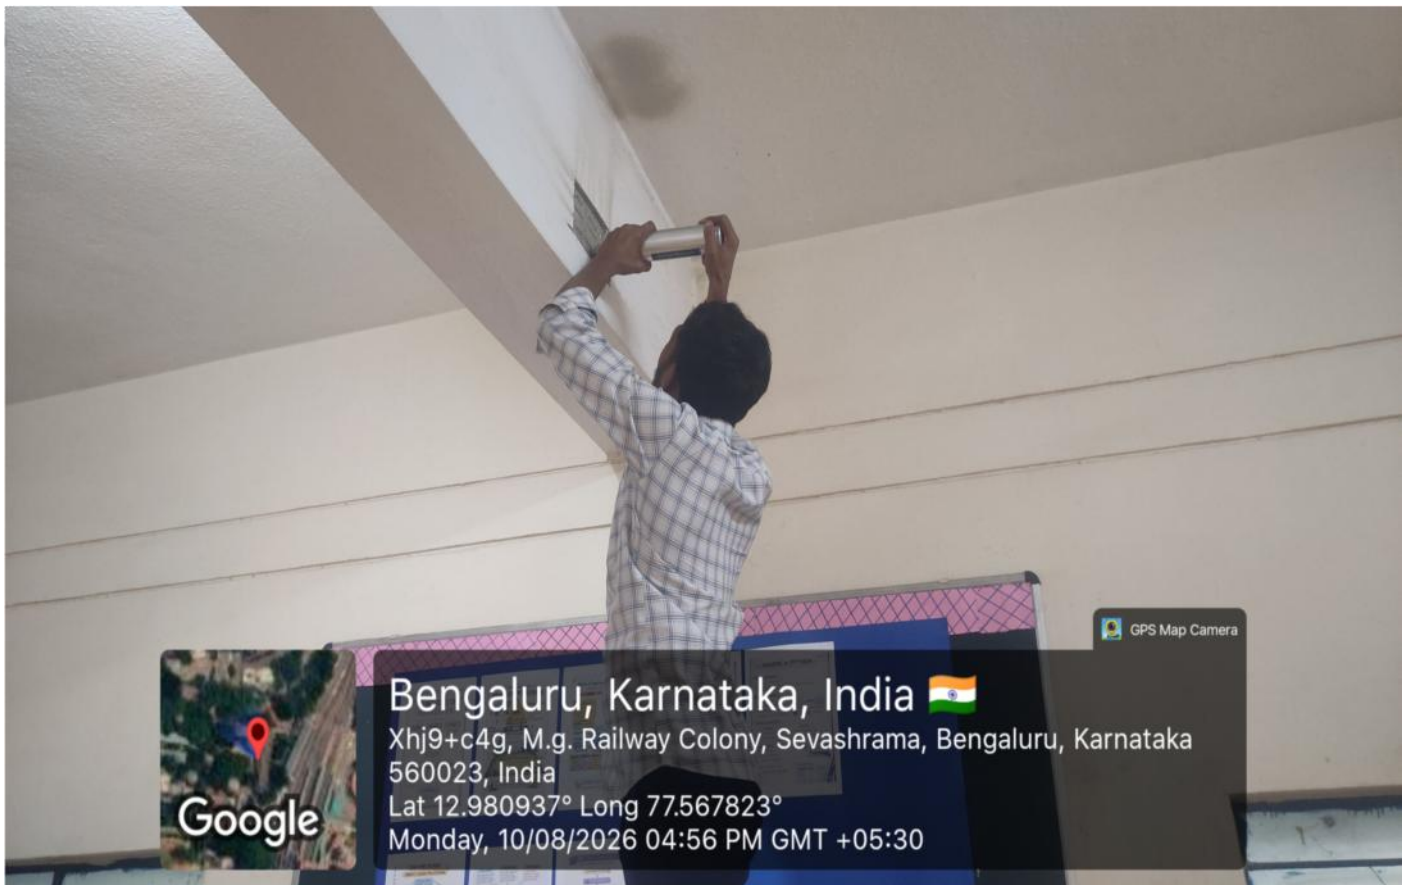
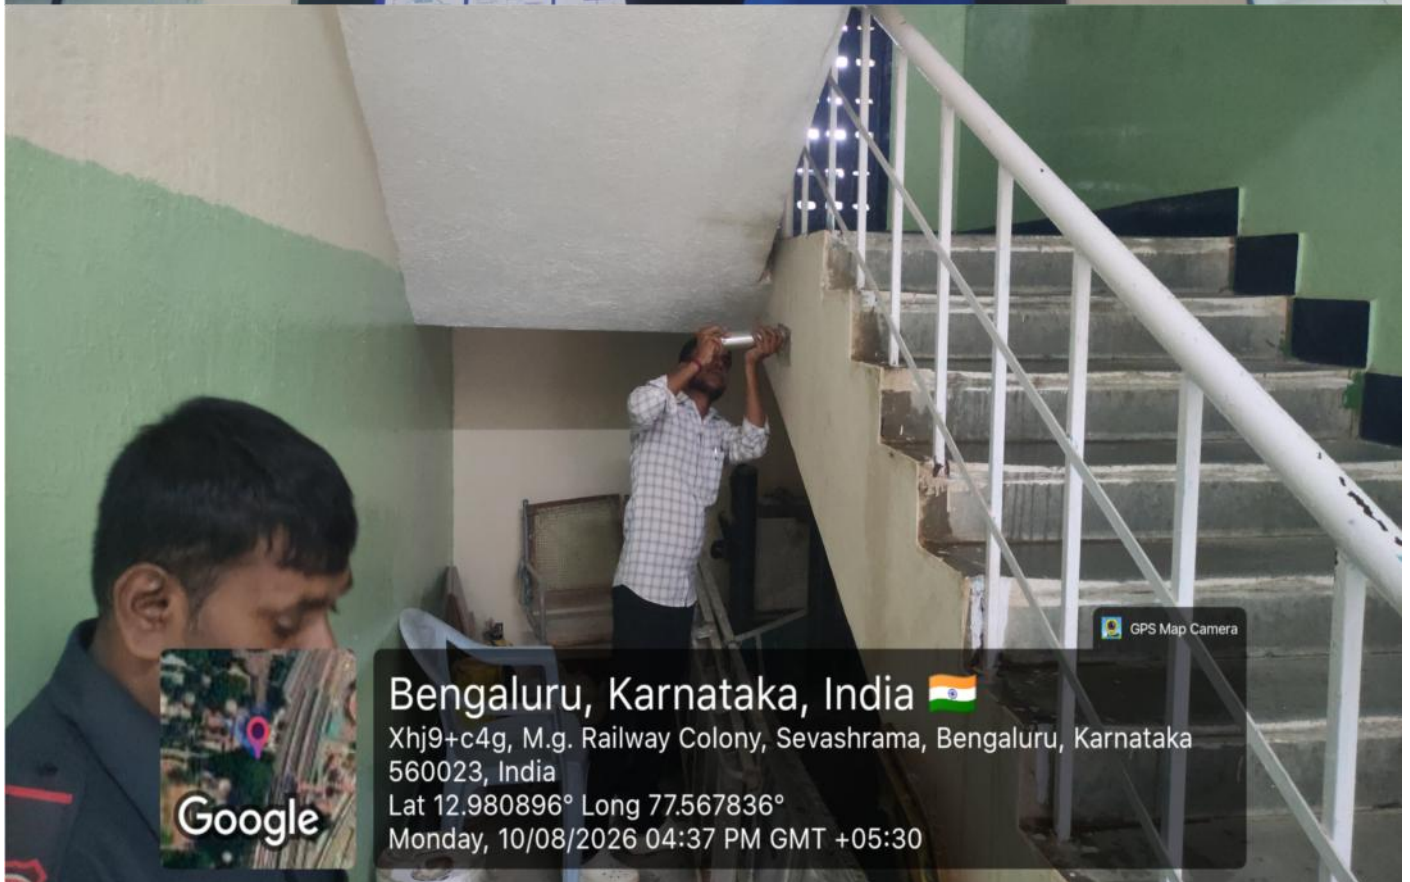
**FIG. NO. 11& FIG.NO. 12: REBOUND HAMMER TEST AT SELECTED BEAM PM SHRI KENDRIYA VIDYALAYA, MG RAILWAY COLONY BENGALURU, 560023**

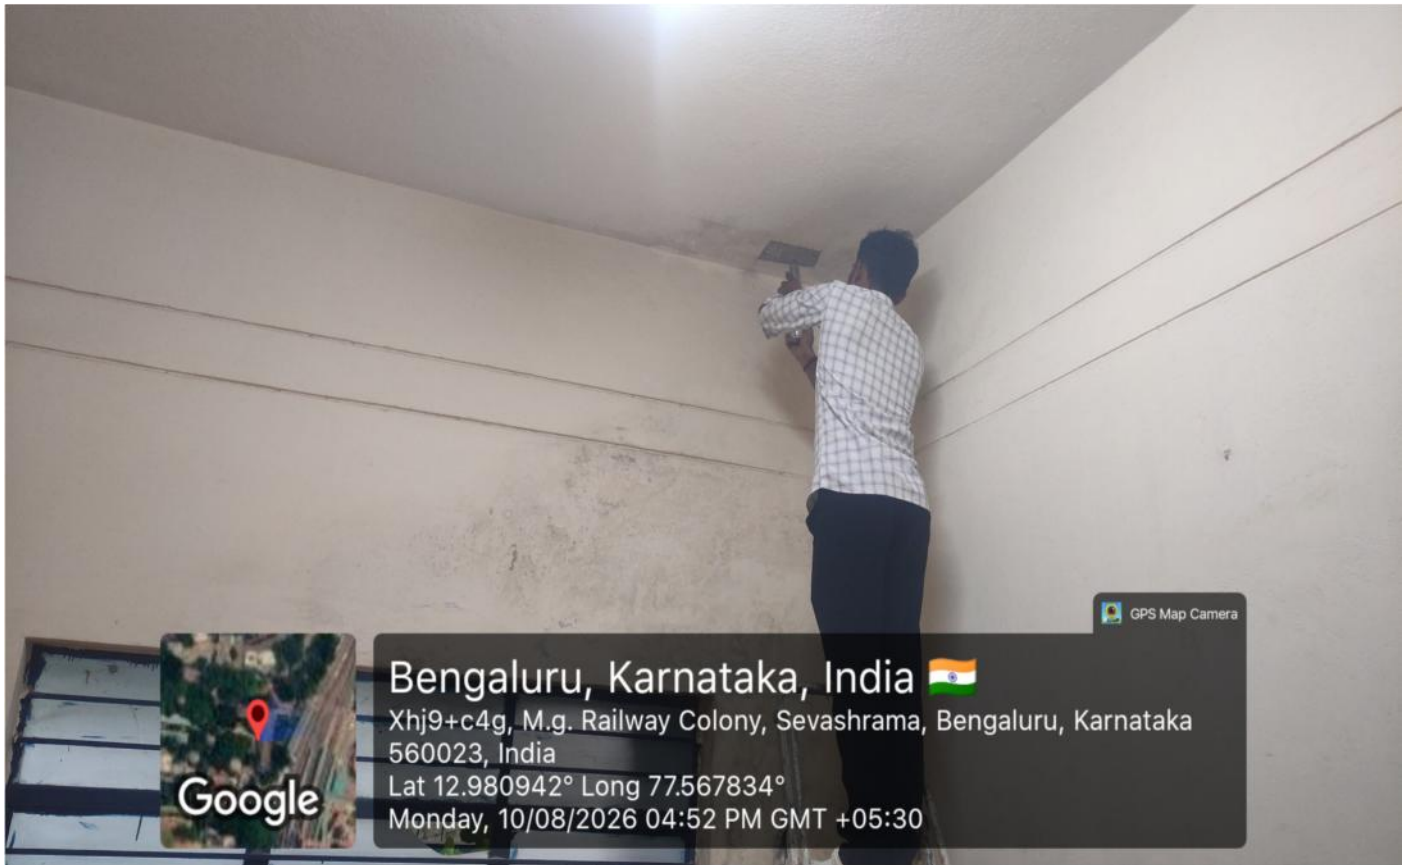
**FIG. NO. 13& FIG.NO. 14: REBOUND HAMMER TEST AT SELECTED SLAB PM SHRI KENDRIYA VIDYALAYA, MG RAILWAY COLONY BENGALURU, 560023**

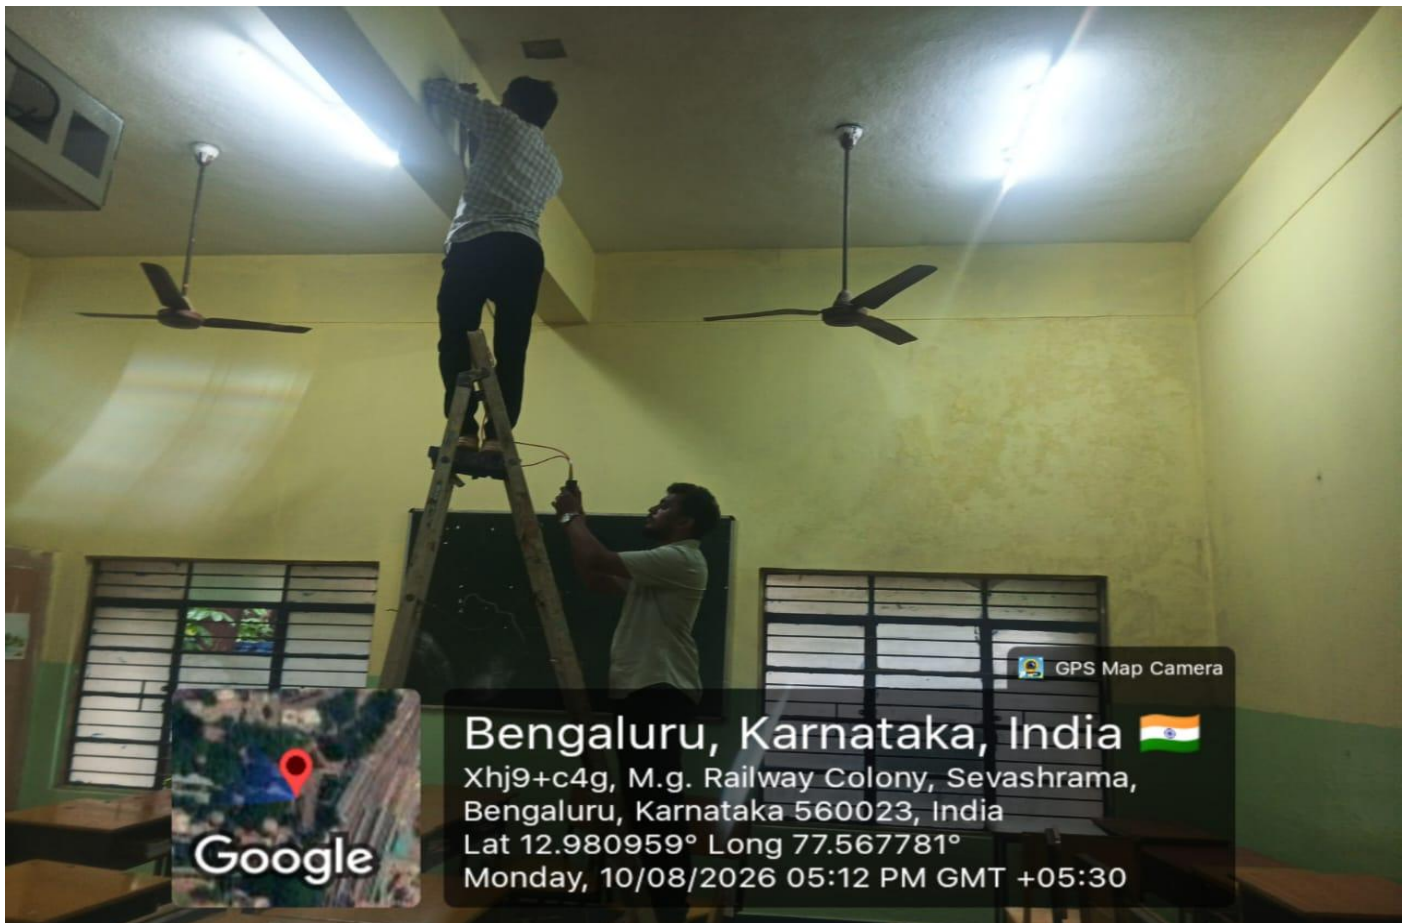
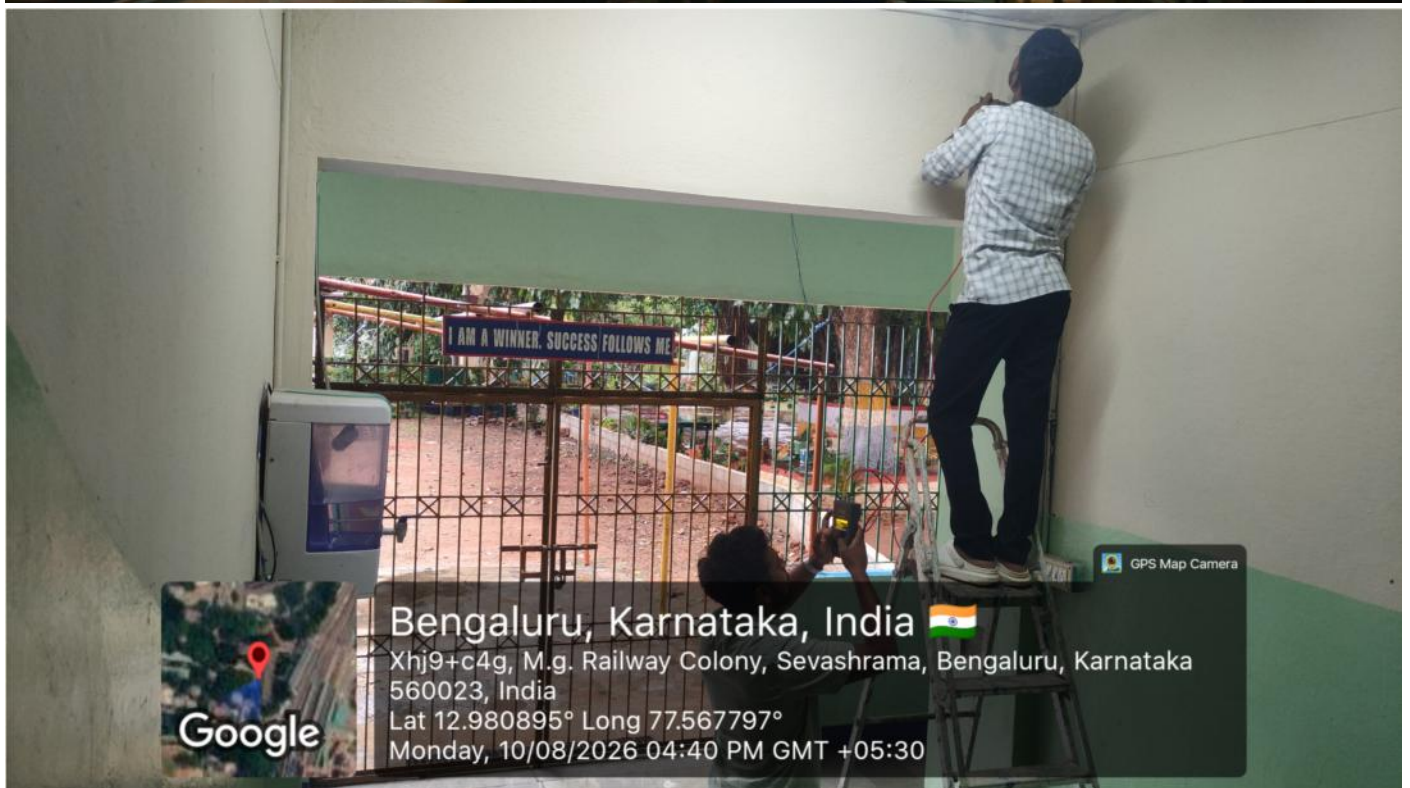
**FIG. NO. 15& FIG.NO. 16: ULTRASONIC PULSE VELOCITY TEST AT SELECTED BEAM PM SHRI KENDRIYA VIDYALAYA, MG RAILWAY COLONY BENGALURU, 560023**

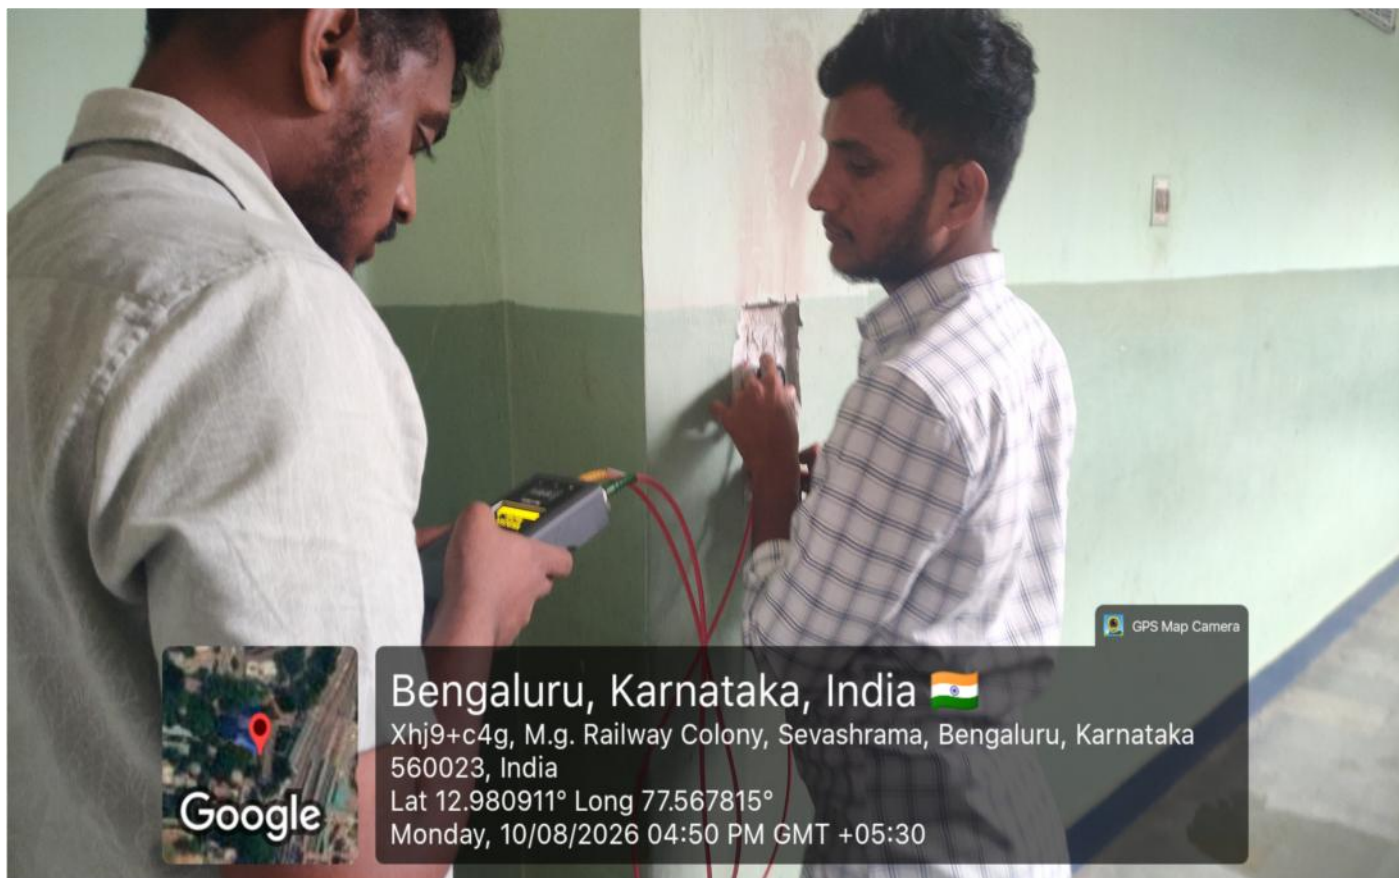
**FIG. NO. 17& FIG.NO. 18: ULTRASONIC PULSE VELOCITY TEST AT SELECTED COLUMN PM SHRI KENDRIYA VIDYALAYA, MG RAILWAY COLONY BENGALURU, 560023**

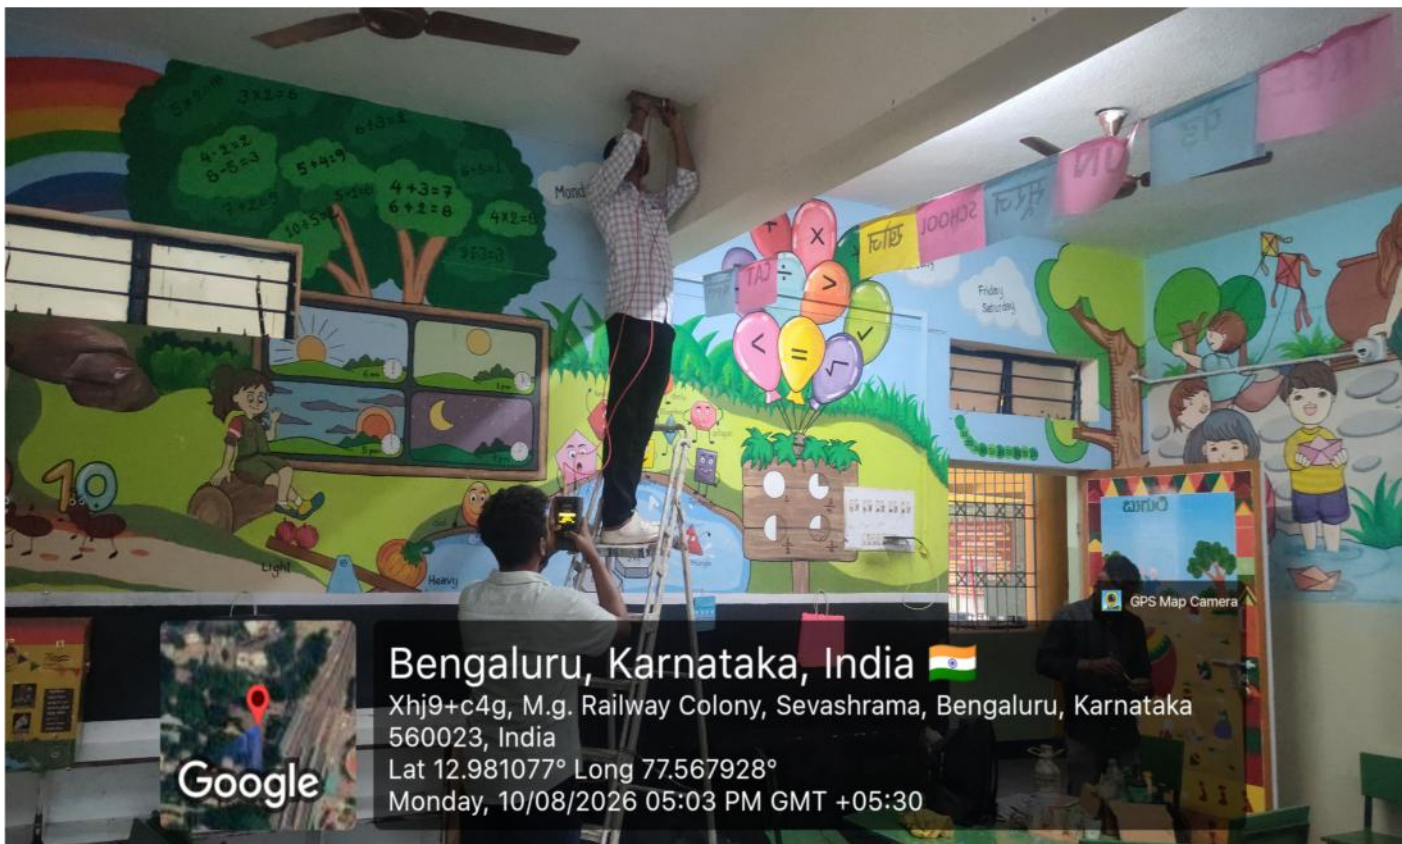
**FIG. NO. 19& FIG.NO. 20: ULTRASONIC PULSE VELOCITY TEST AT SELECTED SLAB PM SHRI ENDRIYA VIDYALAYA, MG RAILWAY COLONY BENGALURU, 560023**
