Project Number: 51308-008  
September 2023

## India: Uttarakhand Climate Resilient Power System Development Project

### Appendices Part 7

**Table 4.7 Representative photos showing impacts on substation flora**

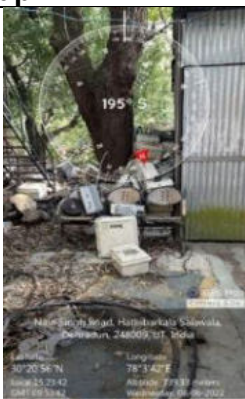
Concern	Sample photograph
<b>Hatibarakala Substation</b> – Electric meters and other wastes dumped and stored on the root/area of two neem trees/Indian lilac ( <i>Azadirachta indica</i> )

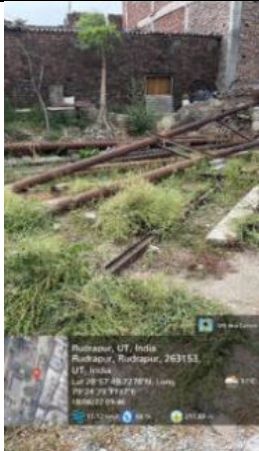
Concern	Sample photograph
<p><b>Badhaipura Substation</b> – Waste dumped and stored on the root/area of Papaya (<i>Carica papaya</i>)</p>

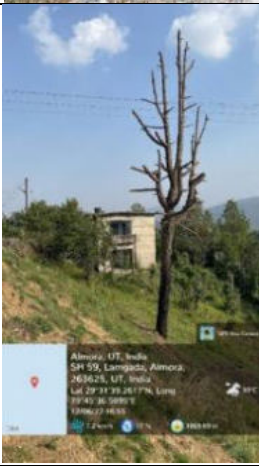
<p><b>Lamgarah substation:</b> Lopped Mountain Cedar tree (<i>Toona ciliata</i>)</p>

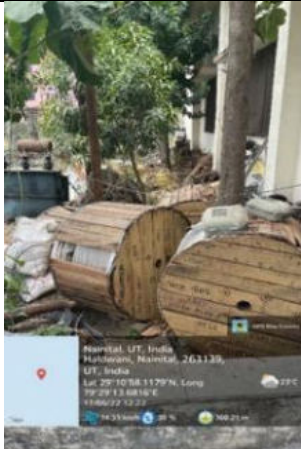
<p><b>Phoolchaur substation:</b> material stored on root zone of Mango (<i>Mangifera indica</i>) and Giant Milkweed (<i>Calotropis procera</i>)</p>

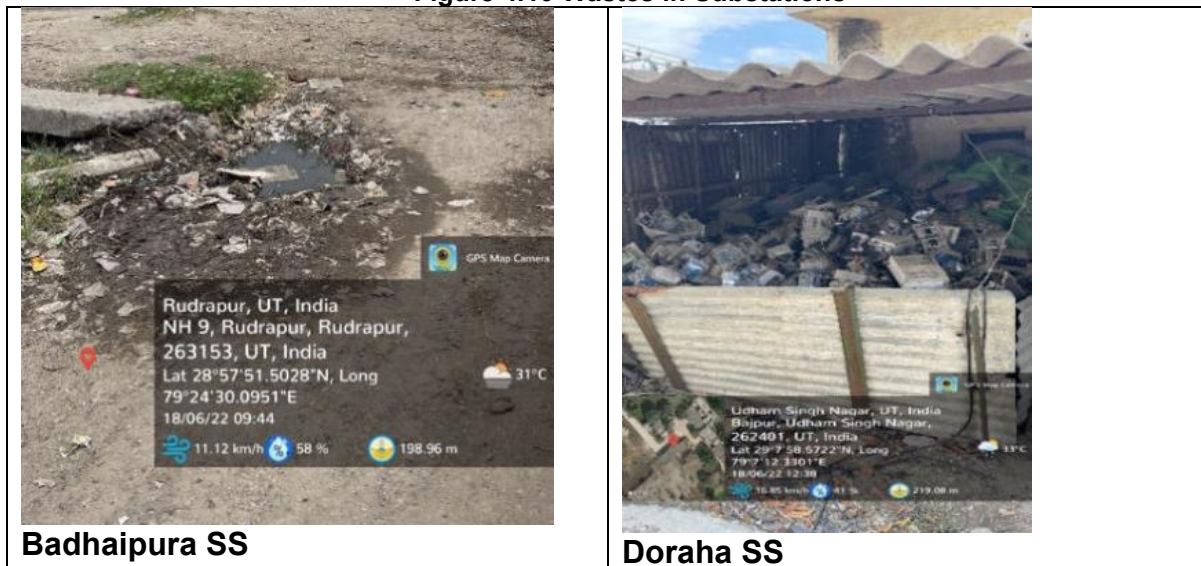
**Figure 4.10 Wastes in Substations**

- ix. Disposal of solid wastes inappropriately on land or in nearby water bodies.

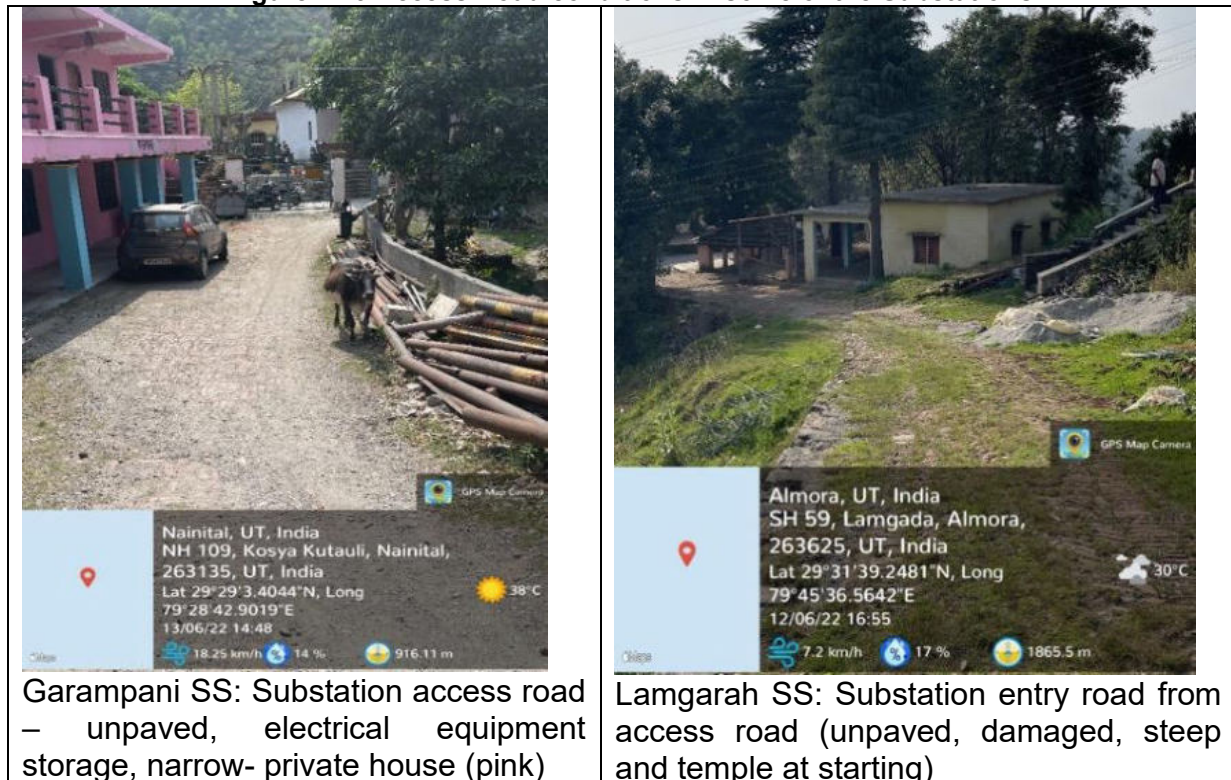
**Figure 4.13 Access Road conditions in some of the Substations**

- xvii. The substation locations are accessible from existing rural and urban main roads and/or state highway. Paved roads at distance varying in the range of 0-40m. nearly all of them are adjacent to the main road. (except Garampani and Lamgarah substation). Some of the access roads are unpaved and/or in need of repair.

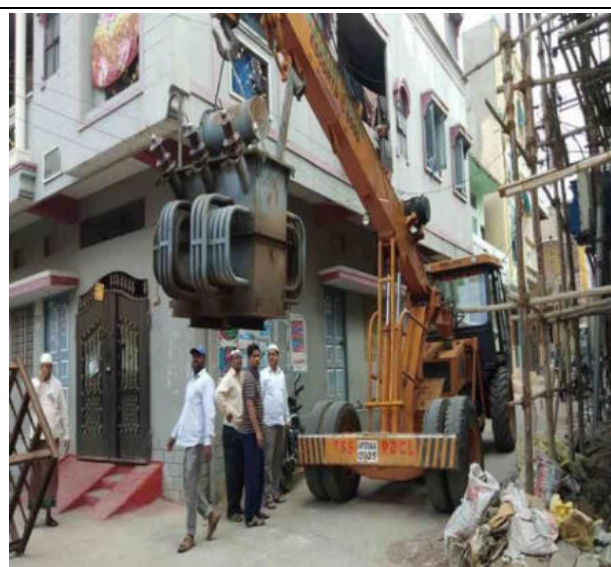
Pines SS: Transformer zone near to main road level – traffic disruption during crane operations to replace transformers.

Representative photograph showing crane used in residential area to replace transformer. (Source: The Hans India)

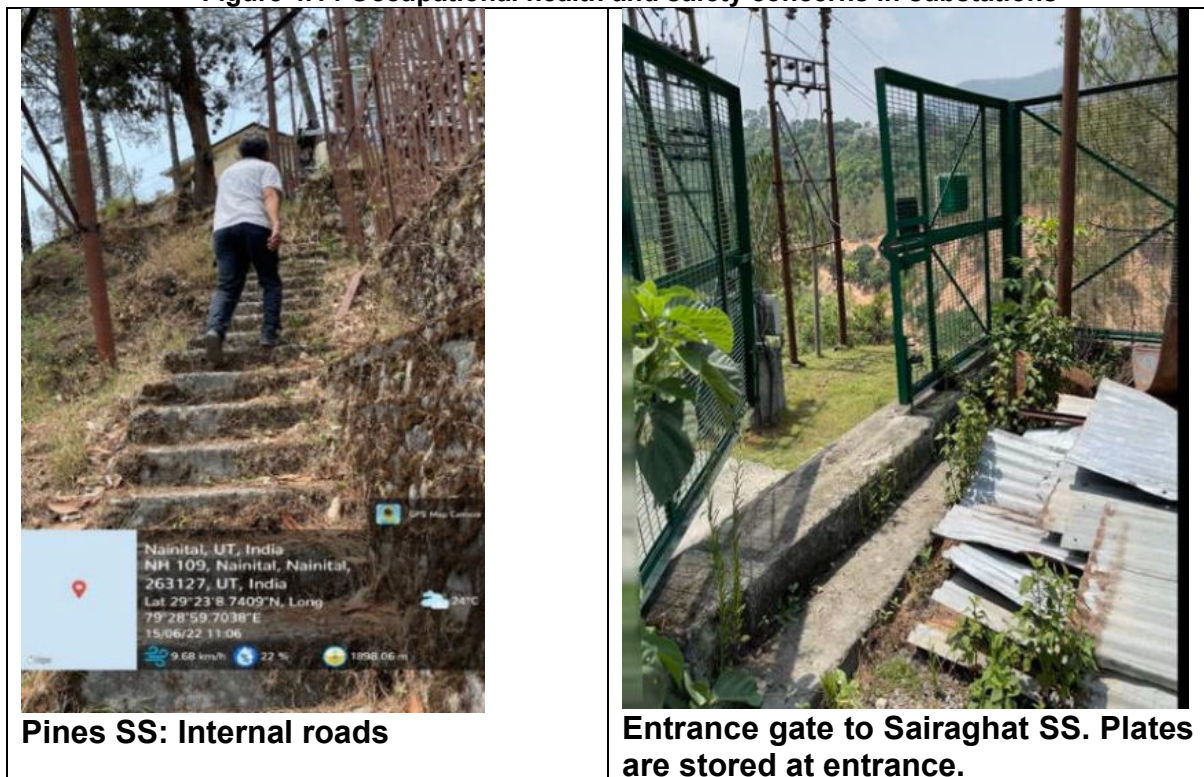
**Figure 4.14 Occupational health and safety concerns in substations**

- ii. Unsanitary and unhealthy working conditions including at overnight accommodation provided by contractor, leading to H&S incidents/accidents
- iii. Conditions for accidents due to falls and trips, lightning, fires, due to inadequate safety arrangements, storage of tools/equipment's, vehicle movement, with no signage and barricades, electrical safety issues, lifting gears/cranes, first aid arrangements not as per standard

- iv. Labour standards - temporary labour camps, sanitation systems, drinking water and other essential requirements inadequate onsite and camps lacking basic infrastructure and sanitation requirements, including very cold weather conditions in high altitude substations like Sawra, Sahiya, Sarghakhhet (snow reported in December-January), Pines, Tarikhhet, etc.

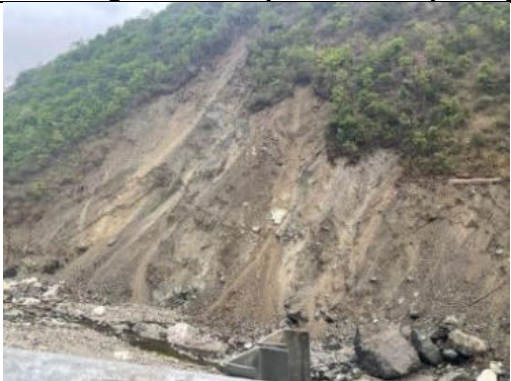
<p><b>Landslide damaged main road: Nainital to Almora</b></p>

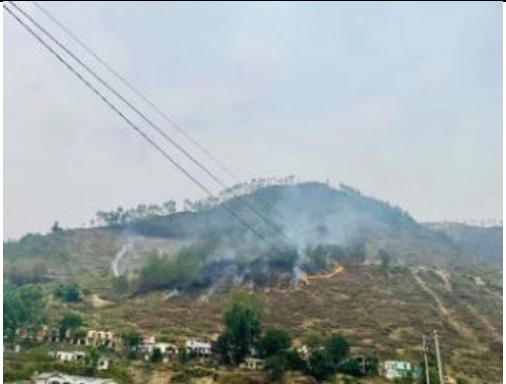
<p><b>Forest fire in Nainital region.</b></p>

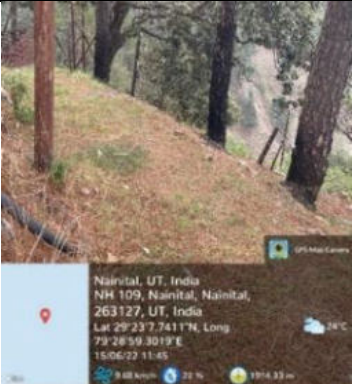
<p><b>Brunt trees in Pines SS</b></p>

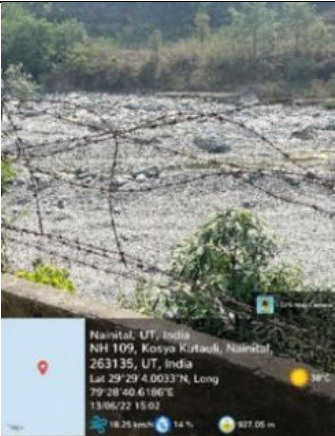
<p><b>Garampani SS: Flood ravaged river 0m from substation</b></p>

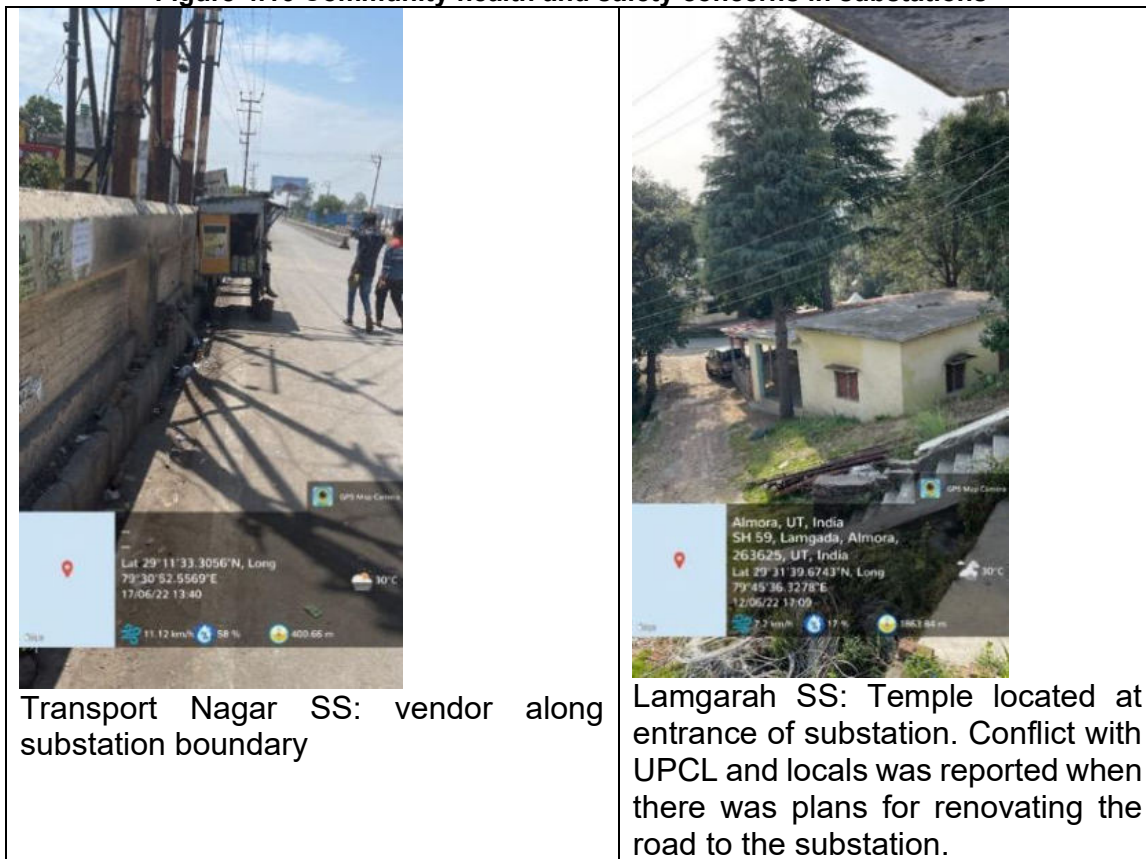
**Figure 4.16 Community health and safety concerns in substations**

- i. Inadequate signage and broken fence/barricades observed; locals have easy access to substation.

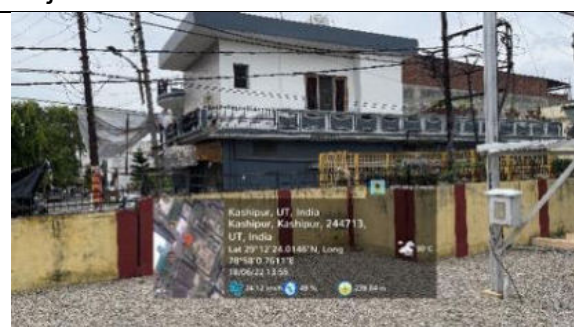
Kashipur SS: private residence adjacent to substation
