# Compliance status report (2026) of 05 Nos Critical recommendations of High Power Committee Final Report (July 2020) for Char Dham Pariyojna

Two roads of Chardham Road Deveopment Pariyojna namely 1- Rudraprayag-Gaurikund M/R NH-107 and 2-Dharasu-Jankichati M/R NH 134 are under purview of High Power Committee (Non stretegic Road). The compliance status report of above two roads is as under.

### Details of Identified Vulnerable Landslide Points on Rudraprayag-Gaurikund NH-107

## Details of Identified Vulnerable Landslide Points on Dharasu – Jankichatti NH-134

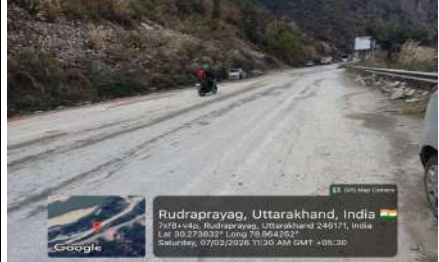
Location No.	Chainage	Latitude / Longitude/ Type of Vulnerability	Proposed / Adopted Treatment Measures	Current Status	Photograph	
					Before	After
1	2	3	4	5	6	
1	0.180 to 0.300	30°16'56.69" N, 78°58'7.99"E,  Sinking	Gabion Wall	Work completed (Stable)	-

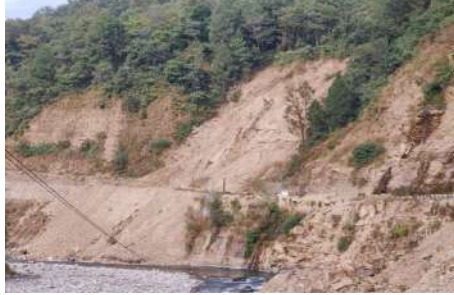
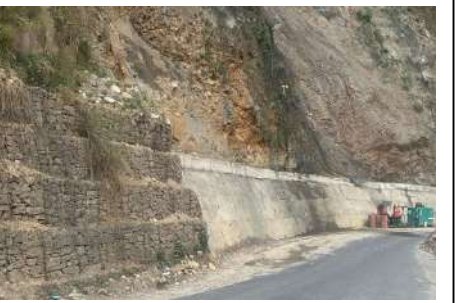
8	28.900 to 29.300	30°15'57.24" N, 79°02'36.60"E Landslide	Shotcrete, Rock Anchors, Cable Netting, Sub-surface Drainage, Stepped Channel, CC Cladding and Gravity Wall	Work in progress

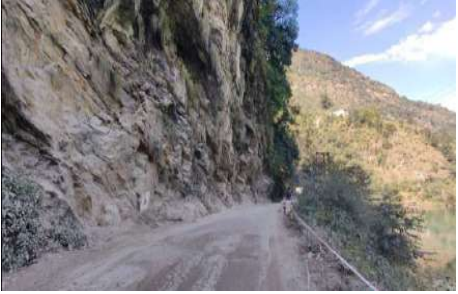
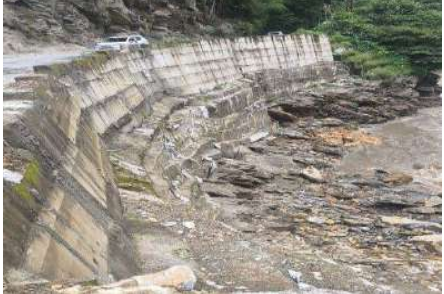
11	35.210 to 35.265	30°30'25.25"N 79° 5'8.08"E Sinking	RCC wall with raft on bundled anchor and lateral SDRA.	Work completed

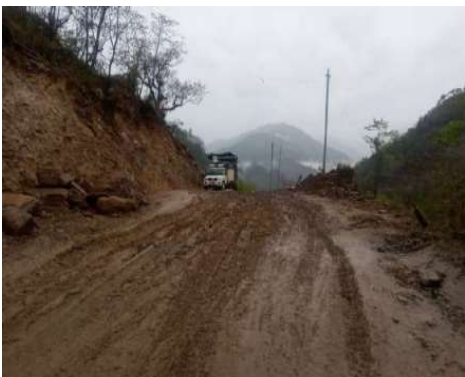
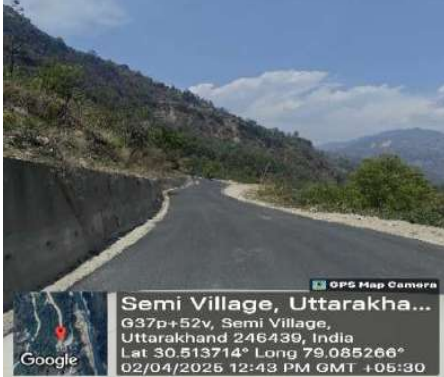
12	35.900 to 36.400	30° 30' 54" N 79° 05' 05" E Sinking	Toe- Articulated concrete block mattress & launching apron, gravity wall, RCC wall Slope- Soil nailing Sinking stretches on road- RCC slab on SDRA bars Drain channel for channelization, sub surface drainage pipe for sub surface water	Work completed

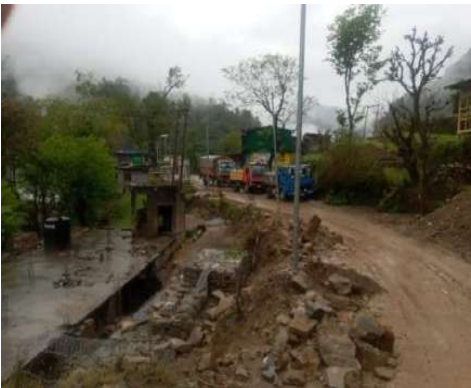
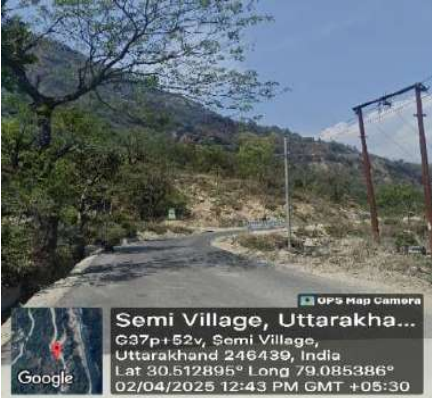
Location No.	Chainage	Latitude / Longitude/ Type of Vulnerability	Proposed / Adopted Treatment Measures	Current Status	Photograph	
					Before	After
1	2	3	4	5	6	
13	36.800 to 37.300	30° 30' 51" N 79° 05' 03" E Sinking	Toe- Articulated concrete block mattress & launching apron, gravity wall, RCC wall Slope- Soil nailing Sinking stretches on road- RCC slab on SDRB bars Drain channel for channelization, sub surface drainage pipe for sub surface water.	Work completed

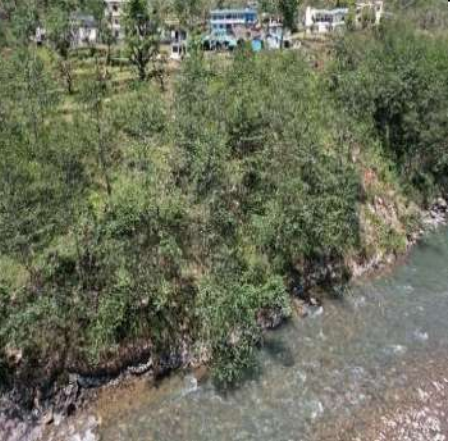
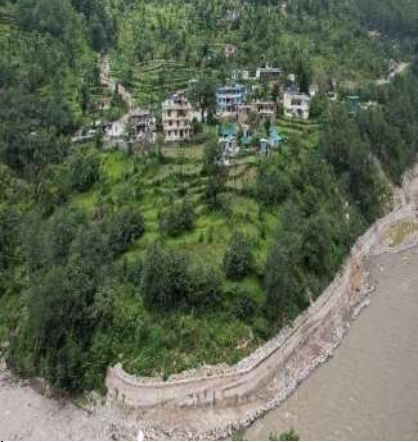
14	38.000 to 38.300	30° 30' 45" N 79° 04' 54" E Sinking	Toe- Articulated concrete block mattress & launching apron, gravity wall, RCC wall Slope- Soil nailing Sinking stretches on road- RCC slab on SDRB bars Drain channel for channelization, sub surface drainage pipe for sub surface water.	Work completed

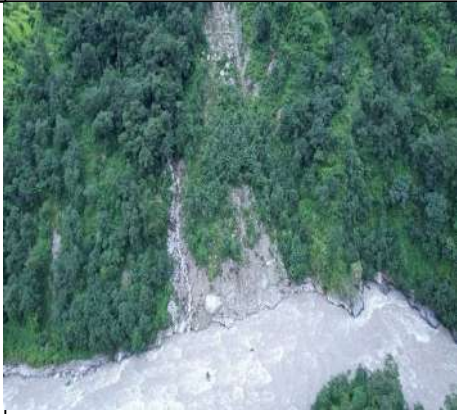
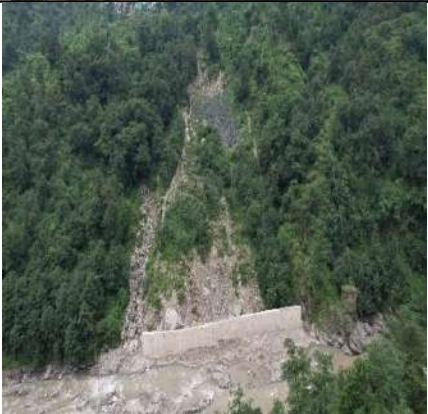
Location No.	Chainage	Latitude / Longitude/ Type of Vulnerability	Proposed / Adopted Treatment Measures	Current Status	Photograph	
					Before	After
1	2	3	4	5	6	
15	39.500 to 40.000	30° 31' 27" N 79° 05' 01" E Sinking	Toe- Articulated concrete block mattress & launching apron, gravity wall, RCC wall  Slope- Soil nailing Sinking stretches on road- RCC slab on SDRA bars Drain channel for channelization, sub surface drainage pipe for sub surface water.	Work completed

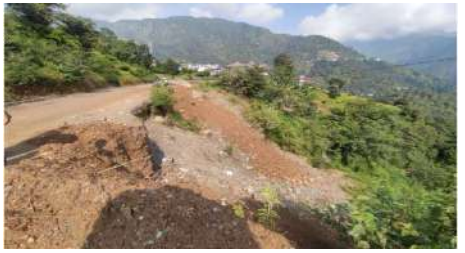
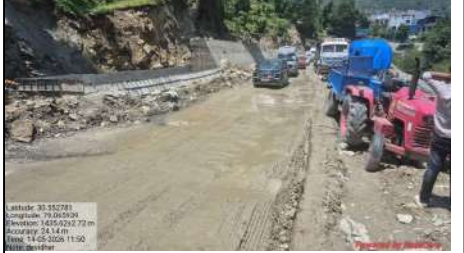
21	53.290 to 53.600	30° 19' 57.36" N 79° 02'17.16" E Sinking	Hill Side Stabilization, Valley Side Stability, Edge & Road Protection and Drainage & Anchoring	Work in progress

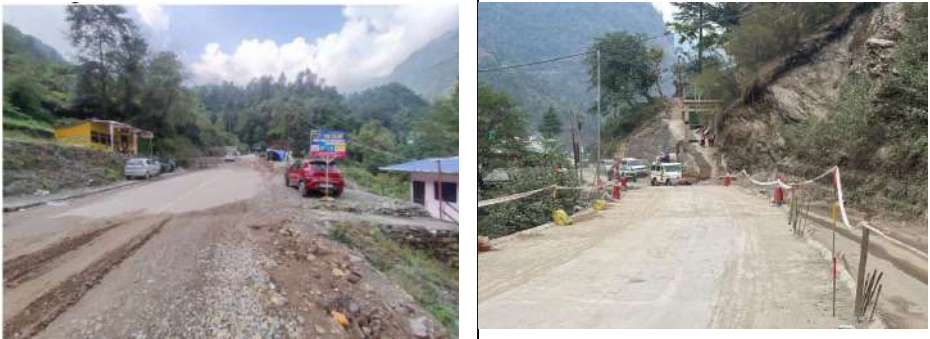
26	55.100 to 55.300	30° 19' 53.76" N 79° 01'53.34" E Landslide	Hill Side Protection, micro-pile, SDRA, Road Level Stabilization, Valley Side Protection with CC gravity wall and RCC box culvert.	Work in progress

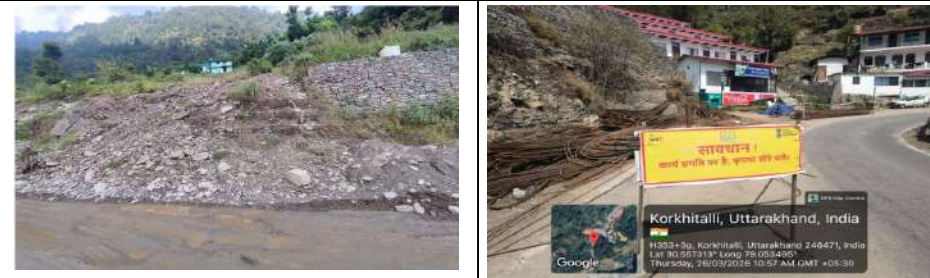
27	56.050 to 56.140	30° 33' 36.11" N, 79° 03' 11.94" E Sinking	SDRA, Netting and Clading wall	Work in progress

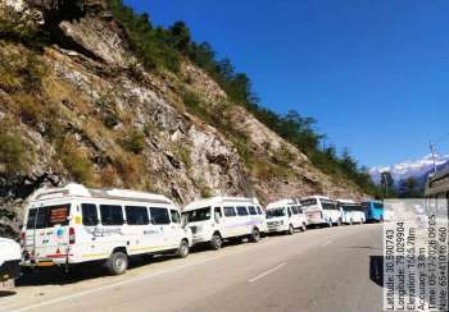
-
32	65.410 to 65.460	30°35'28.877" N 79°1'47.869" E Landslide	Rocky strata, already stabilized	Breast wall Constructed. Now slope is Stable	-

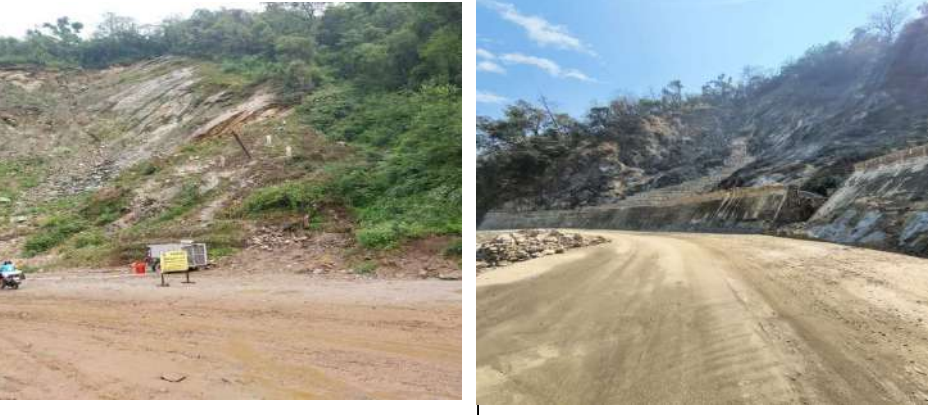
36	69.850 to 69.980	30° 36' 42.69" N 79° 0'55.43" E Landslide	Hill side- soil nailing, with chainlink and shortcrete , CC gravity wall with raft with SDRA cluster, cladding wall with lateral SDRA. Gabion cascade for water channelisation, RCC Road on SDRA cluster Valley side- gabion matteress with geocell, hydroseeding and mulching.	Work completed

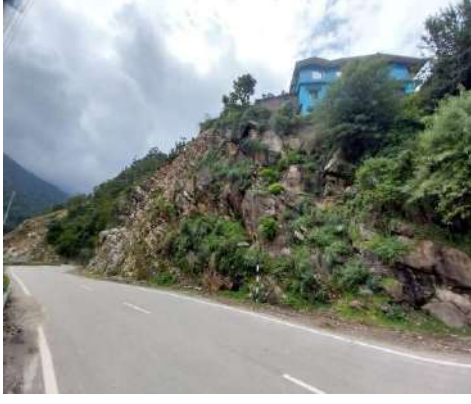
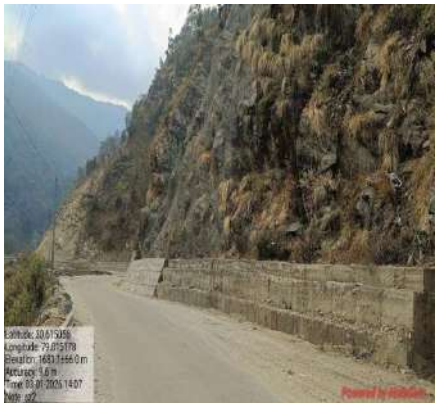
Location No.	Chainage	Latitude / Longitude/ Type of Vulnerability	Proposed / Adopted Treatment Measures	Current Status	Photograph	
					Before	After
1	2	3	4	5	6	
37	70.540 to 70.610	30°36'50.00"N 79° 0'52.00"E Sinking	Hill side- RCC Raft with SDRA, High Tensile Steel Wire Mesh, SDRA Valley Side- Gabion wall. 200mm thick Geocell application covering. Installation of 6m deep SDRA. CC Wall with lateral SDRA. CC Cladding with lateral SDRA.	Work completed

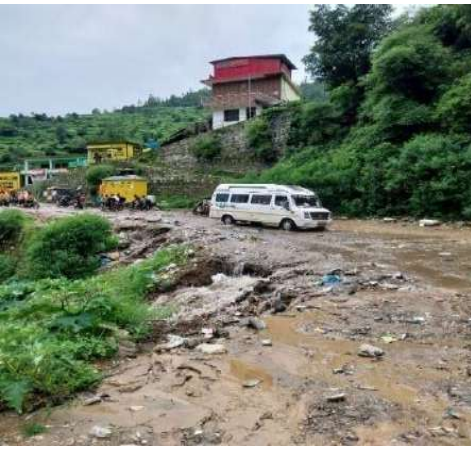
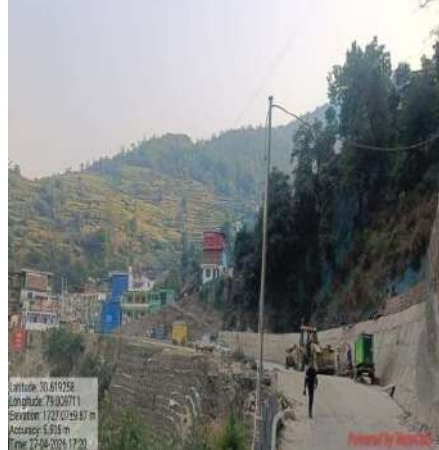
Latitude: 30.61500 Longitude: 79.01500 Elevation: 1643.1444 m Accuracy: 1.6 m Time: 03.01.2025 14:07 img_02
38	71.400 to 71.520	30°37'08.27"N 79° 00'34.92"E Sinking	Hill side- RCC Raft with SDRA clusters, Double-twisted mesh over Geo-Jute and Hydroseeding. Road Stability: New CC road on RCC Raft with deep SDRA Toe Protection CC wall on RCC Raft with lateral anchors for toe support. River-Side Protection. CC Retaining Wall on RCC Raft with deep clusters and lateral SDRA	Work completed

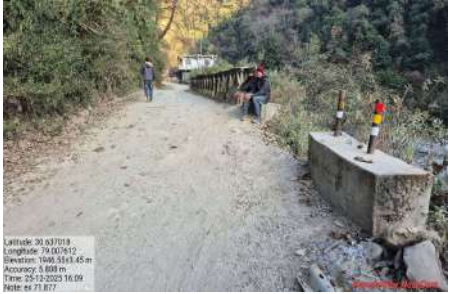
Location No.	Chainage	Latitude / Longitude/ Type of Vulnerability	Proposed / Adopted Treatment Measures	Current Status	Photograph	
					Before	After
1	2	3	4	5	6	
42	Exist Ch. 71.900 to 72.000	30° 38' 58.2"N 79° 1' 28.32"E Landslide	Slope treatment will be done.	DPR stage

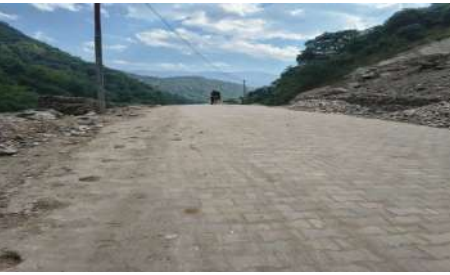
-
43	Exist ch 73.360 to 73.480	30° 39' 45.5"N 79° 2' 8.14"E Landslide	Breat wall with Gabbions constructed. For remaining treatment DPR is being framed.	Site inspection done by THDC. DPR awaited.

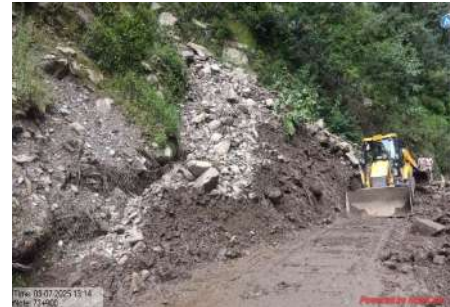
-
44	Exist ch 73.880 to 73.960	30° 39' 52.8"N 79° 2' 14.5"E Landslide	Breat wall with Gabbions constructed. For remaining treatment DPR is being framed.	Site inspection done by THDC. DPR awaited

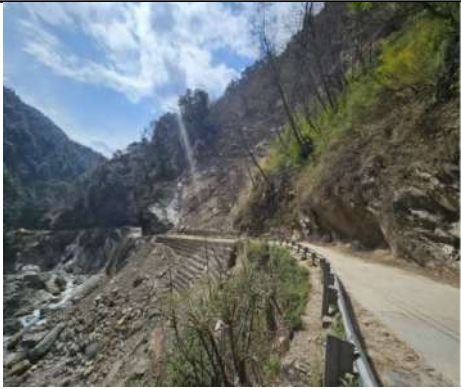
Location No.	Chainage	Latitude / Longitude/ Type of Vulnerability	Proposed / Adopted Treatment Measures	Current Status	Photograph	
					Before	After
1	2	3	4	5	6	
45	Exist ch 74.366 to 74.471	30° 38' 58.2"N 79° 1' 28.32"E Landslide	Hill cutting, SDRA, Hydroseeding, geo jute mat, Anchored CC gravity wall over raft with micro-pile, anchored cc gravity Wall over raft after dismantling of bulged gabion wall and CC cladding	Work in progress

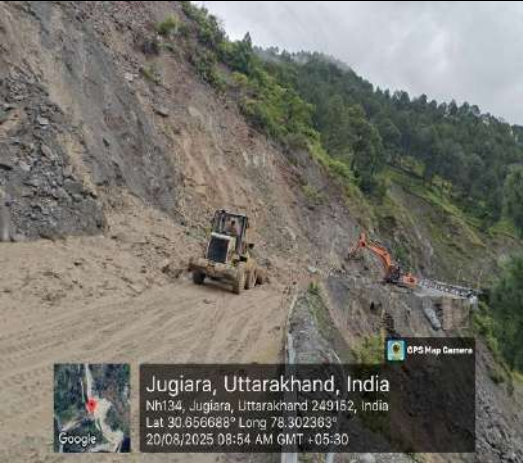
6	7.600- 7.800	30.656688 78.302363  Landslide	-	DPR Stage

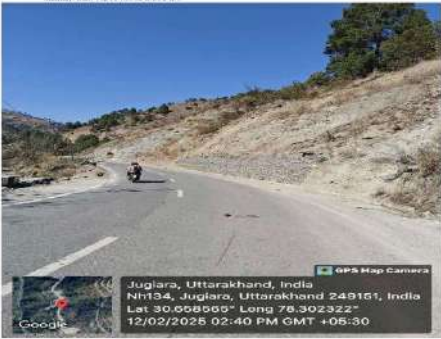
Location No.	Chainage	Latitude / Longitude/ Type of Vulnerability	Proposed / Adopted Treatment Measures	Current Status	Photograph
1	2	3	4	5	6
7	7.940 – 8.070	30.65861111 78.30250000  Landslide	1. Terracing and Benching 2. HT Wire mesh. 3. Longitudinal Drain 4. RCC Toe Wall over micropiles	Bid Invited

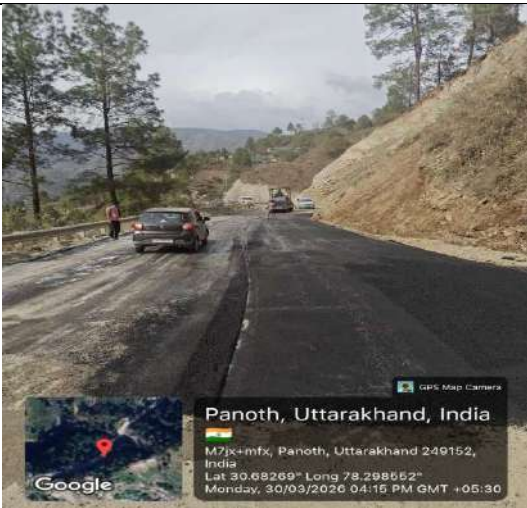
Location No.	Chainage	Latitude / Longitude / Type of Vulnerability	Proposed / Adopted Treatment Measures	Current Status	Photograph
1	2	3	4	5	6
13	11.820 - 11.900	30.68269-78.298552  Landslide	-	Survey stage

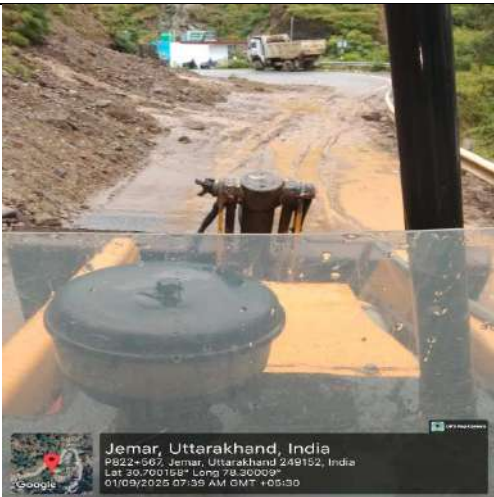
Location No.	Chainage	Latitude / Longitude/ Type of Vulnerability	Proposed / Adopted Treatment Measures	Current Status	Photograph
1	2	3	4	5	6
16	15.220-15.280	30.700158 78.30009  Landslide		Survey stage

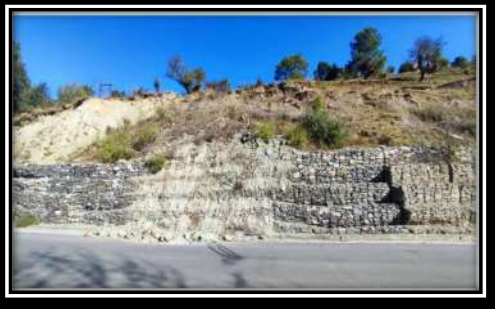
21	53.160 to 53.330	30.80542083 78.23854097  Landslide	RR Breast Wall	Work Completed

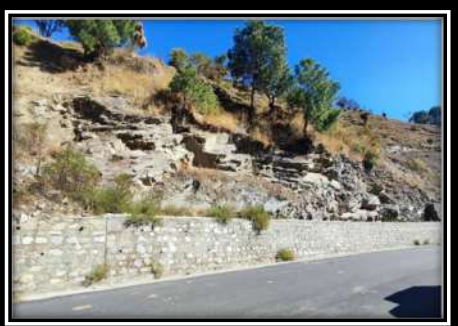
Location No.	Chainage	Latitude / Longitude/ Type of Vulnerability	Proposed / Adopted Treatment Measures	Current Status	Photograph
1	2	3	4	5	6
22	53.450 to 53.500	30.80542083 78.23854097  Landslide	RR Breast Wall	Work Completed

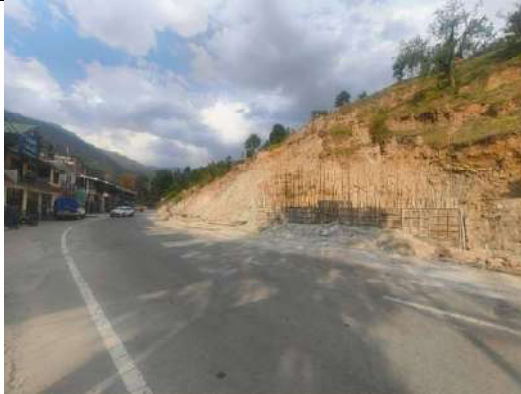
23	53.670 - 53.810	30.80928831 78.22056583  Landslide	1. Offloading of Mass 2. Geojute and seeds 3. Anchored RCC Toe Wall over raft	Work In Progress

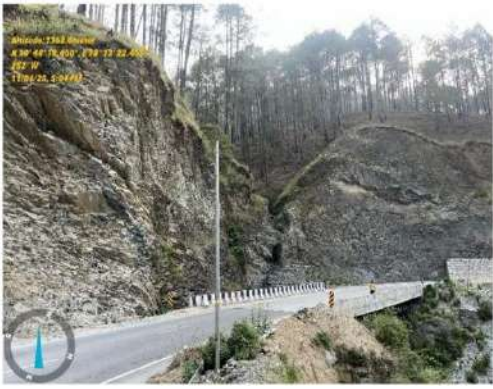
24	56.822 – 57.161	30.8030138889 78.2221777778  Landslide	1. Terracing and Benching 2.DT Mesh and Hydroseeding. 3. CC Channel with SDRA 4. RCC Toe Wall over micropiles 5. Rockfall barrier.	Bid Invited

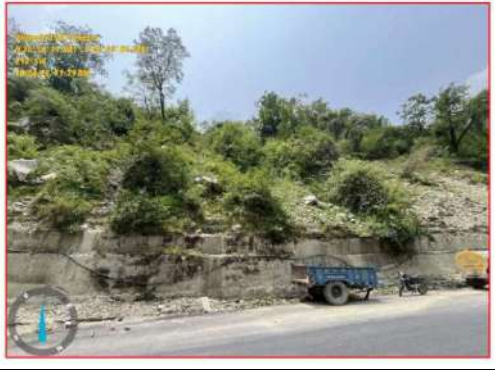
37	70.458 – 70.558	30.8875611111 78.309175  Landslide	1. Removal of overburden and debris. 2. Provision of CC gravity wall over bundled SDRA. 3. Strengthening of existing CC wall with SDRA.	Bid Invited

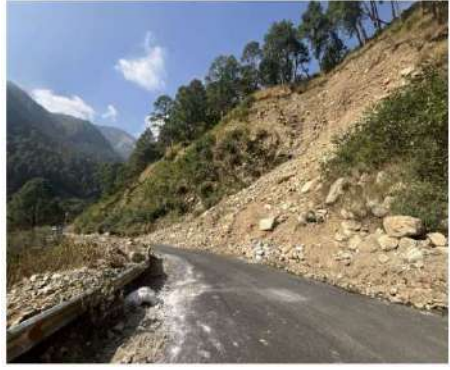
38	71.185 – 71.260	30.8619138889 78.2883416667  Landslide	1. Strengthening of existing CC cladding. 2. HT rolled cable net with SDRA. 3. Provision of CC gravity wall over micropiles. 4. Semi-perforated drainage pipe system.	Bid Invited

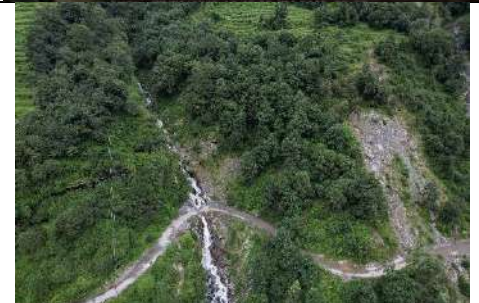
41	84.550 - 84.750	30.92270362 78.38421862	-	DPR Stage

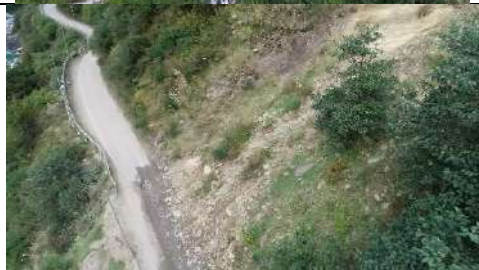
42	85.200 – 85.800	30.92783544 78.39278296	-	DPR Stage

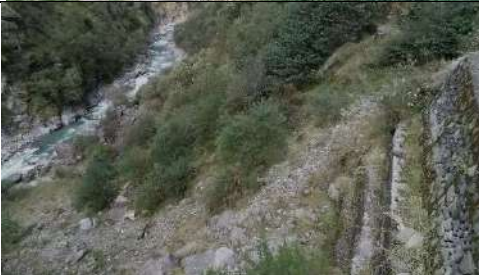
43	86.400 – 86.600	30.92921256 78.39686624	-	DPR Stage

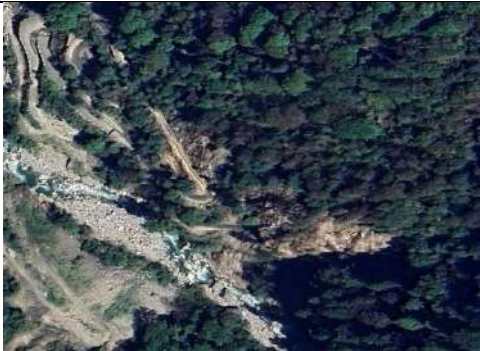
Location No.	Chainage	Latitude / Longitude / Type of Vulnerability	Proposed / Adopted Treatment Measures	Current Status	Photograph
1	2	3	4	5	6
44	88.100 – 88.600	30.94054784 78.40490138	-	DPR Stage

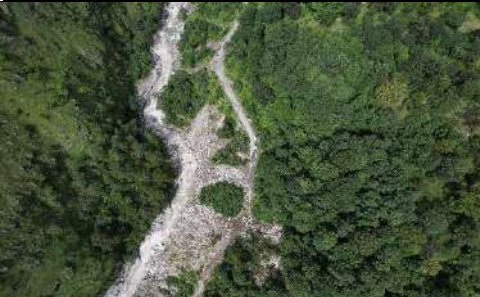
45	88.700 – 89.000	30.9381322 78.4018192	-	DPR Stage

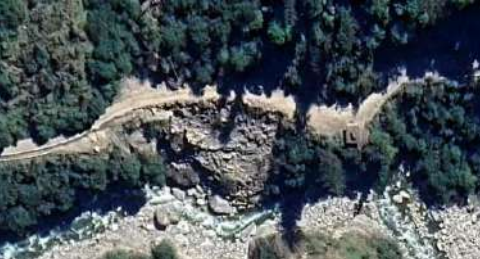
46	89.900 – 90.000	30.95008333 78.41329167  Sinking	-	DPR Stage

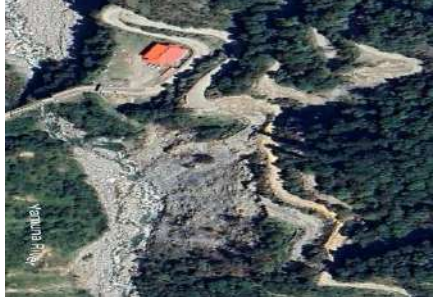
47	91.500 – 91.600	30.95814666 78.42041722	-	DPR Stage

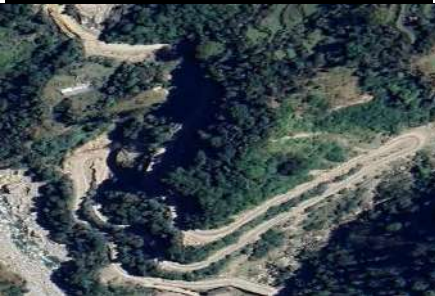
48	91.800 – 92.000	30.9543997 78.417458	-	DPR Stage

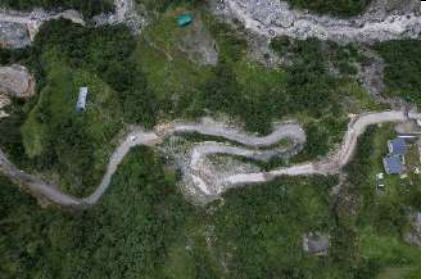
Location No.	Chainage	Latitude / Longitude / Type of Vulnerability	Proposed / Adopted Treatment Measures	Current Status	Photograph
1	2	3	4	5	6
49	92.300 – 92.600	30.95990635 78.42587173	-	DPR Stage

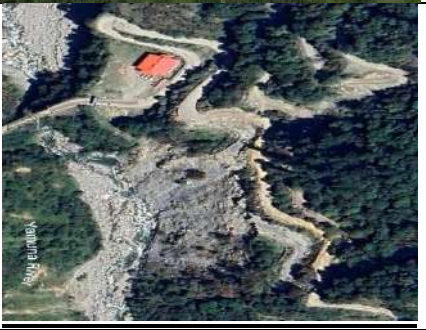
50	93.550 – 93.750	30.96416313 78.43065452	-	DPR Stage

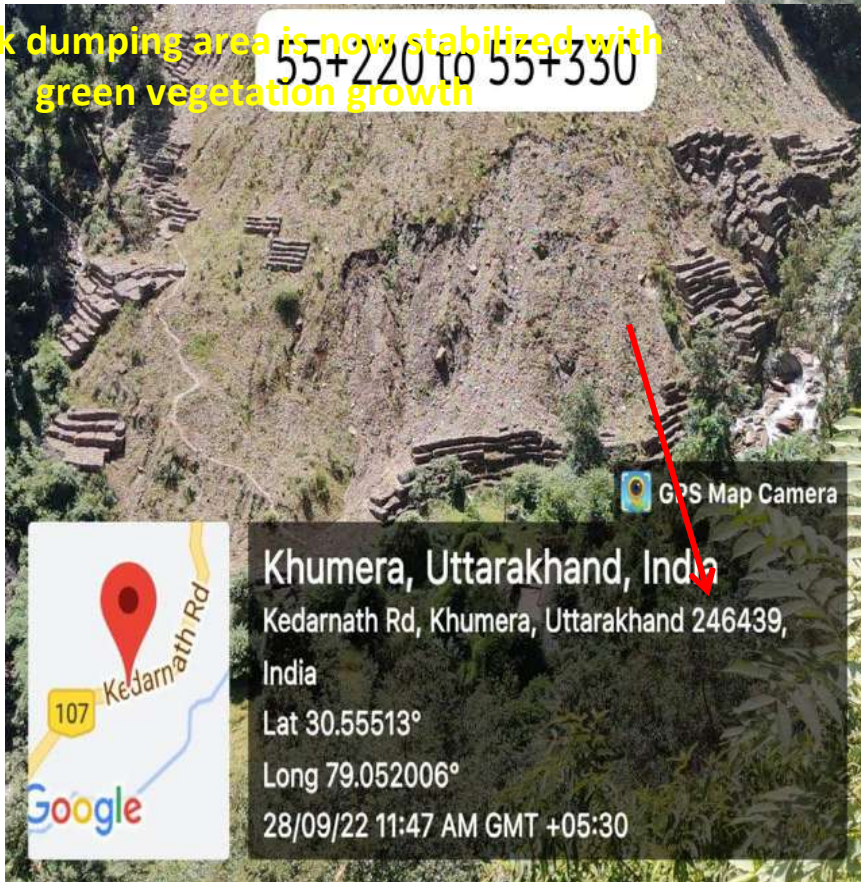
55+220 to 55+330

The muck dumping area is now stabilized with green vegetation growth

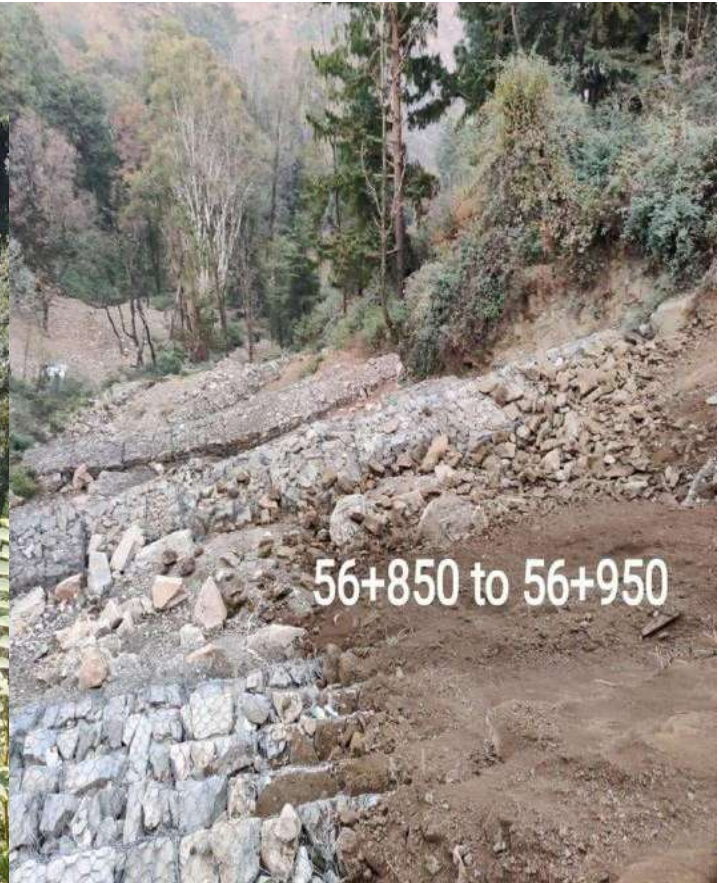
56+850 to 56+950

**The muck dumping area is now  
stabilized with green vegetation growth**

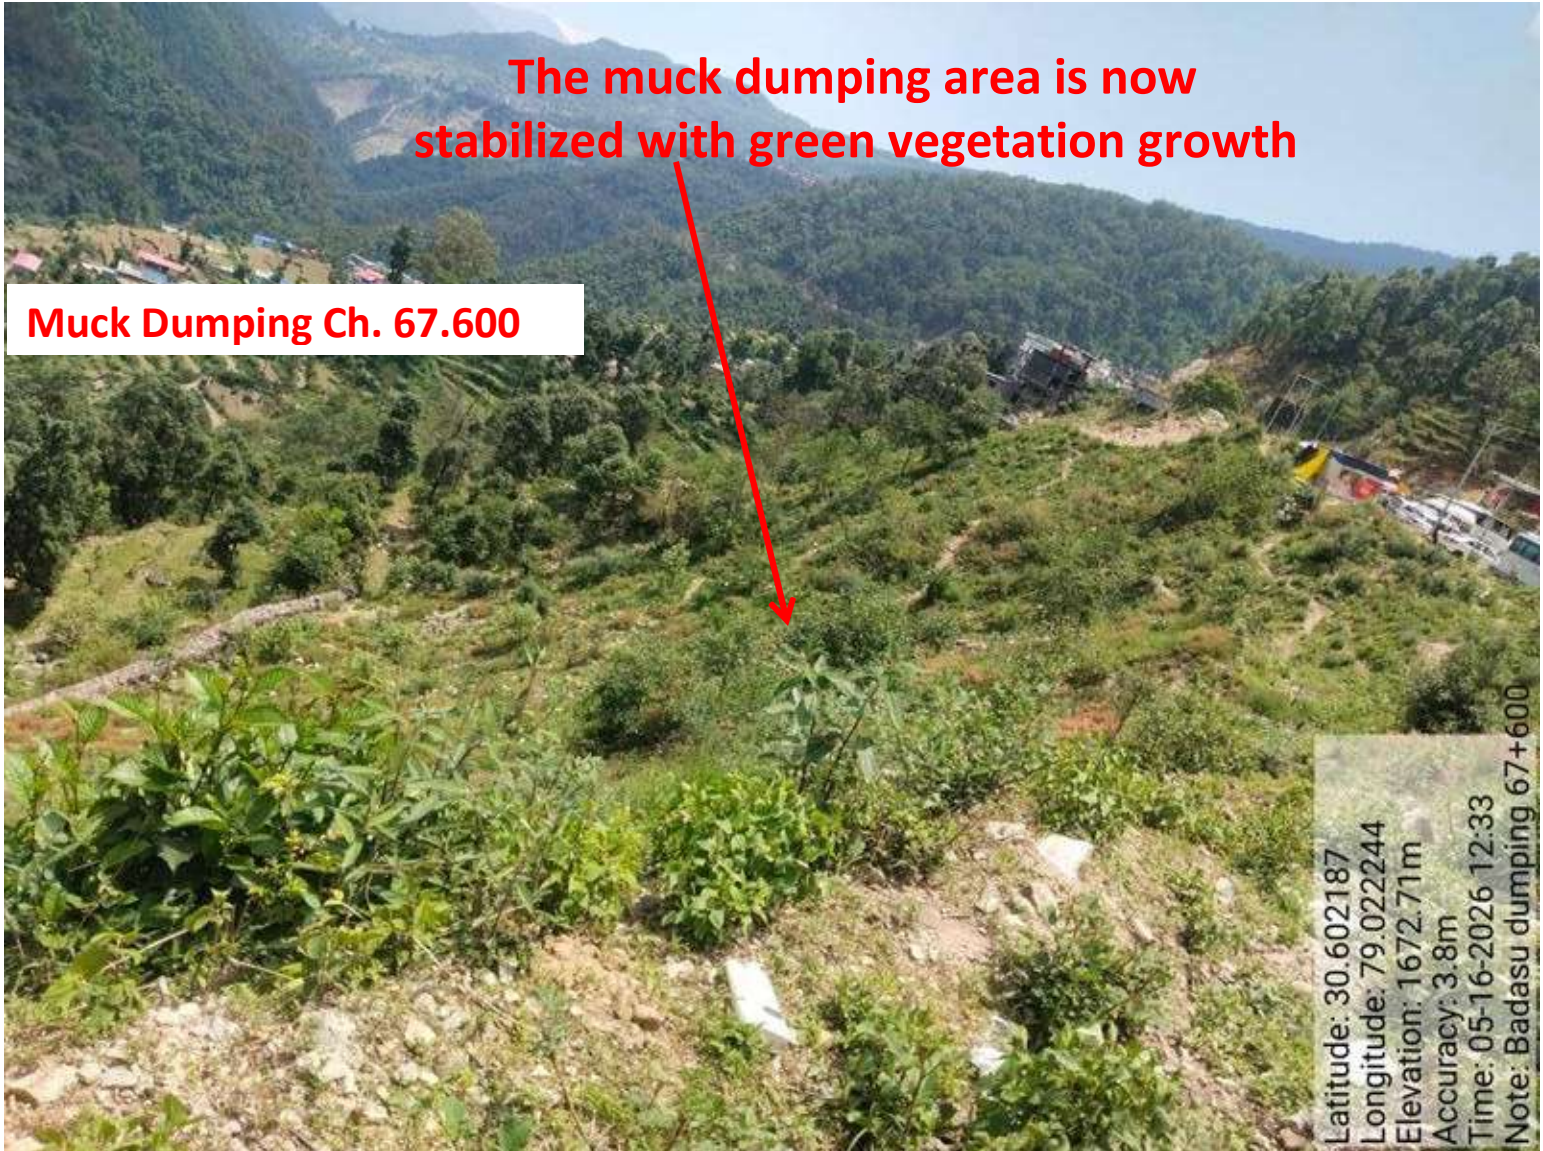
**Muck Dumping Ch. 67.600**

Latitude: 30.602187  
Longitude: 79.022244  
Elevation: 1672.71m  
Accuracy: 3.8m  
Time: 05-16-2026 12:33  
Note: Badasu dumping 67+600

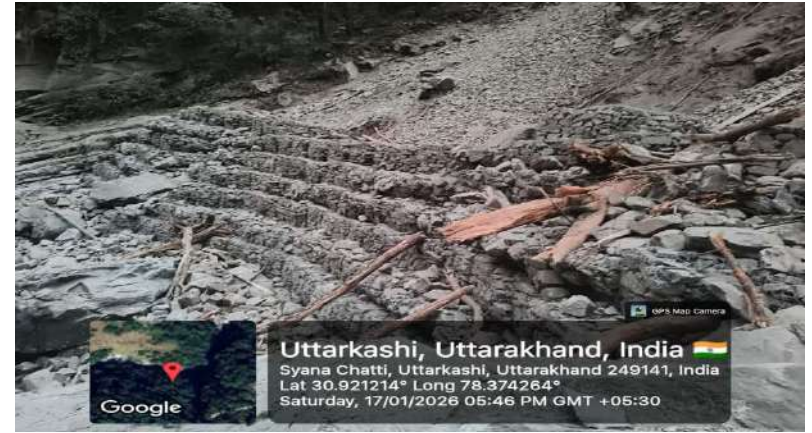
**Ch. 83.500**

<b>2</b>		78+150	30°54'20.04"	78°20'55.37"	Muck Dumping in progress and simultaneously toe protection is being done with gabion wall.
<b>3</b>		83+500	30°55'10.43"	78°22'32.99"	
<b>4</b>		85+400	30°55'10.22"	78°23'22.72"	
<b>5</b>		90+150	30°57'15.05"	78°24'53.31"

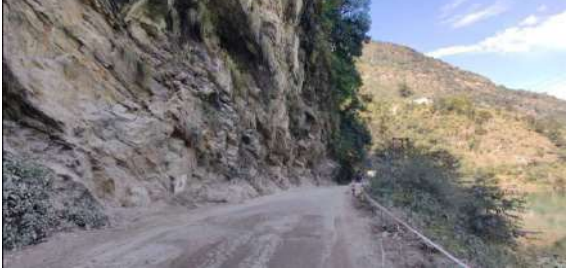
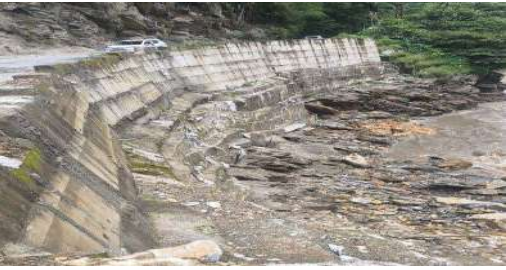
S.No.	Stretch / Section	Details of Vulnerable Downhill Slope							Photographs	
		Location (Chainage)			Length (m)	Longitude	Latitude	Remark	Before	After
		Location Name	From	To						
1	Rudraprayag to Gaurikund Section NH-107	Kund Barrage	35.210	35.265	0.055	30°30'25.25"N	79° 5'8.08"E	Slope Stabilization work has been completed in all locations.

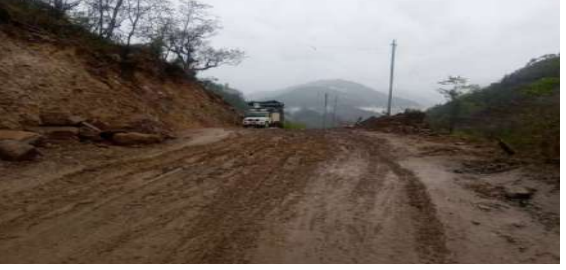
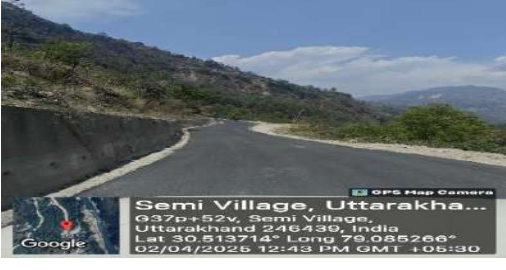
2		Semi I	35.900	36.400	0.500	30° 30' 54" N	79° 05' 05" E

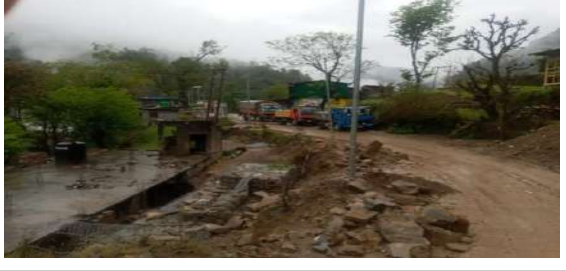
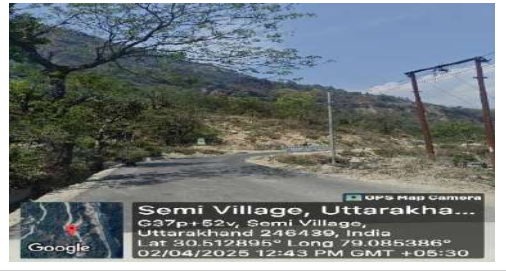
3		Semi II	36.800	37.300	0.500	30° 30' 51" N	79° 05' 03" E

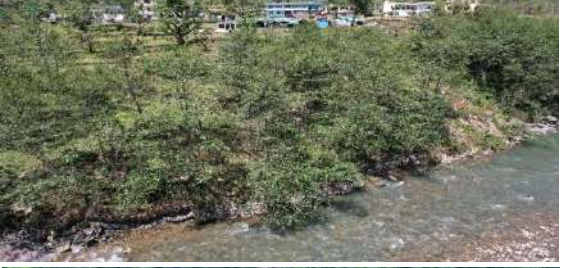
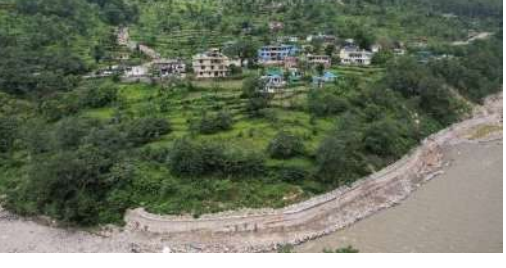
4		Semi III	38.000	38.300	0.300	30° 30' 45" N	79° 04' 54" E

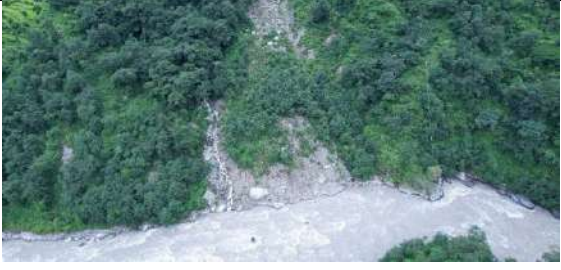
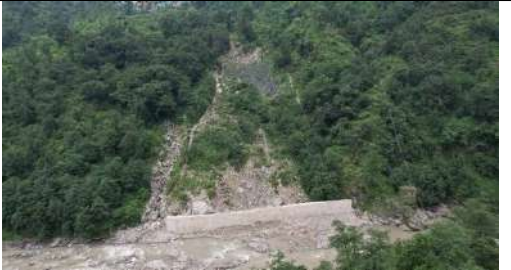
5	Rudraprayag to Gaurikund Section NH-107	Bhainsari I	39.500	40.000	0.500	30° 31' 27" N	79° 05' 01" E	Slope Stabilization work has been completed in all locations.

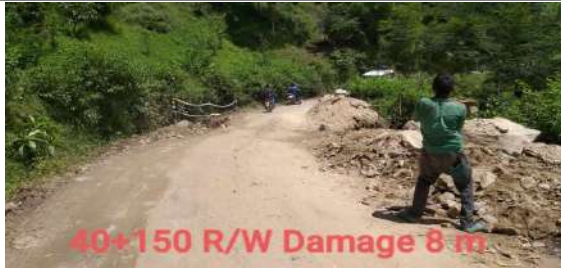
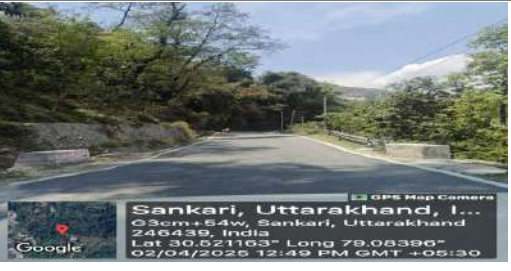
6		Bhainsari II	40.700	41.000	0.300	30° 31' 31" N	79° 04' 55" E

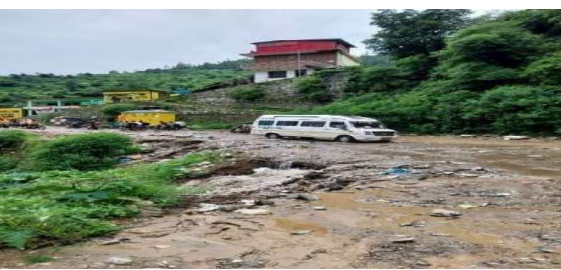
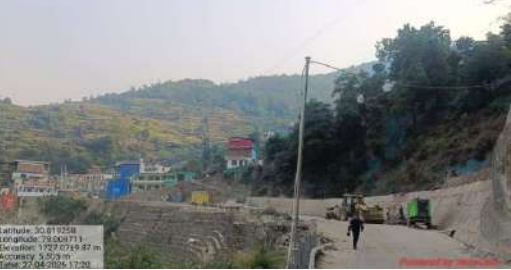
7		Rampur	71.400	71.520	0.120	30°37'08.27"N	79° 00'34.92"E
