## **A Hydrogeological Investigation Report on Land Subsidence in Joshimath Town, Chamoli District, Uttarakhand**

**By**  
**Central Ground Water Board,**  
**Department of Water Resources, River Development and**  
**Ganga Rejuvenation, Ministry of Jal Shakti**  
**Govt of India, Dehradun**

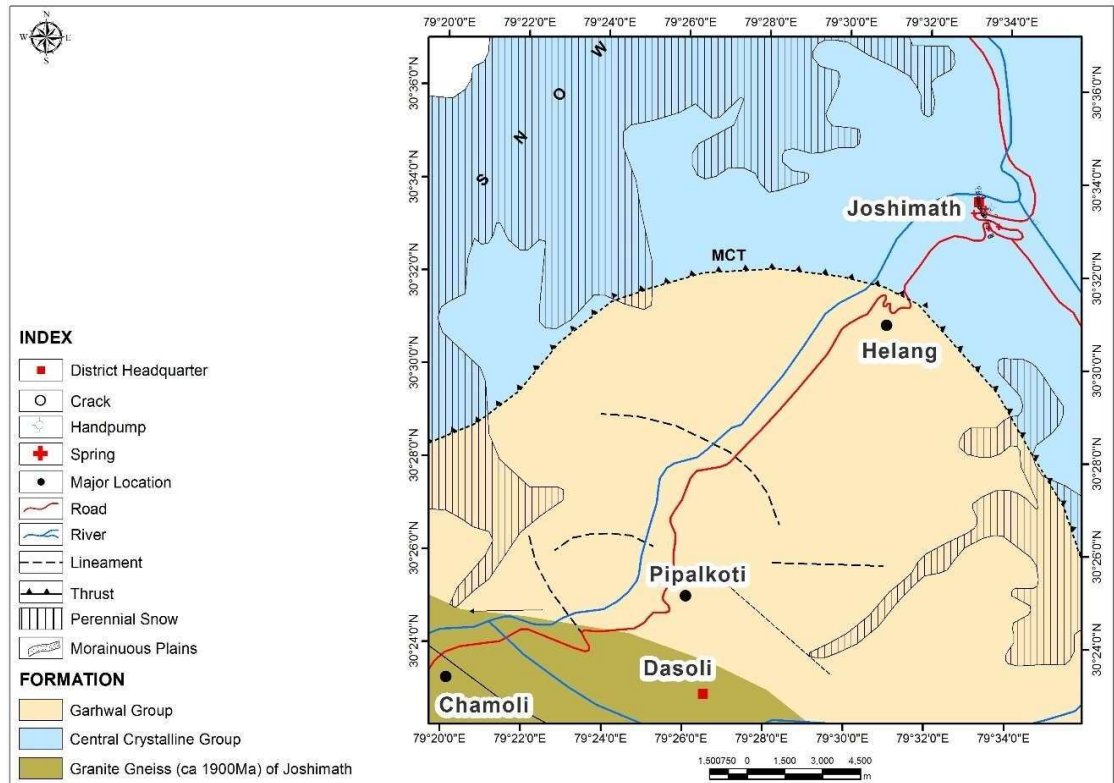
**Figure- 2 Geology of Joshimath Area, Chamoli District**

The Main Central thrust (MCT) traverse in southern part of the study area. Beside this there are number of weaker plains present in the area. The area along these weaker plains is highly vulnerable for landslides/land subsidence. (Figure- 2). Geological succession is furnished in Table -1

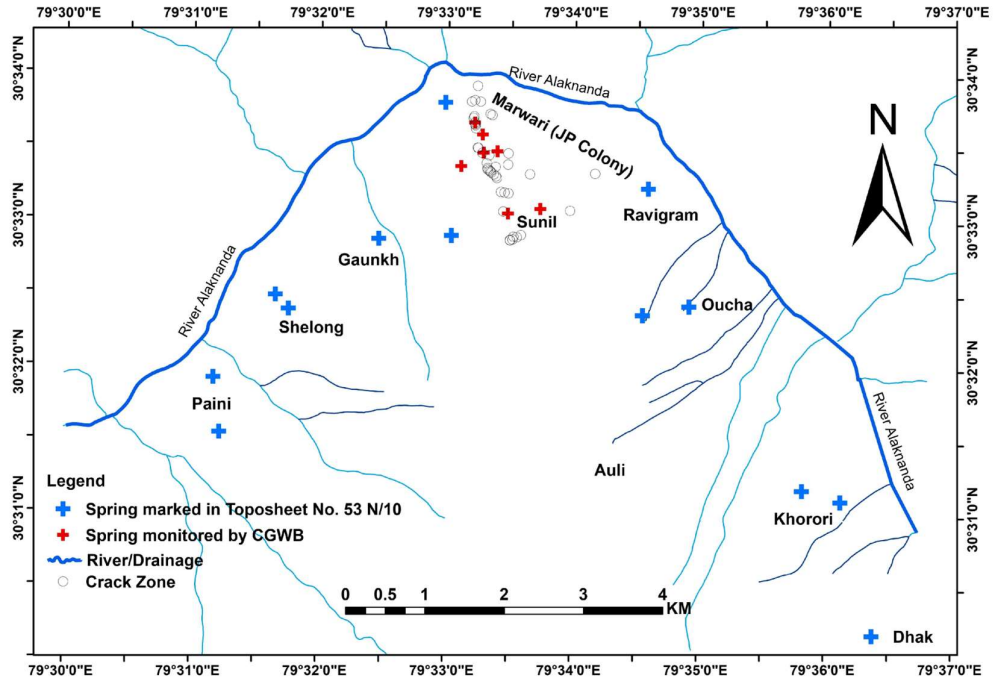
Figure- 3 B Location of Spring Monitored during CGWB Survey and Marked in Toposheet 53 N/10 in and around Joshimath Town, Chamoli District, Uttarakhand.

A total of 46 cracks/subsidence zones are observed which are oriented in North-West to South-East direction (Figure- 3 A) (Annexure- I). The slope direction of the study area is South to North. (Figure- 3 B) The crown of the subsidence marks at house of Sh Vinod Saklani, Village Upper Sunil and extend upto JP township at Marwari village. The intensity of the cracks is increasing from south to north and it maximum observed in Manohar Bagh area where one of the hotels building lean over adjoining hotel building. The depth of the cracks observed in the agriculture land is upto 03 ft deep and 1-2 ft wide.

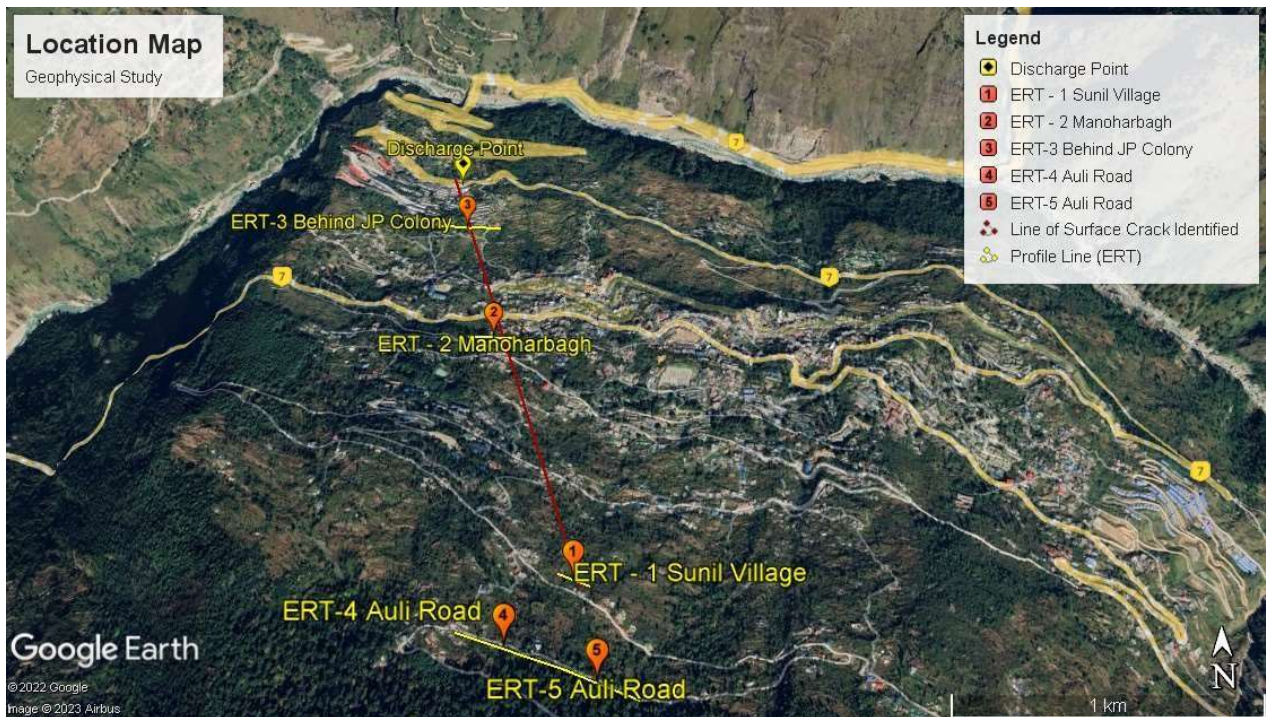
**Figure 6 A: Location map of the study area along with ERT Profile line and Crack Zone, Joshimath, Chamoli District**

In the present study area, ERT profile lines are conducted at five locations across the cracks zone (Fig. 6 A & 6B). As the open land in Joshimath town is very limited, the spread for the ERT profiles varies from 105 m to 360 m. All efforts were done to locate the profile linear to cracked line/subsidence area and with a maximum space availability using two types of electrode configurations i.e., Gradient and Wenner configurations for maximum data and comparative study in NW-SE direction. The coordinates of profile line are given in Table 5. The data have been processed using RES2DINV software. On the basis of ERT results, low resistivity zones were identified i.e. weak zones which may be the cause of cracks/subsidence due to steep gradient of groundwater flow towards north. Overall, the two electrode configurations have yielded almost same the results. Topographically corrected model resistivity sections using Wenner and Gradient are shown Fig. 7 ( A & B), 8 ( A & B), 9 ( A & B), 10 ( A & B), 11 ( A & B) respectively.

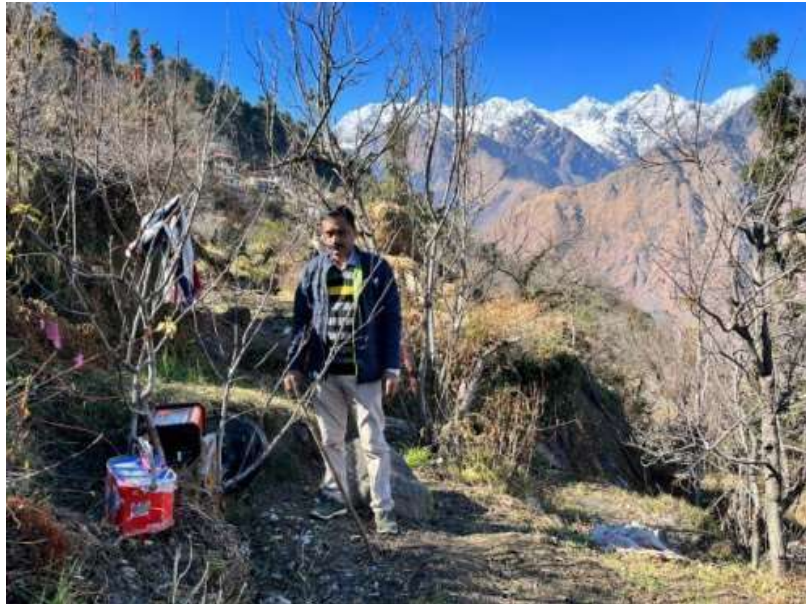
**Site-1 (ERT-1): In agricultural land of Sh Vinod Saklani, Upper Sunil, Joshimath, Chamoli District**

First 2D electrical resistivity tomography (ERT-1) has been carried out across the cracks developed in agricultural land of Sh Vinod Saklani Joshimath area, District Chamoli, Uttarakhand. Length of ERT profile was 105 m. Resistivity value received during ERT indicates that boulders are embedded into loose sediments. Saturated formation occurs at a depth of 15 m below ground level (Figure 7A & 7 B).

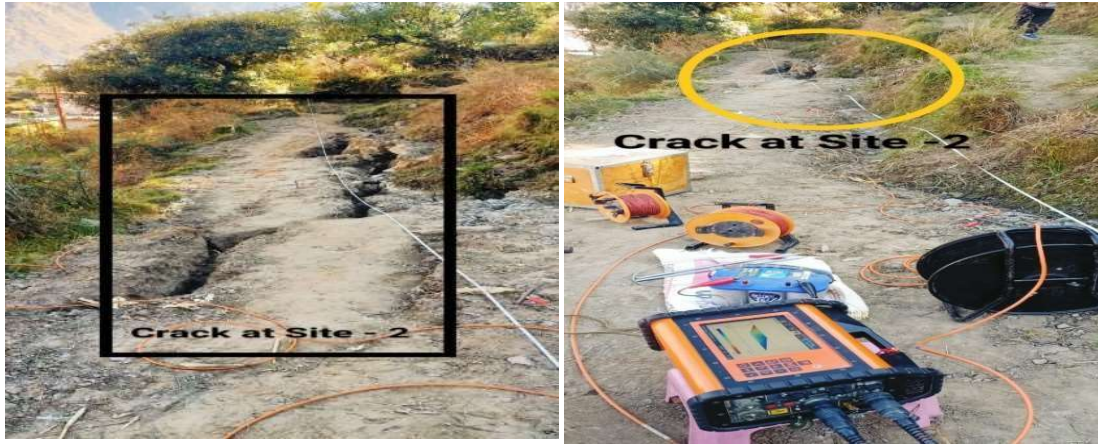
Site-2 (ERT-2): In agricultural land of Village Manoharbagh, Joshimath, Chamoli District

Second ERT has been conducted at Manohar Bagh area of Joshimath town where intensity of cracks is maximum. Length of ERT profile was 180 m and maximum depth of investigation is about 35 m bgl. Altitude of the ERT point is 1920 m amsl and it is about 500 m distance towards north from ERT-1. The ERT results shows that the loose formation and boulders are present under saturation with water below the depth of 30 m bgl (Figure 8A & 8 B).

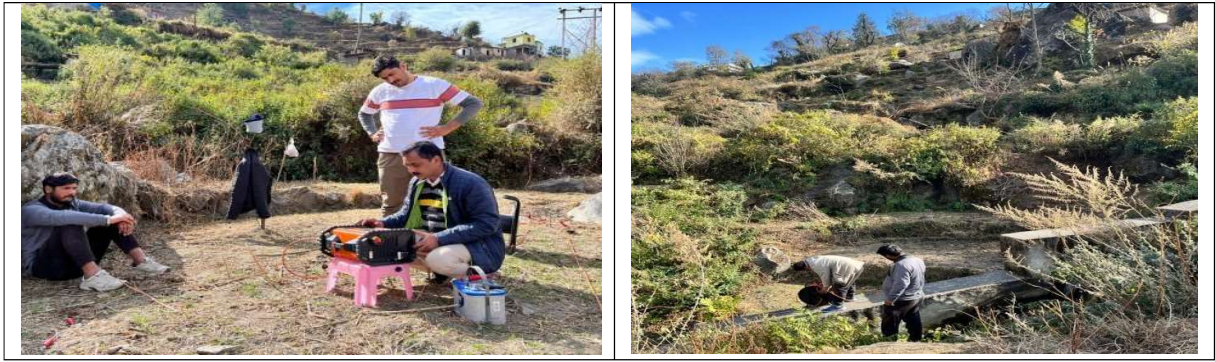
**Site-3 (ERT-3): In open land, between Singhdhar and JP Premise, Joshimath, Chamoli District**

Third ERT was conducted 200 m south of the spot where sudden gush of water occurred on 2 / 3<sup>rd</sup> of January 2023. Here, the spread of ERT profile was 230 m and maximum depth of investigation was about 50 m (Fig.9A & 9B). ERT-3 results shows that area lying west of the cracks zone is consolidated in nature. East of the cracks zone have resistivity values in range of 200 – 300 ohm.m at a depth of 10 m to 50 m bgl which indicates the formation encounter in this depth range is saturated with water on the ERT profile between distance 100 and 170 m. It has the 70 m in horizontal extends which may act as path of the subsurface water flow.

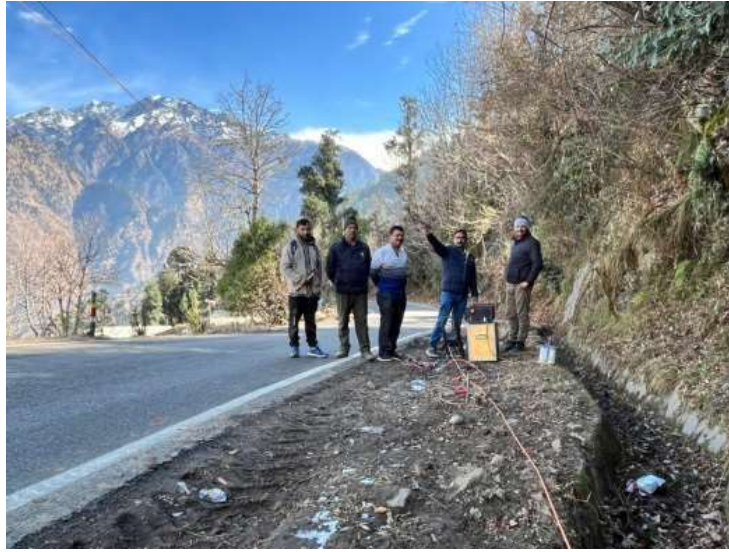
**Site-4(ERT-4): Just above the Upper Sunil Village towards Auli Joshimath, Chamoli District**

ERT-4 carried out along the Auli road in NW-SE direction about 200 m towards SW of the Sunil Village (Fig. 10 A & 10 B). A patch of low resistivity (100-300 ohm.m) was observed on the ERT-4 profile line between the distance of 50 and 100 m indicates the presence of saturated loose formation with boulders up to depth of about 25 m bgl.

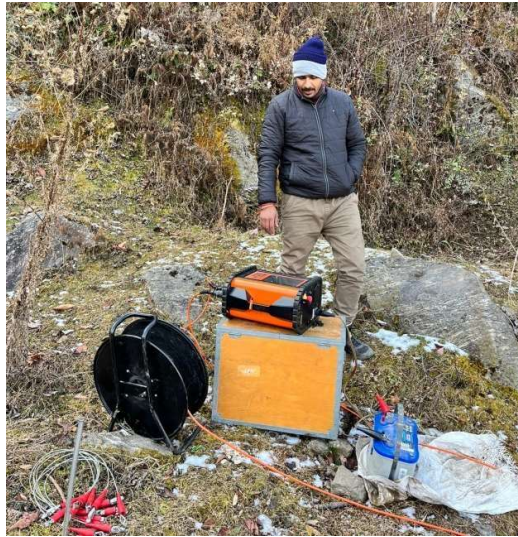
**Site-4(ERT-5): Just above the Upper Sunil Village towards Auli Joshimath, Chamoli District**

ERT-5 conducted as a roll along of ERT-4 towards east covering profile length of 250 m distance (Fig. 11A & 11 B). A patch of relatively low resistivity (800-900 ohm.m) was also observed compared to the surrounding resistivity values (more than 2000 ohm.m) on ERT-5 profile between 120 and 170 m distance on profile line. It may be indication of fracture in consolidated rock up to the depth of about 10 m bgl.

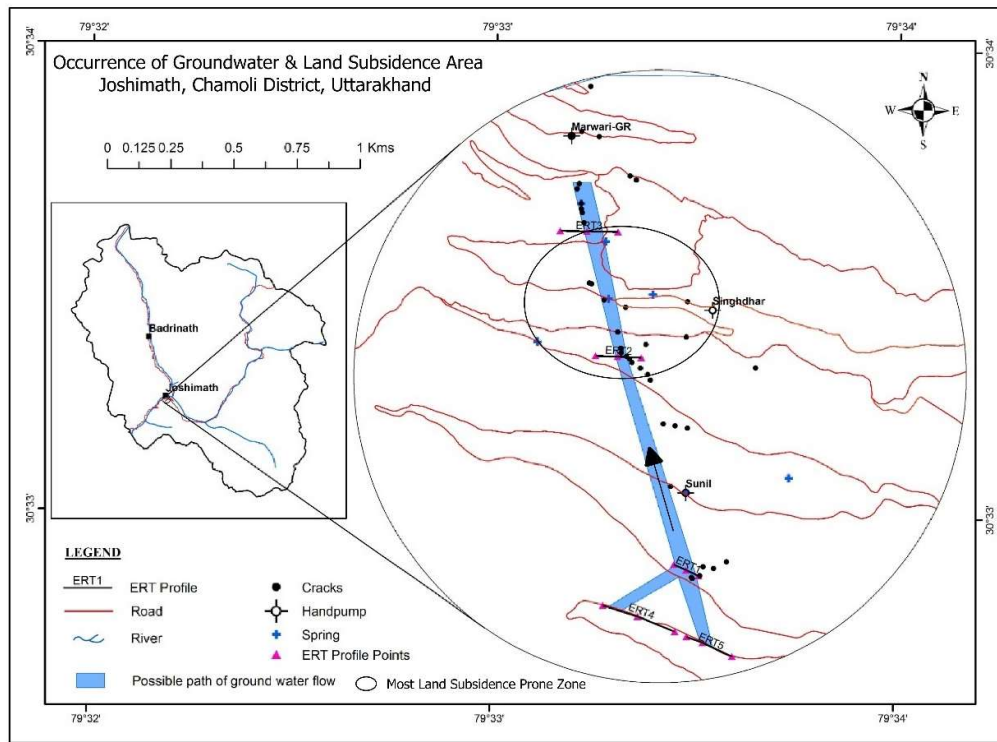
**Figure – 13- Occurrence of Groundwater and Land Subsidence Area, Joshimath, Chamoli District**

On perusal of the Figure 12 A, it is observed that thickness of the unconsolidated material increasing from Auli Road to J P Colony. Occurrence of water saturated formation becomes deeper from Auli Road to J P Colony. Ground water flows towards North direction (Fig 13). Large boulders are embedded in loose material especially in and around Manohar bagh. Findings of hydrogeological and geophysical studies conducted in the area reveals that the thickness of overburden (loose material) and saturated zone are comparatively more in Manohar Bagh-Singhdhar area, which may causes this area becomes susceptible to land subsidence. Further, the crack and subsidence in the area have relation with low resistivity shallow zones with groundwater flow occurring within 50 m depth.
